Investigation Report

Type of Occurrence:	Incident
Date:	21 May 2015
Location:	Frankfurt/Main
Aircraft:	Airplane
Manufacturer / Model:	The Boeing Company / B767-300
Injuries to Persons:	None
Damage:	Minor damage to aircraft
Other Damage:	None
Information Source:	BFU staff
State File Number:	BFU 15-0553-PX

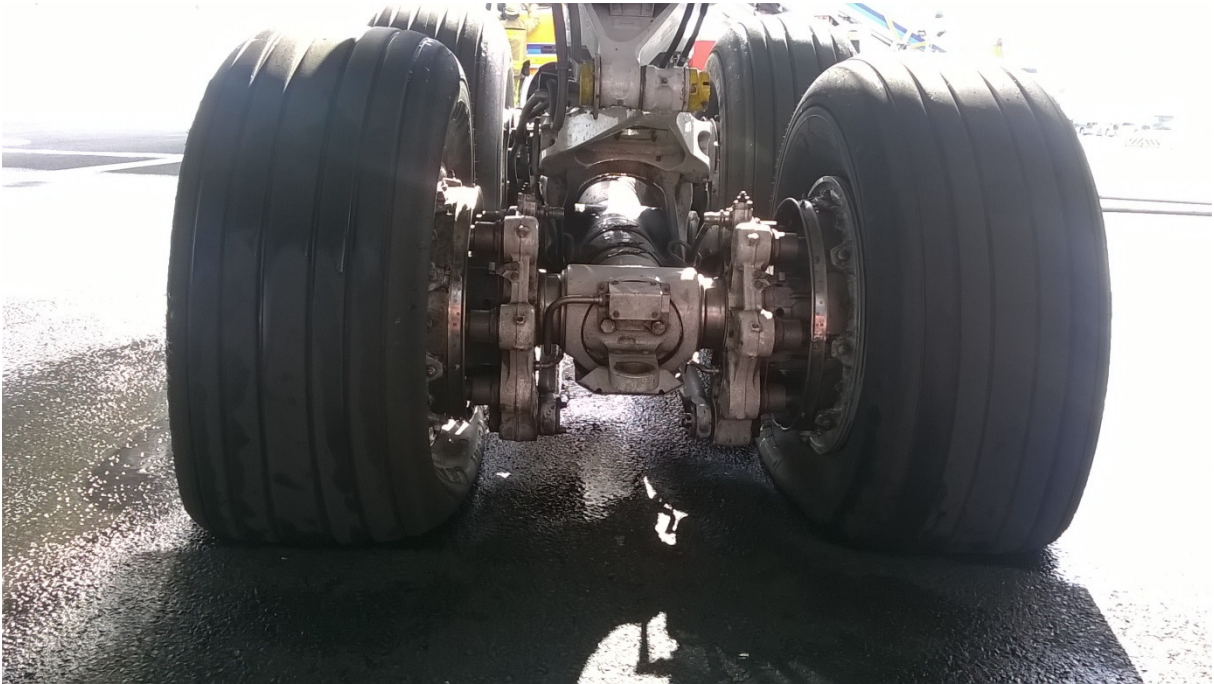
Left main landing gear

arrival determined red-hot brakes. The fire brigade cooled them down. The front wheels of the left main landing gear showed complete pressure loss.

The operator had inspected the main landing gears and determined damages on all four axes. The melting plug of the front wheels of the left main landing gear had melted. The front wheels of the left main landing gear showed total pressure loss. The brakes of the wheels 1, 2, 3, 4, 5, 7, and 8 leaked hydraulic fluid.
