# Factual Report

| Type of Occurrence: | Serious incident |
| Manufacturer / Model: | The Boeing Company / B 747-8 |
| State File Number: | BFU 15-1075-5X |

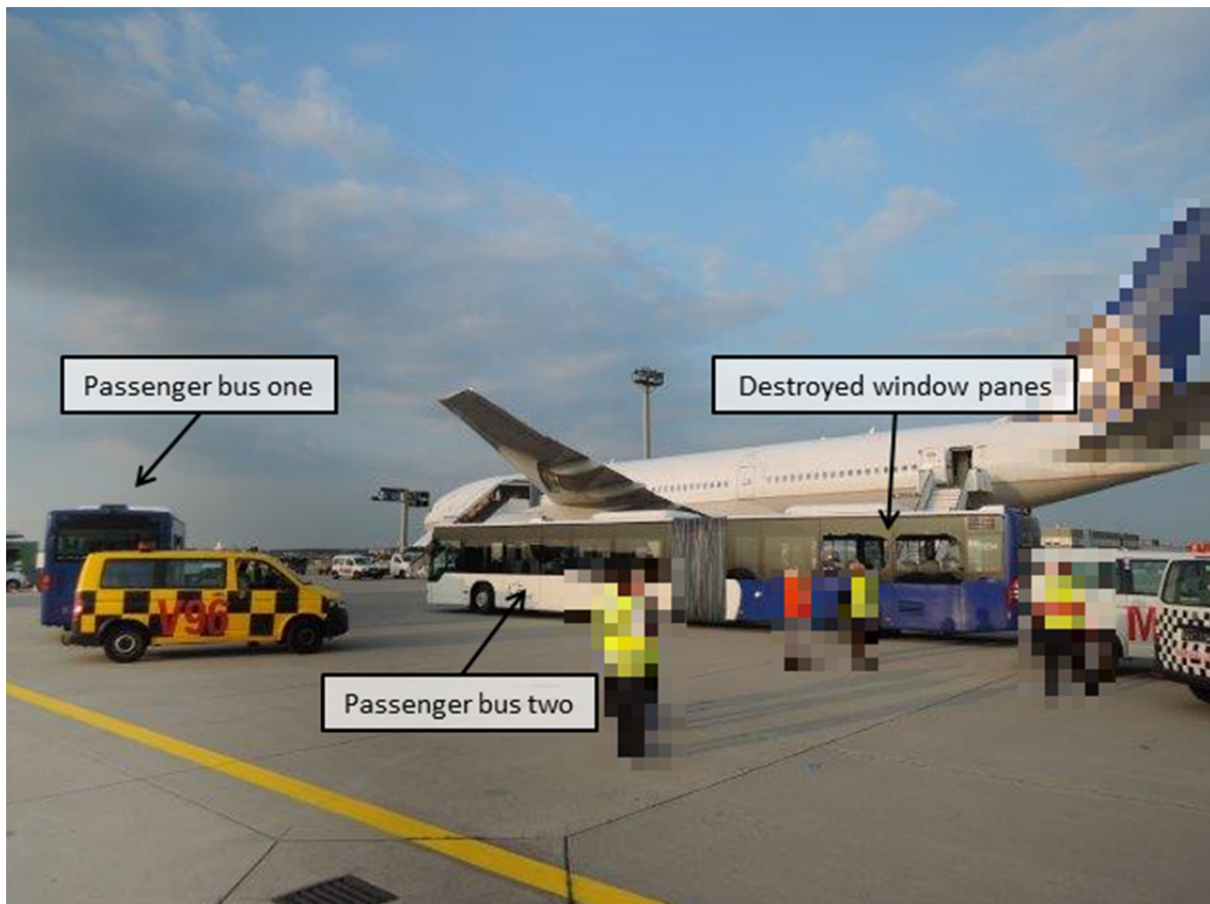
View on parking position V129 in westerly direction

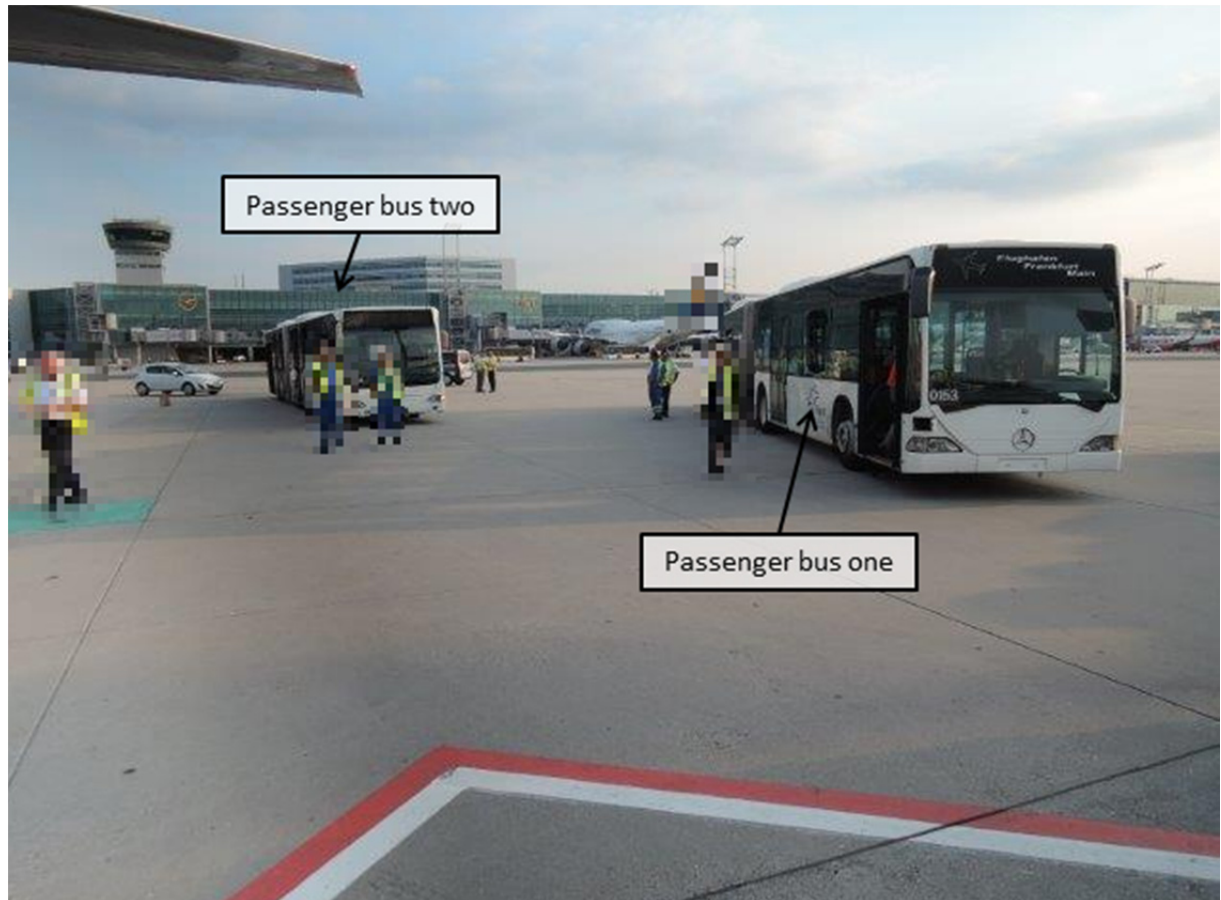
The second bus had already begun to board passengers of an aircraft parked at parking position V129. Two windows on the aft left part of the bus were destroyed. According to witness' statements approximately 70 passengers had at that time already been on board. One passenger suffered from minor cuts to the face.

On the right side of the first vehicle one window between the front and centre access door had been destroyed. The aft left engine cover of the vehicle had been torn from its mounting and deformed. Two windows at the aft left side, abeam of the rear axle, of the second bus, which was positioned at parking position V129, had been destroyed. The fracture pieces burst through the open rear door (right) of the vehicle on to the apron. Witnesses stated that the pieces had scattered across parking position V129.

Damaged passenger busses on V129

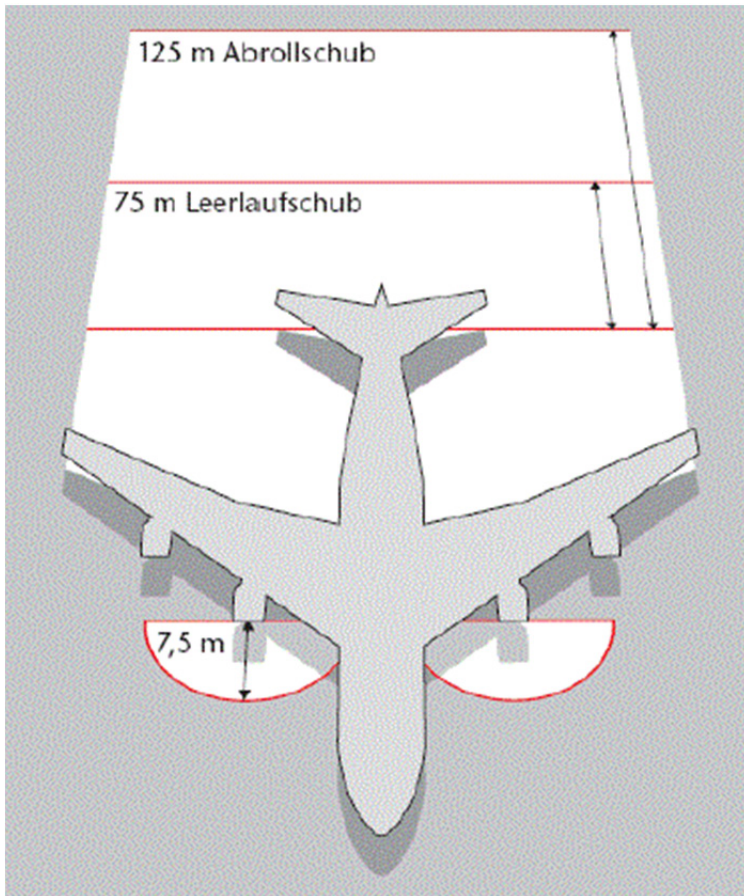
The traffic and registration regulations 1.3 (7) of Frankfurt/Main Airport stipulated the following: *“Behind aircraft taxiing autonomously (rolling thrust) by means of turboprop engines a safety distance of 50 m, and with jet engines of 125 m has to be adhered to. The operator describes in the Operations Manual Part-B (OM-B) 2-3-10 Taxi the use of thrust during taxiing: “[...] Idle thrust is adequate for taxiing under most conditions. A slightly higher thrust setting is required to begin taxiing. [...]. Breakaway power should be limited to 40% N1!” OM-B 2-1-70 states: “One or two engine(s) should be shutdown for environmental reasons and fuel saving, taking into account*

Safety distance behind taxiing aircraft

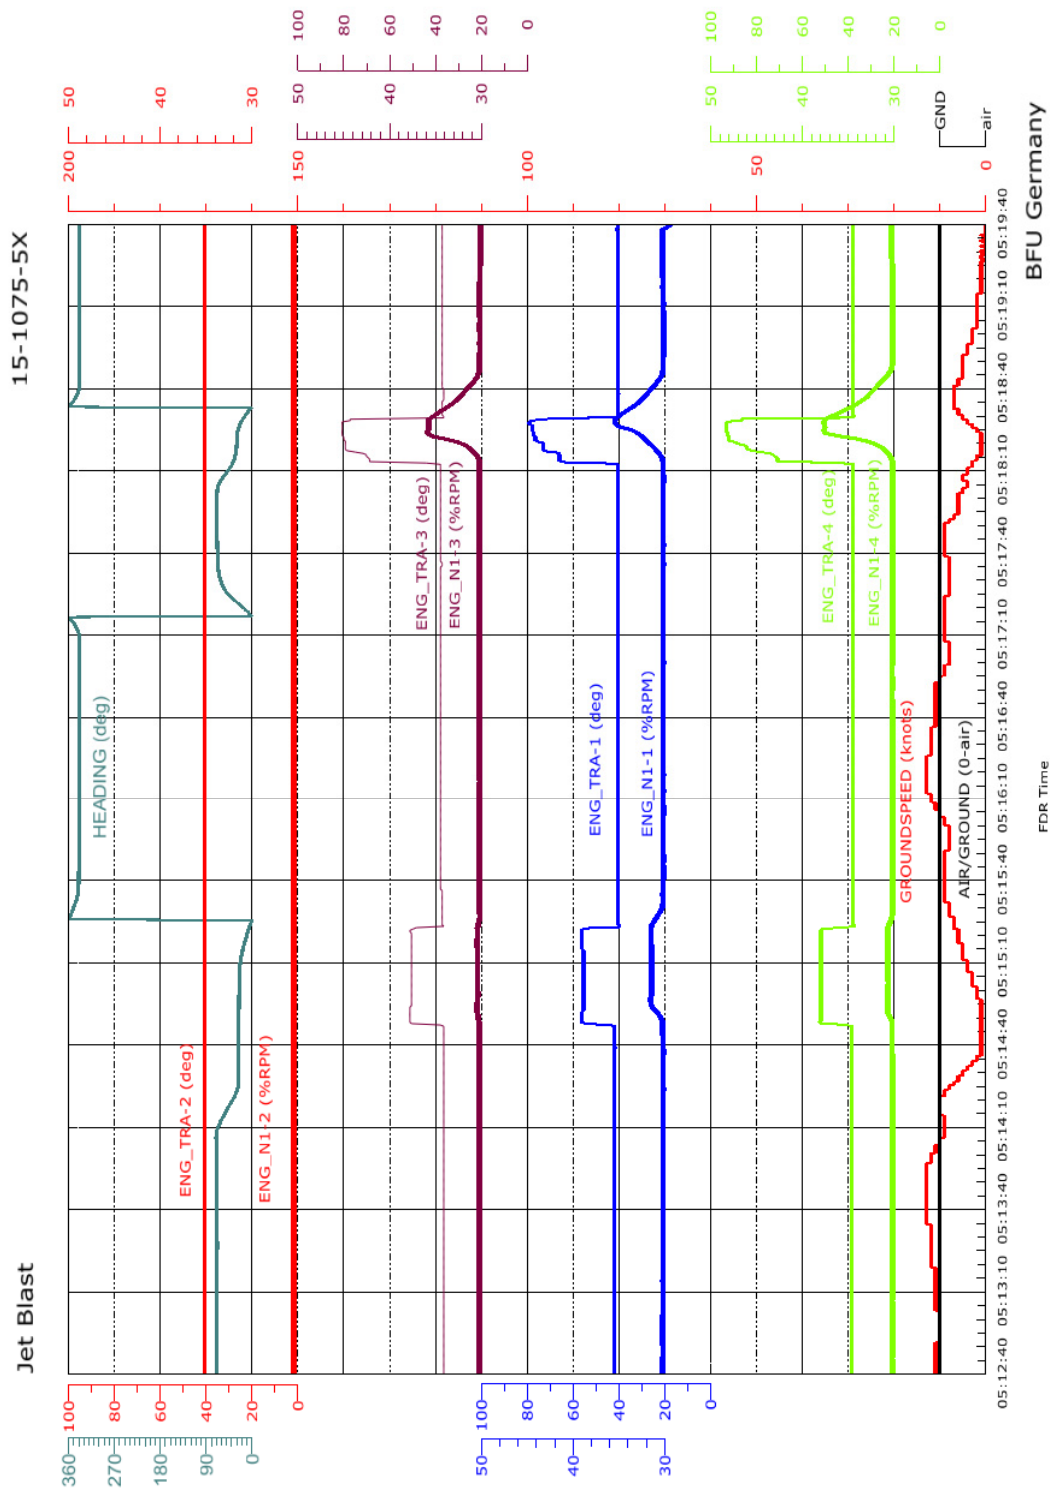
FDR data graph

The Flight Data Recorder (FDR) recording showed that the heading of the aircraft changed approximately 10 minutes and 58 seconds after the landing over a time of 35 seconds from 070° to 330°. During this time period the recorded groundspeed decreased from 5 kt to 1 kt and increased again to 7 kt. At the same time the FDR recorded an increase of engine rpm N1 of engine #4 (right outer engine) to 50%. Engine rpm of the engines #1 and #3 were recorded with 40% N1 and 43% N1, respectively. Engine rpm of engine #2 was 0% N1.
