# Investigation Report

Type of Occurrence:	Serious incident
Date:	14 May 2017
Location:	Near Munich
Aircraft:	Airplane
Manufacturer / Model:	Boeing / B737-600
Injuries to Persons:	None
Damage:	None
Other Damage:	None
State File Number:	BFU17-0501-EX

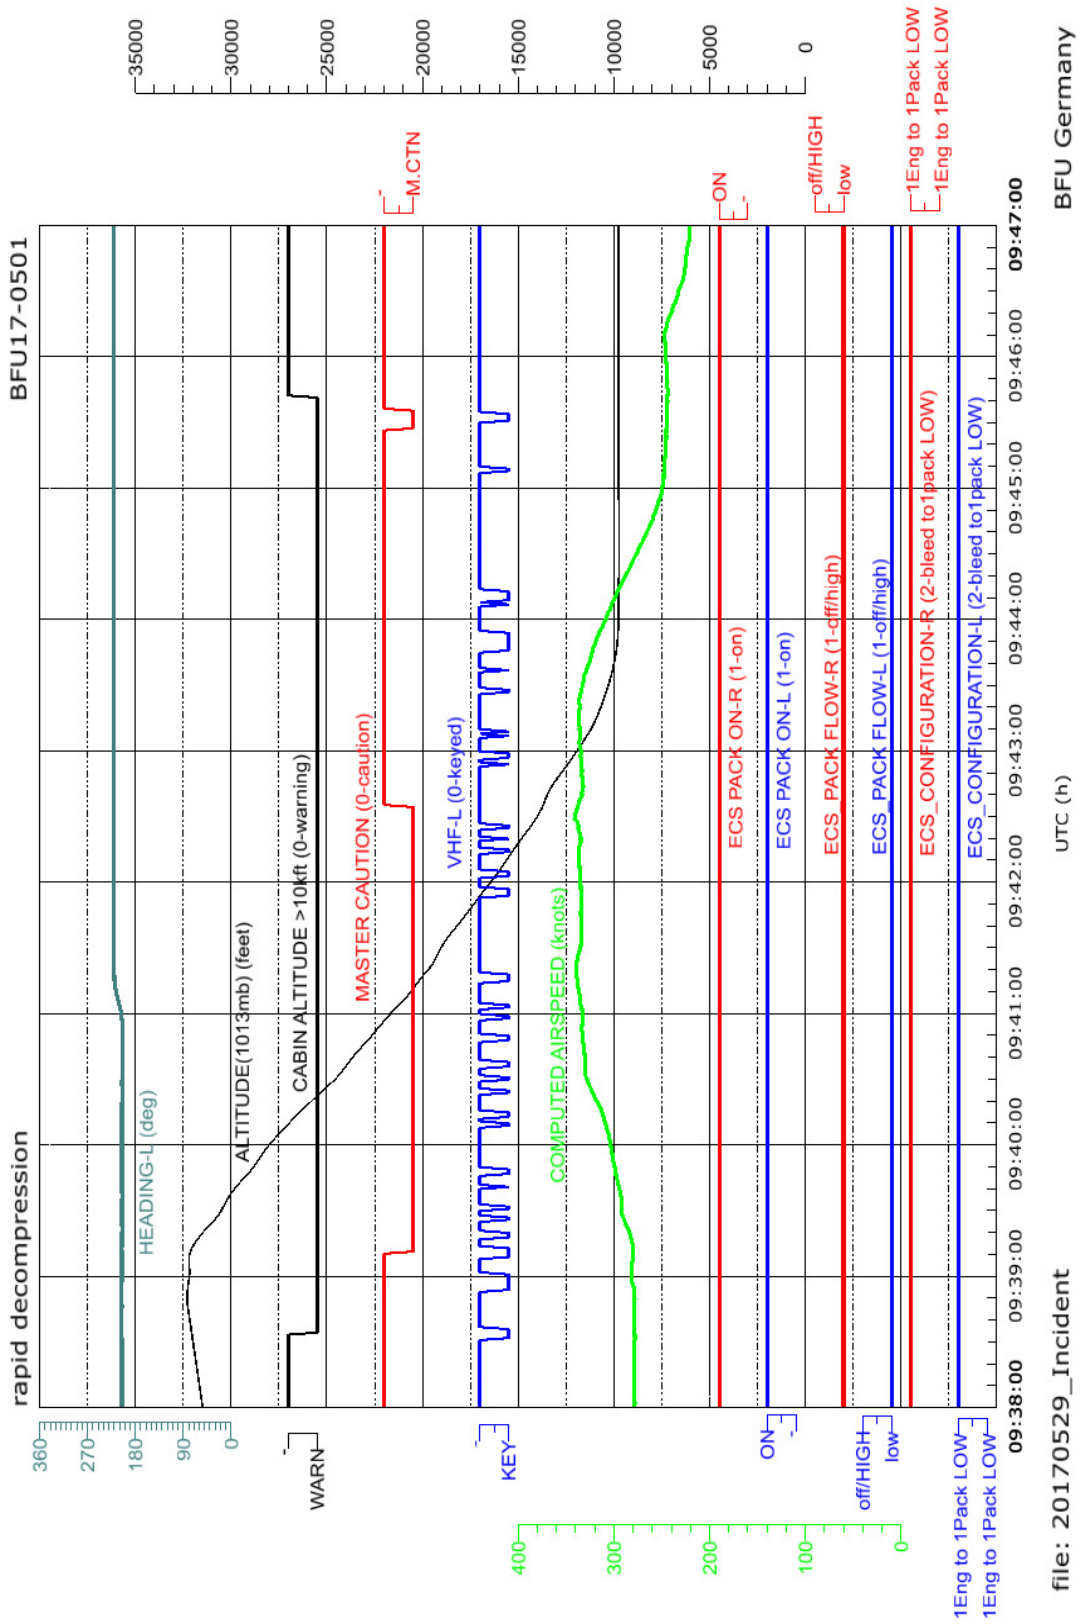
The following graph shows the technical reaction of the cabin altitude switch (CABIN ALTITUDE > 10kft) during the time of the event until a flight altitude of 10,000 ft was reached. The black line (ALTITUDE 1013mb) represents the progression of the barometric altitude until an altitude of 10,000 ft was reached. Both packs were switched on.

Both Cabin Pressure Controllers (CPC) were read out. Both had recorded the error High Cabin Air Leak Rate. One condition for this error being recorded is that the cabin pressure rate was more than 2,000 SLFPM (sea level feet per minute).

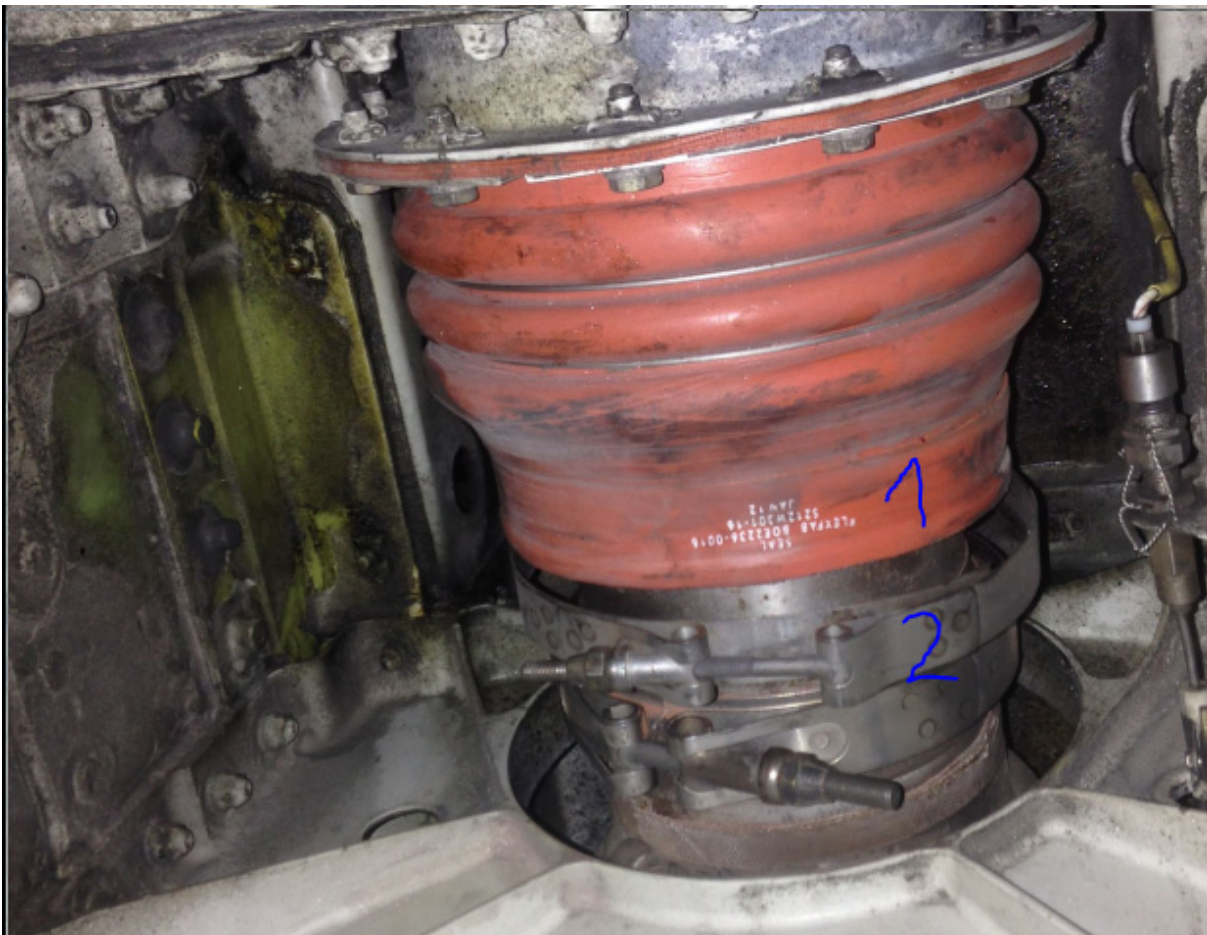
A leaky valve at the bulk seal at the keel beam of the APU bleed duct was identified as reason for the depressurisation.

The following photo shows the loose clamp in position 2 which should have been above the bulk seal in position 1.

Bulk seal including loose clamp

After the irregularities had been eliminated a cabin pressure test was conducted which revealed leakage at the left-hand pack. After the left-hand pack had been closed down the leak tightness of the pressurized cabin was established and the aircraft cleared for service in accordance with the Minimum Equipment List (MEL) for a flight without passengers up to FL250.
