# Investigation Report

Type of Occurrence:	Incident
Date:	16 June 2017
Location:	Hamburg
Aircraft:	Airplane
Manufacturer / Model:	Airbus Industry/A319-114
Injuries to Persons:	None
Damage:	None
Other Damage:	None
State File Number:	BFU17-0716-PX

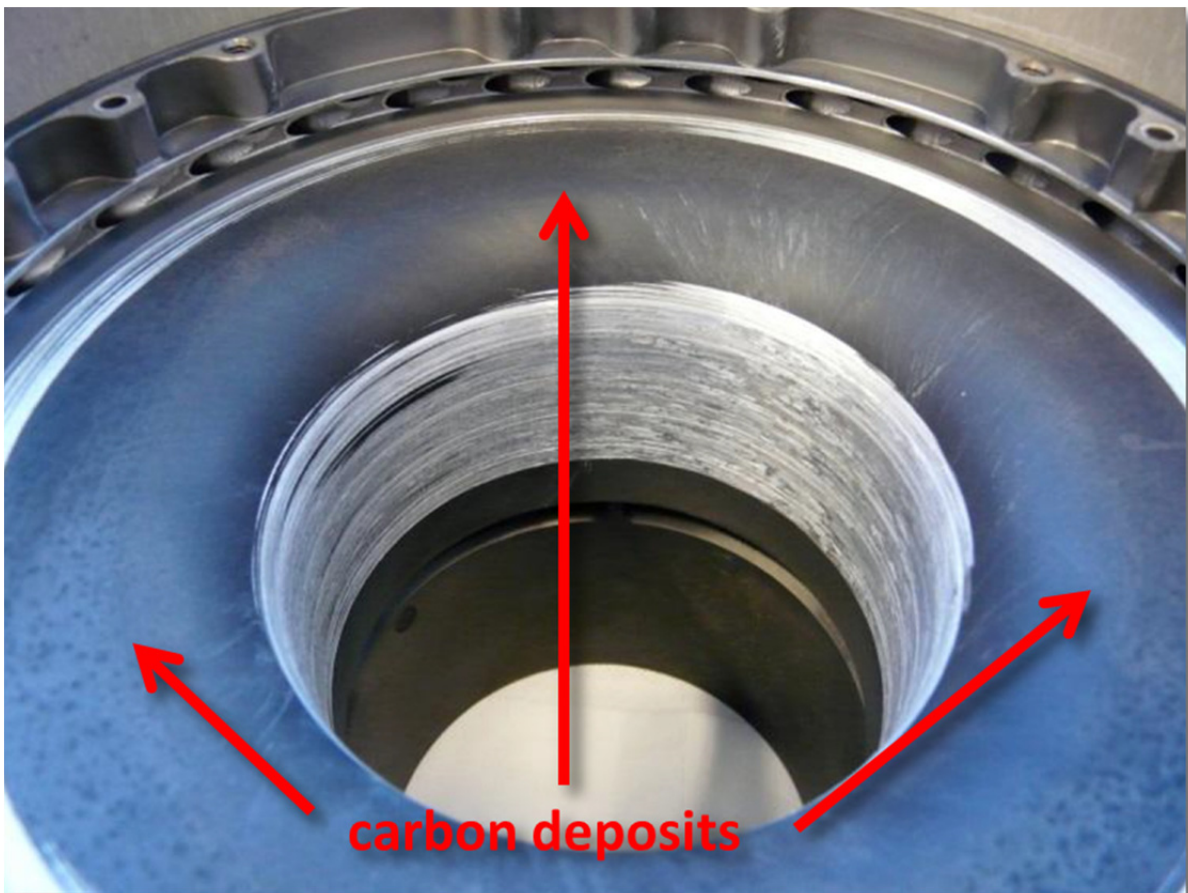
The turbine casing showed heavy chafing marks caused by the turbine wheel. The surface was scratched and showed chafing marks caused by the high temperatures the chafing of the turbine wheel had generated.

The dark colour was caused by carbon deposits during normal operation.

(2) Turbine casing of the air cycle machine

During normal operation of the air bearings the metal does not come into contact with the disc. The journal bearing failed and caused a compressor shaft imbalance. It chafed against the inside of the turbine casing. The turbine casing and the compressor shaft consisted of an aluminium alloy.

The maintenance organisation of the operator examined the left air conditioning system (PACK No. 1) and determined that the cause for the smoke development was a defective air cycle machine. As part of the maintenance work, the air cycle machine and a recirculation filter were replaced. After the components had been installed both air conditioning systems (PACKS No. 1 and 2) were checked. Their proper function, without any irregularities, was determined. On 17 June 2017 the aircraft was released to service.

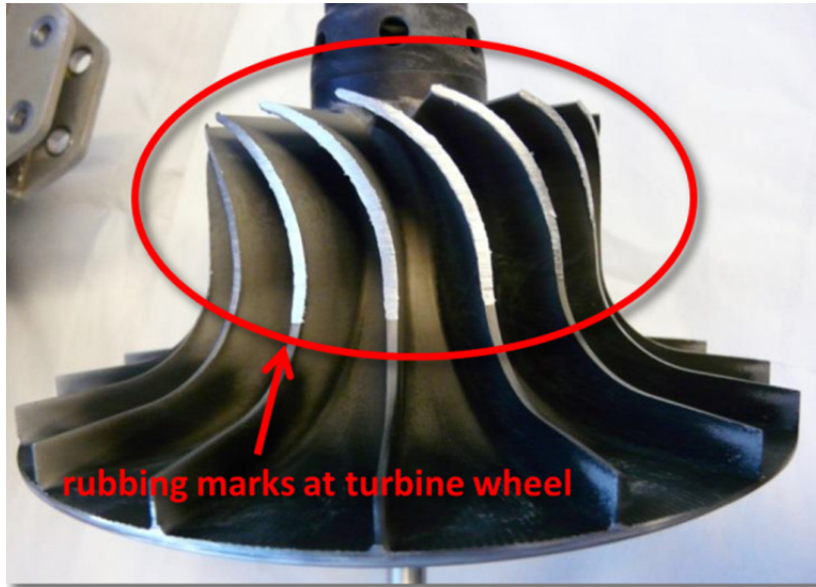
The turbine wheel showed corresponding rubber marks resulting from the chafing against the turbine casing. The dark colour at the air intake of the turbine wheel was due to carbon deposits during normal operation.

(3) Turbine wheel within the air cycle machine

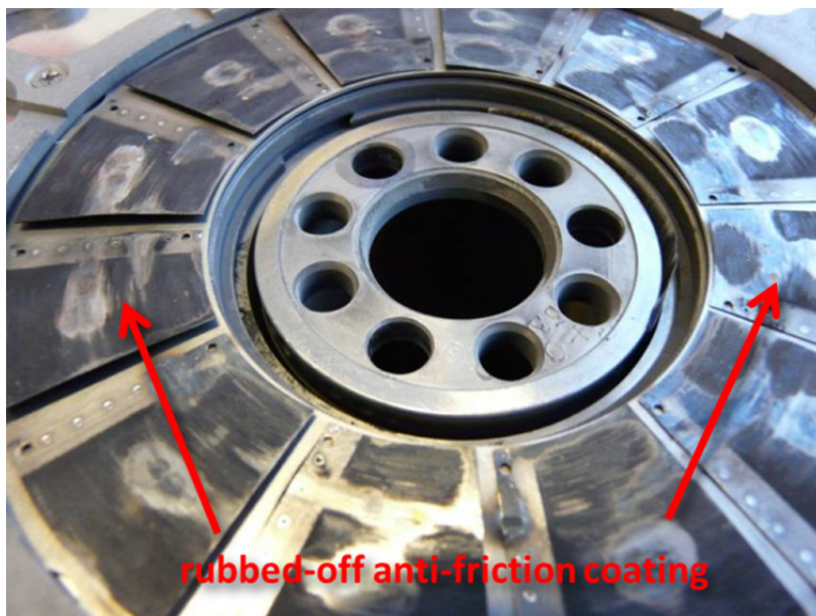
The thrust bearing showed chafing marks and rubbed-off anti-friction coating.

(4) Thrust bearing (anti-friction coating)

The thrust bearing failed and the disc chafed against the anti-friction coated metal with high rotational speed. This caused the overheating of the air bearing. The failure of one of the journal bearings at the turbine side was identified as the cause of the smoke and smell development. The maintenance organisation stated that such a damage pattern is not unusual if an air cycle machine fails.

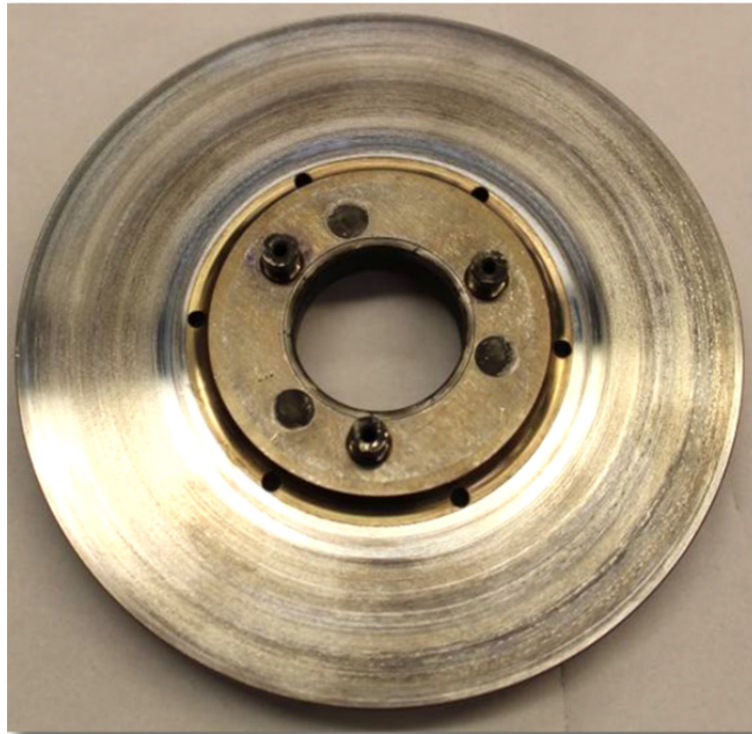
On the turbine side the disc showed chafing marks.

(5) Disc

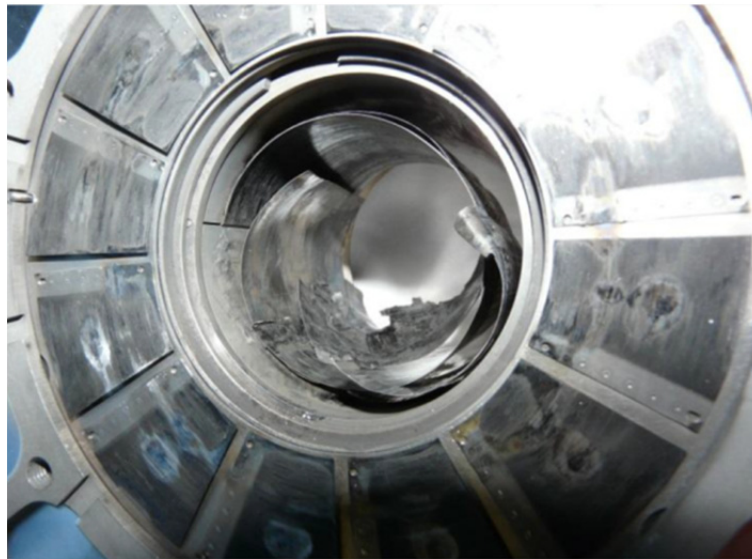
At the turbine side the journal bearing failed. This journal bearing was an air bearing.

(6) Defective journal bearing

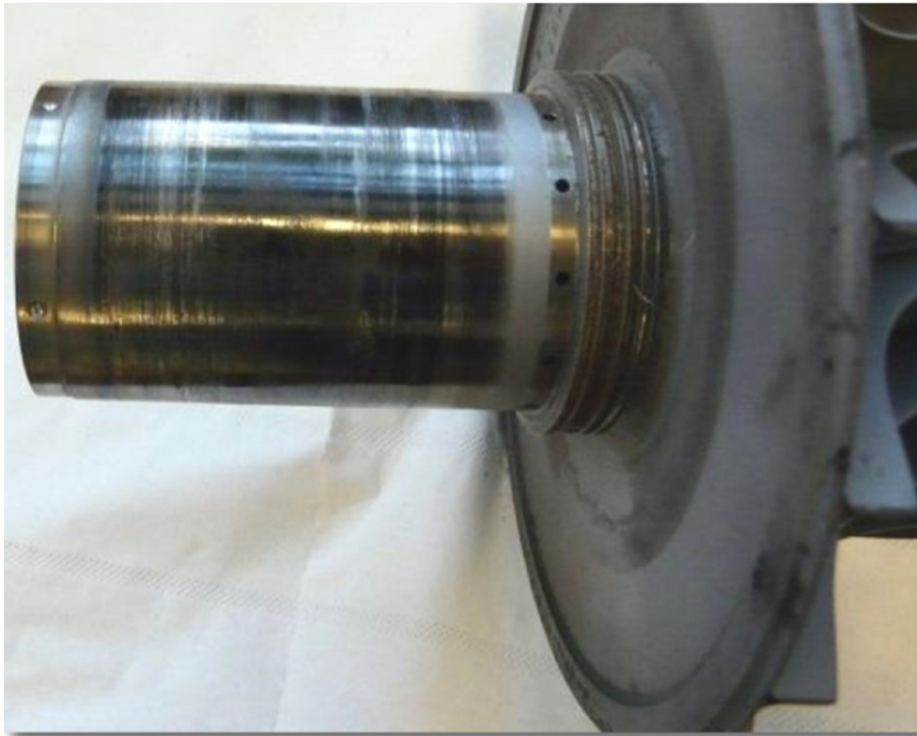
Worn and discoloured compressor shaft as a result of the failed journal bearing.

(7) Worn and discoloured compressor shaft

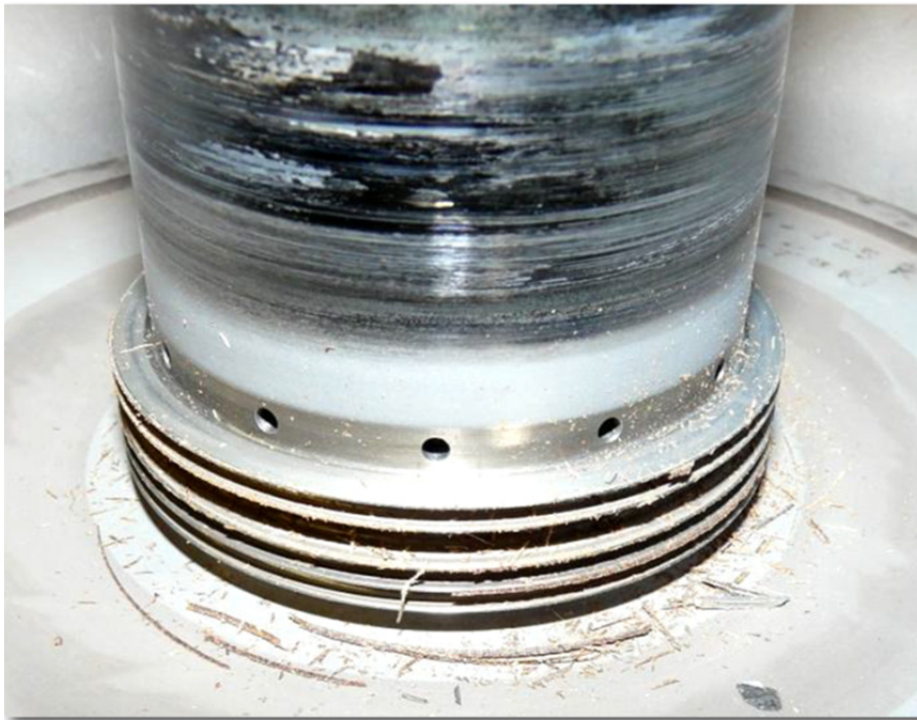
(8) Abraded compressor shaft
