Investigation Report

Type of Occurrence:	Accident
Date:	2 April 2018
Location:	Near Uetersen/Heist Airfield
Aircraft:	Helicopter
Manufacturer / Model:	Bell Helicopter Textron Canada (BTHC) / Bell 206L-1
Injuries to Persons:	None
Damage:	Aircraft severely damaged
Other Damage:	Damage to forest
State File Number:	BFU 18-0324-3X
Published:	September 2018

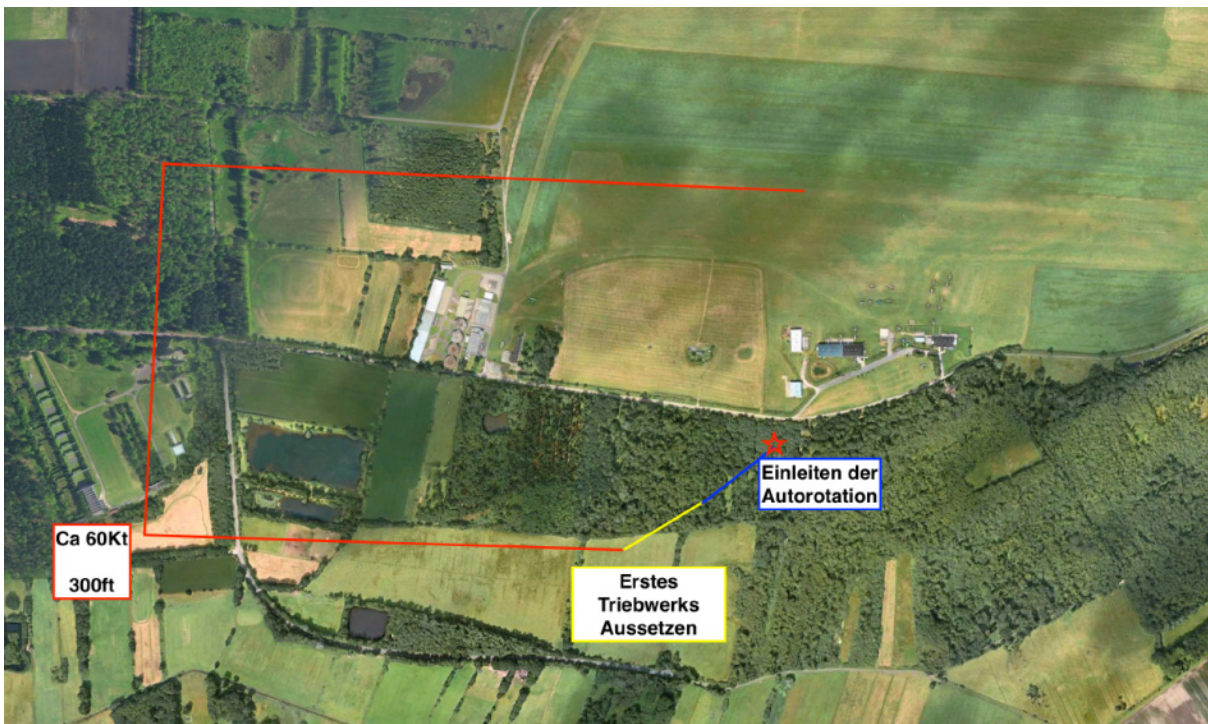
Reconstruction of the flight path

Above the trees he had flared the helicopter, pulled the pitch fully and in the last moment yawed consciously by about 180°, because he did not want hitting the trees in a forward direction. Then the helicopter had fallen from only a few meters vertically into the trees.

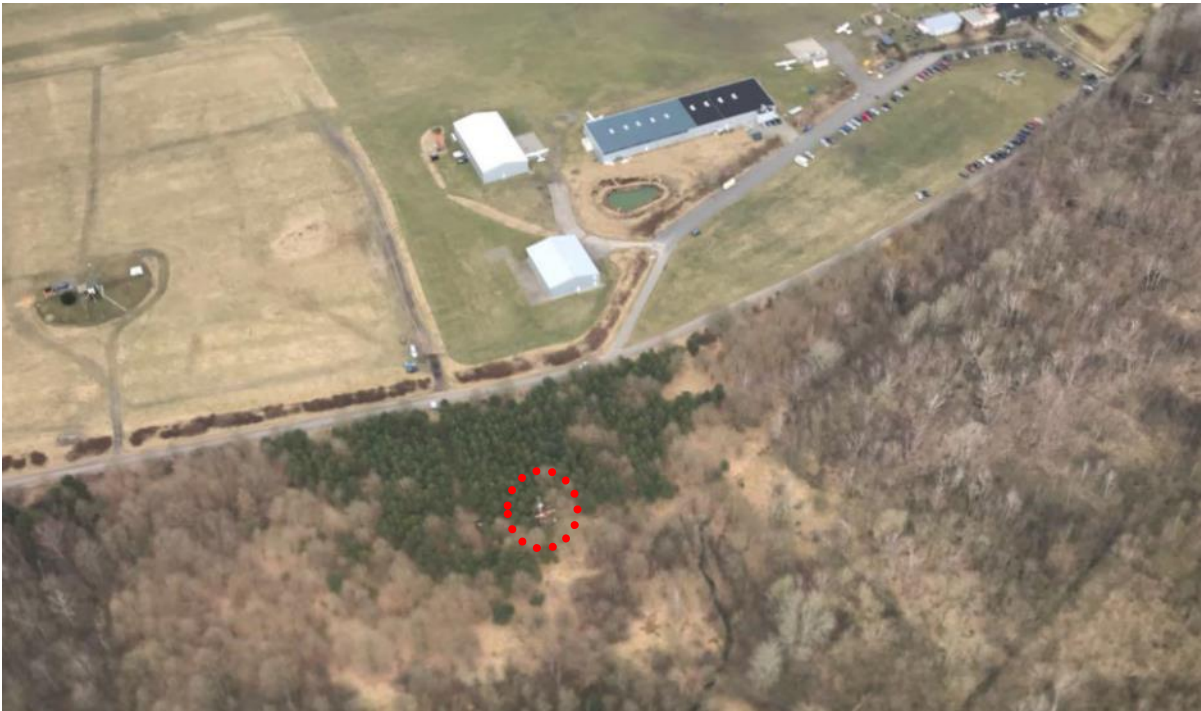
The accident site was located approximately 60 m south of the airfield street and about 450 m south of runway 09/27 in a wooded area.

The helicopter stood/hung upright tilted slightly to the right towards 190° at the southern edge of a young forest plantation with fir trees about 5 m high.

Accident site south of EDHE Airfield

The helicopter had sustained damage primarily to the right fuselage side. There the fuselage showed several holes. The tail rotor drive shaft had been twisted and severed at approximately half its length. The main drive shaft was intact. The free-wheeling unit opened and locked as designed. The main rotor blades showed multiple damages in the area behind the leading edges or the holm profile, respectively. The right skid tip was bent and torn from the front crosstube towards the fuselage centre. The tail boom showed several dents.

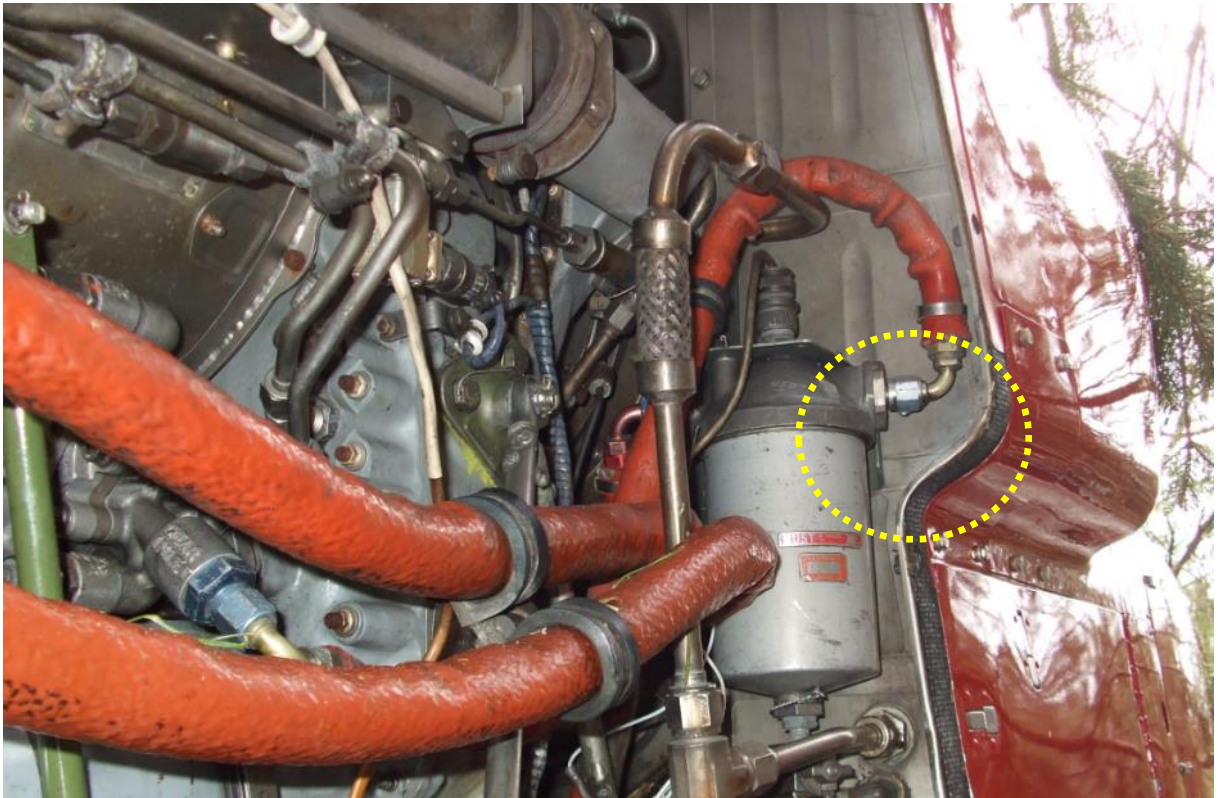
After the battery had been reconnected the caution and warning lights were checked. Warning lights for metal chips did not illuminate. The fuel gauge showed more than 200 lbs. One after the other, both electrical fuel pumps were switched on. The function of the pumps could be heard. Once the respective fuel pressure was reached the warning light shut off. After fuel pressure had been generated leakage at the screw fitting at the fuel pipe from the fuel filter to the engine fuel pump was determined. Fuel leaked directly at the filter. The screw fitting was only hand-tight.

Leaking screw fitting

On 16 April 2018 a Part-145 maintenance organisation examined the screw fitting of the fuel pipe to the fuel filter. According to the engine manufacturer it should be fastened with 80-120 lb/in. Already with a slight fastening torque (less than 40 lb/in) the fitting was free of leakage under normal operating pressure (30 psi).

On 26 June 2018 the engine was examined in the USA under the supervision of the FAA and the presence of the expert of the engine manufacturer. Engine start-up and the test run were uneventful. All test run parameters required by the engine manufacturer were met. The expert of the engine manufacturer did not notice any indications of other causes for the engine failure than the loose fuel pipe found at the accident site.

A good practice recommended in aviation as basically useful action: *Mark installed hardware with torque seal/lacquer after it has passed torque check. The marking allows visual detection of hardware that may have loosened before it falls off.*

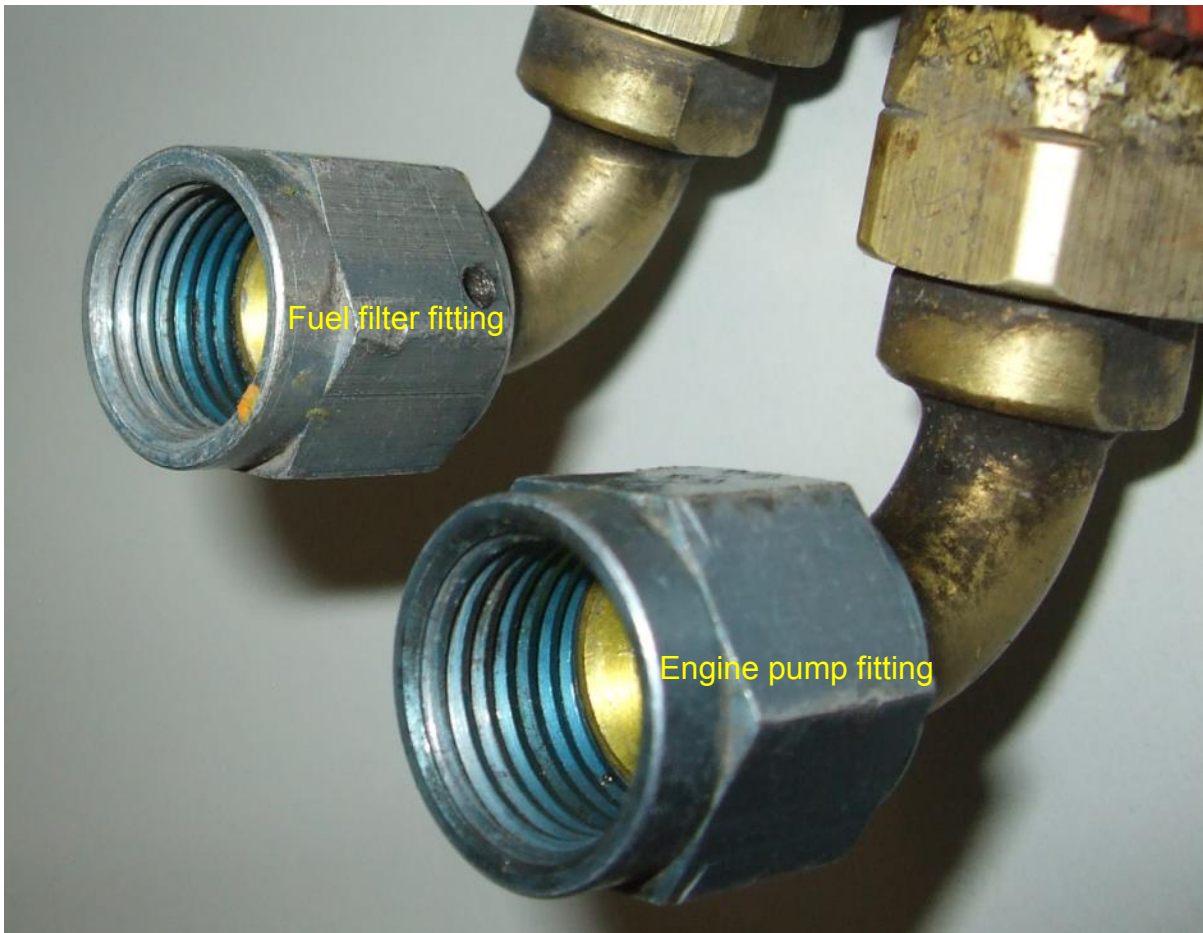
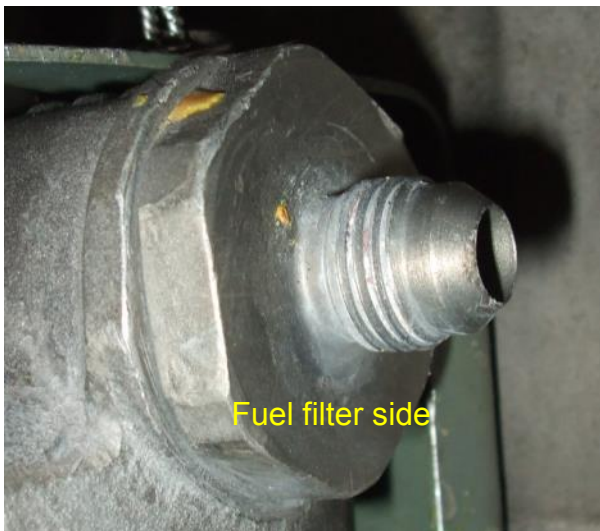
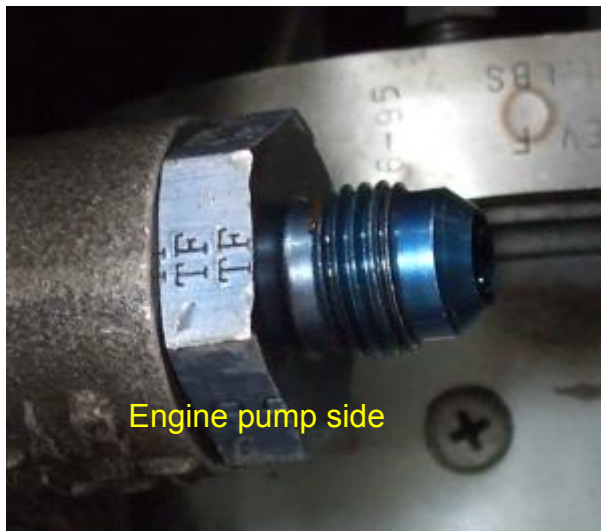
Screw fitting of the fuel pipe

On 7 April 2018 the BFU examined the engine together with an expert from the engine manufacturer. No external damages, which could have been considered to be the cause for the engine failure, were determined. N1 and N2 power trains could be rotated. No indications for any technical malfunction were found. The expert noticed individual screw fittings and maintenance actions, which were uncommon. In addition, almost no screw fitting at the engine showed any torque seal or lacquer. Often times only residue of old markings was visible.

Fuel filter side

Engine pump side
