# Interim Report

Type of Occurrence:	Serious incident
Date:	8 July 2016
Location:	Near Paris
Aircraft:	Airplane
Manufacturer / Model:	Airbus / A320
Injuries to Persons:	None
Damage:	Aircraft not damaged
Other Damage:	None
State File Number:	BFU16-0919-6X
Published:	November 2016

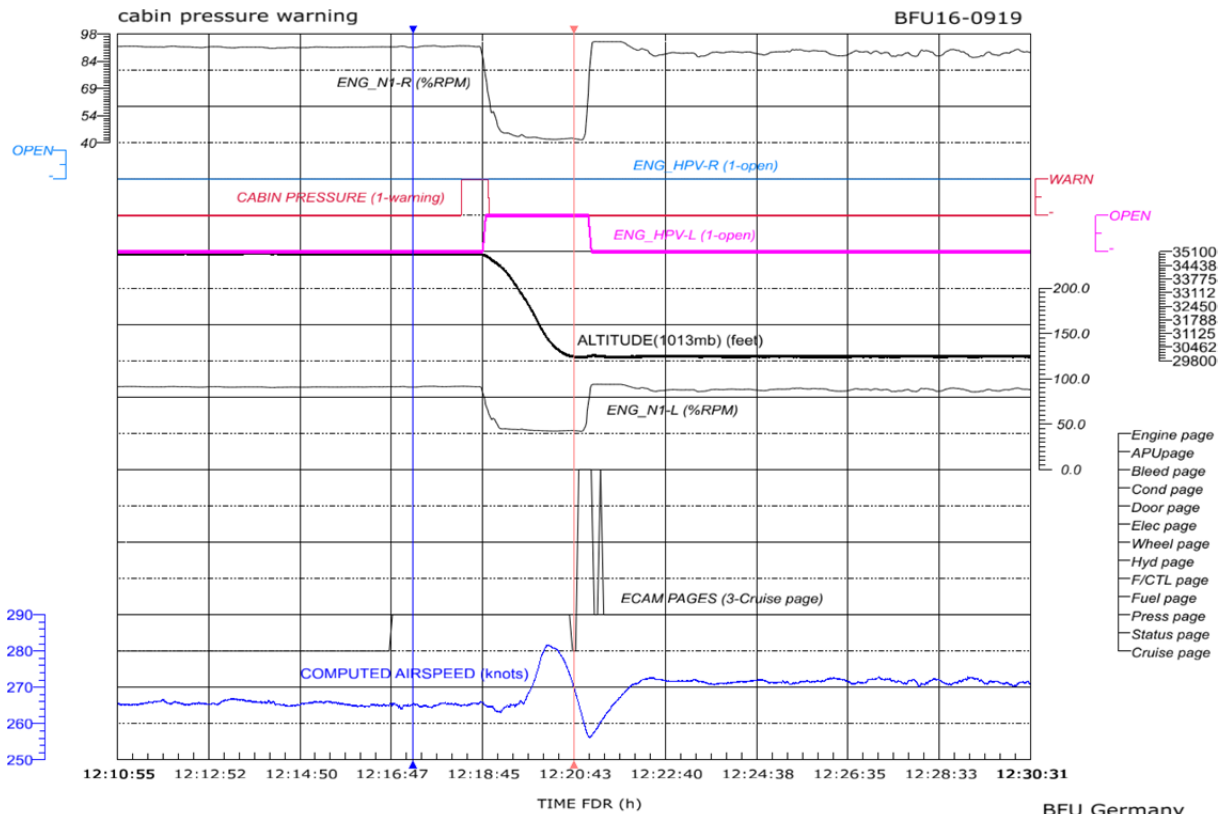
Cabin pressure warning

The graph of the FDR analysis shows the time of the cabin altitude warning.

While the aircraft was at cruising level at FL350 north of Paris, the Pressure Regulating Valve (PRV) malfunctioned. In addition, there was an error in the Thermostat Solenoid. In this combination the two malfunctions caused the pressure fluctuation in the engine bleed air system of engine No 1. The cabin pressure altitude increased and the ECAM generated a cabin pressure advisory. At that time neither of the two aircraft air conditioning systems (PACK) was supplied with engine bleed air.
