# Interim Report

Type of Occurrence:	Serious incident
Date:	31 July 2016
Location:	Stuttgart
Aircraft:	Airplane
Manufacturer / Model:	The Boeing Company / B737-800
Injuries to Persons:	None
Damage:	Minor damage to aircraft
Other Damage:	None
State File Number:	BFU16-1061-5X
Published:	November 2016

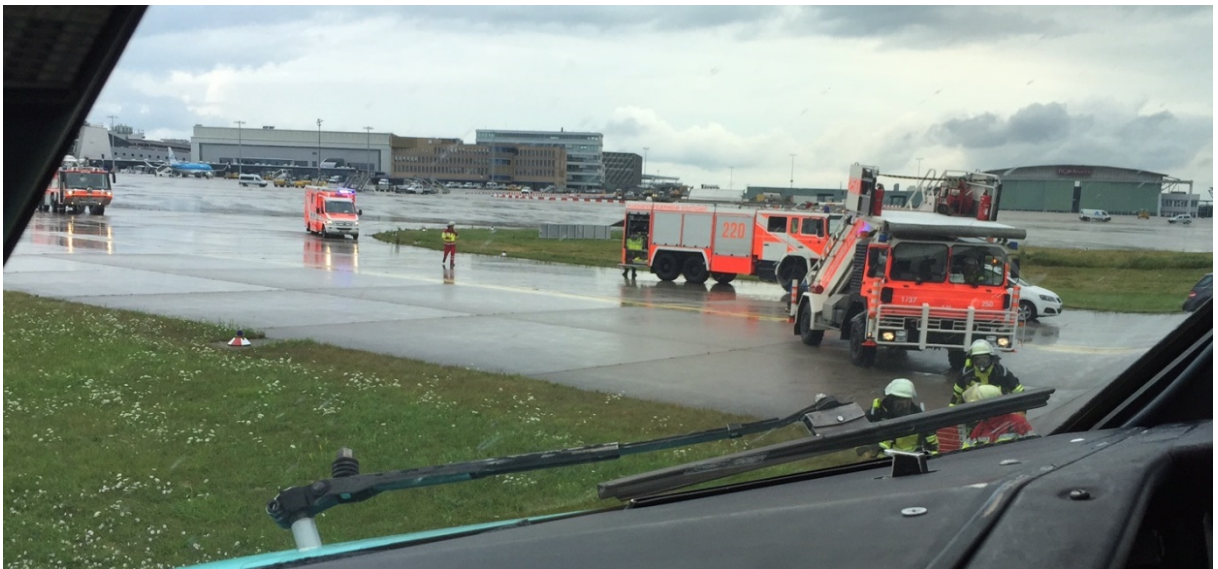
At about 1123:41 hrs the aircraft came to a stop next to taxiway I. At 1136 hrs the operations manager on duty and a paramedic entered the aircraft via a scaling ladder.

(3) Photo taken immediately after the aircraft had come to a stop

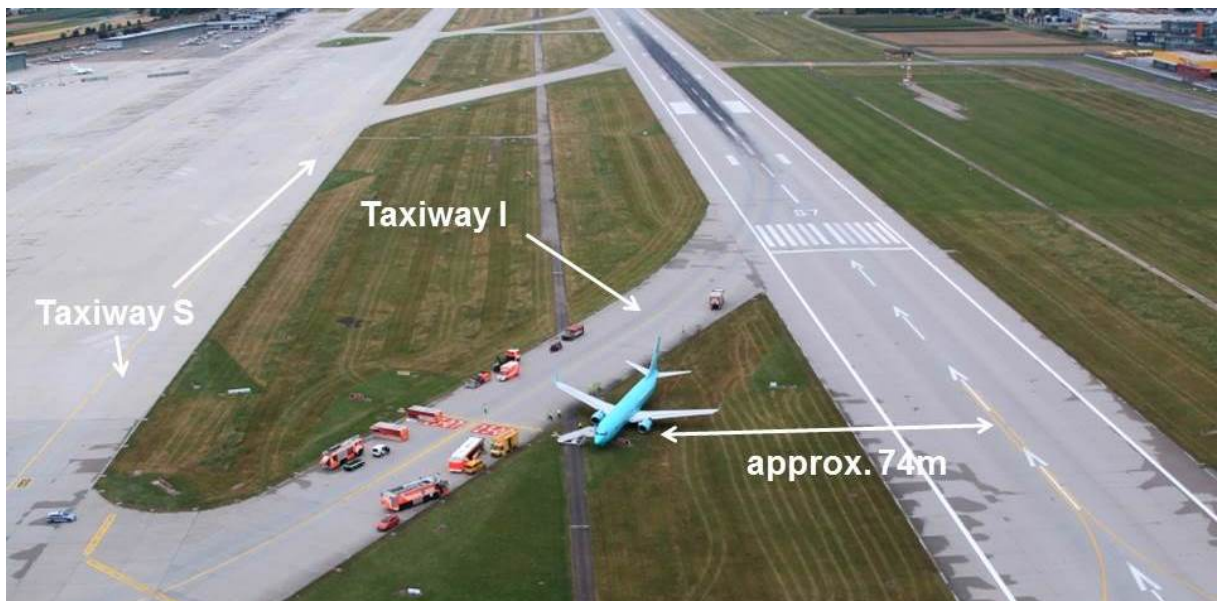
After the auto brake had been deactivated the brake pressure increased to about 1,000 psi. At that time the aircraft had a taxi speed of about 82 kt and was just about abeam of taxiway H. Then the aircraft left runway 25 and turned, with a taxi speed of approximately 61 kt, into taxiway I. As the aircraft was on taxiway I the brake pressure increased further to the maximum value of 3,000 psi. With a taxi speed of approximately 23 kt the aircraft veered off taxiway I, about abeam of the second lamp of the runway edge lighting.

(4) Aerial photo of the runway excursion

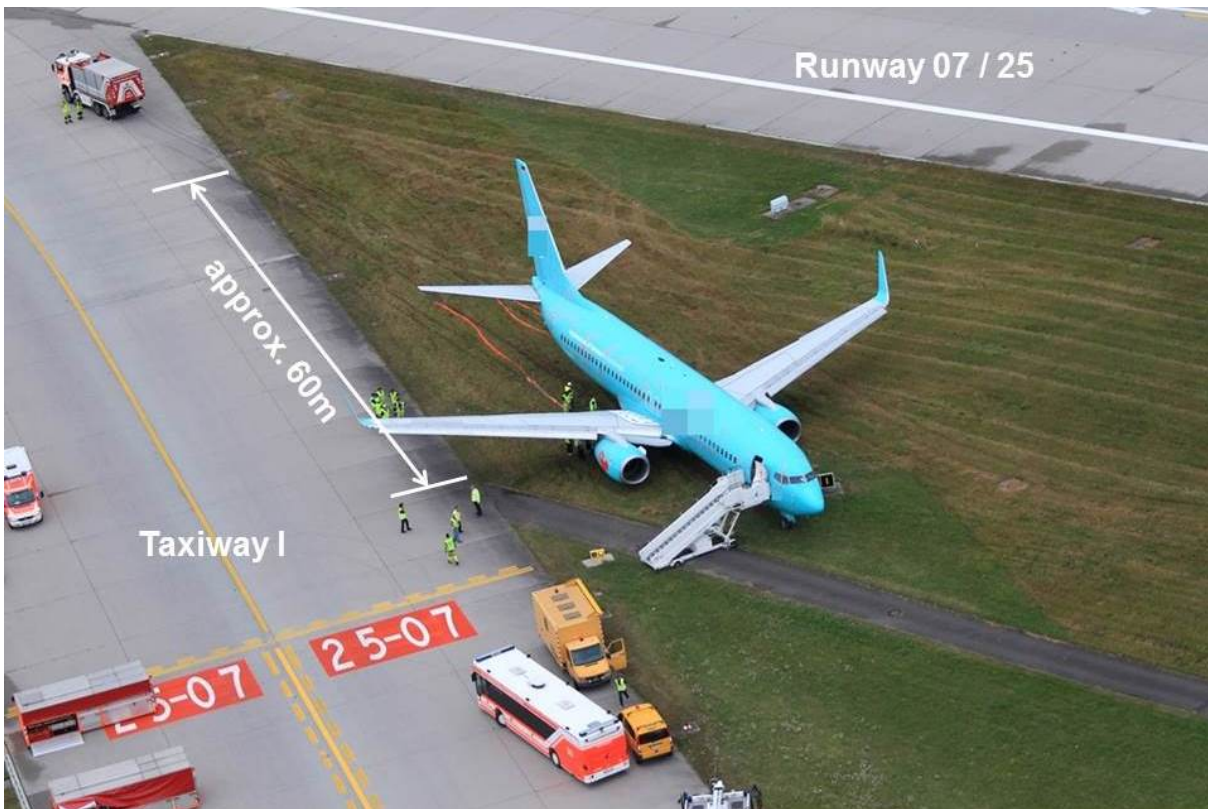
The operator's maintenance organisation had conducted a Runway/Taxiway Excursion inspection. According to the provided documentation the wheels Nos 1, 2, and 3 of the main landing gear and both wheels of the nose landing gear were replaced. The Steering Metering Valve Assy of the nose landing gear was defective and therefore replaced.

(5) Aerial photo of the runway excursion

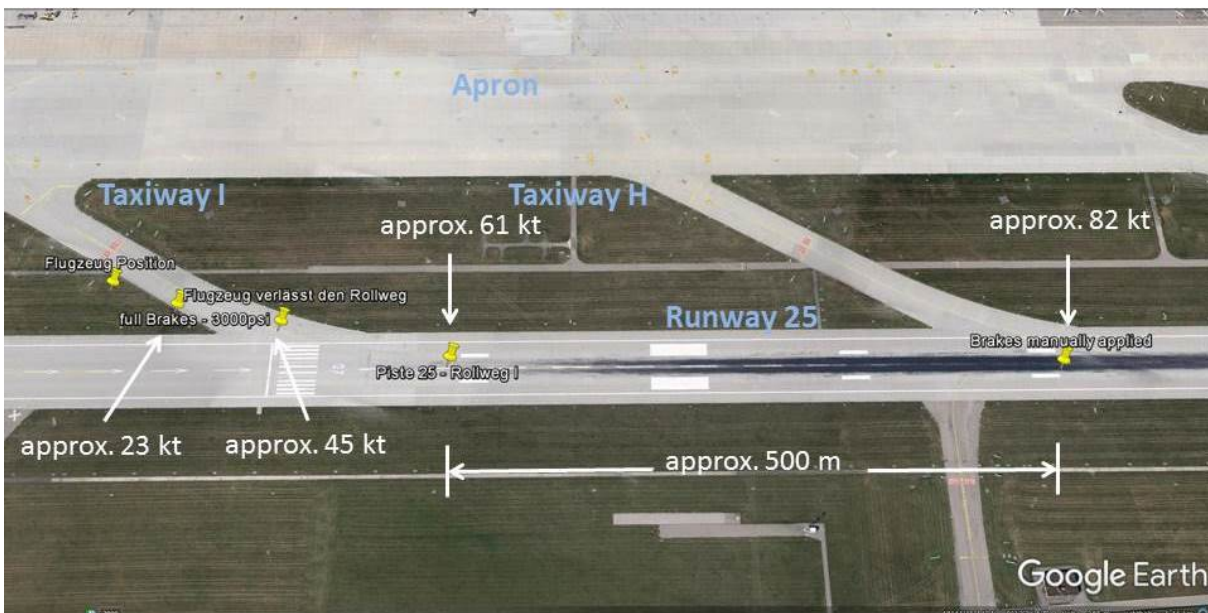
During an interview conducted by the BFU, the PIC stated that a large puddle of water had formed in the intersection region between runway 25 and taxiway I. According to his statement the aircraft had had a maximum taxi speed of 30 kt. Due to the water puddle in the intersection region between runway and taxiway its moving direction was no longer controllable. The braking action had been marginal

(6) Overview of the runway excursion

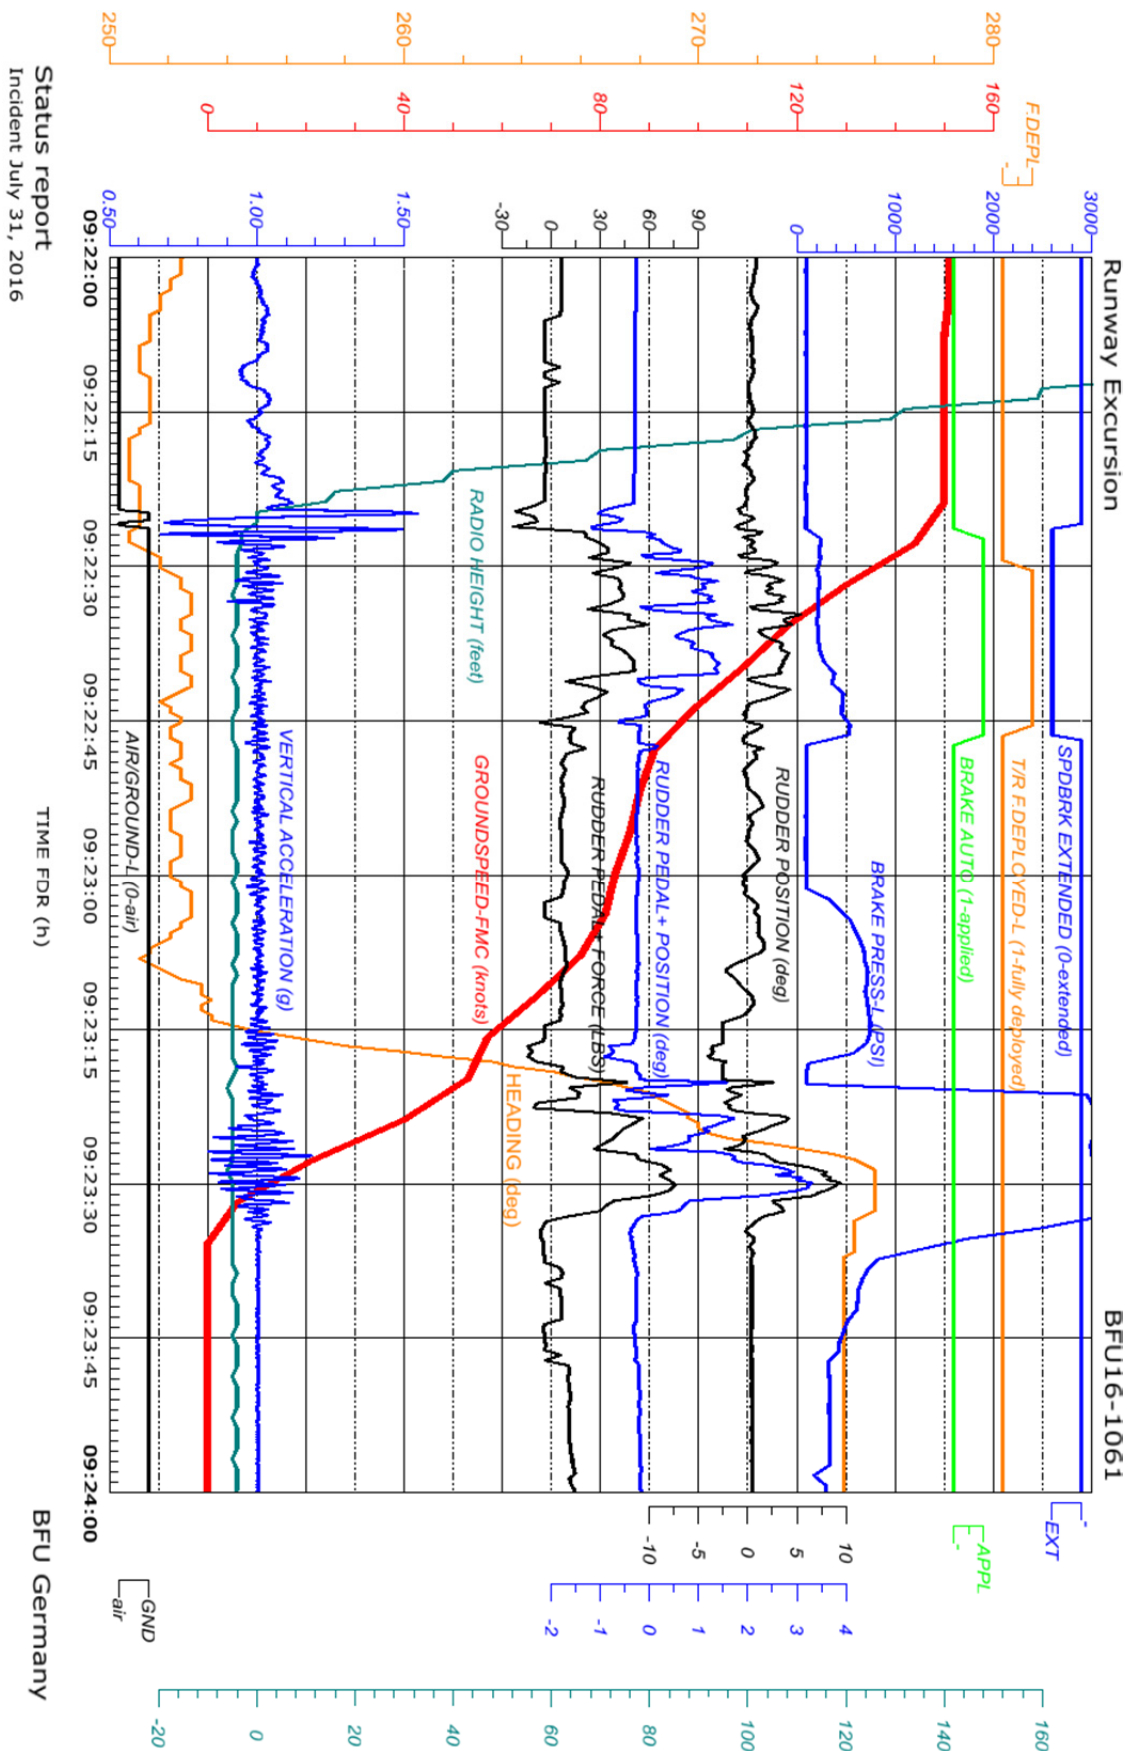
(7) Overview FDR parameters

With a ground speed of approximately 150 kt and a landing mass of about 59 t the aircraft touched down within the touchdown zone of runway 25. Immediately after touch-down the thrust reversers and the speed brakes were activated. The auto brake system controlled the wheel brakes. By means of the Flight Data Recorder (FDR) data it was possible to retrace as to when the individual systems had been activated and deactivated. At a ground speed of approximately 92 kt, the speed brakes, the thrust reversers, and the auto brake system were deactivated. In the following approximately 12 seconds the wheel brakes were not activated. The aircraft's speed decreased from approximately 92 kt to about 82 kt.

Based on the FDR data it was possible to identify the time when the aircraft left the runway centreline. The heading, in combination with longitude and latitude positions, was used. The aircraft turned into taxiway I with a taxi speed of approximately 61 kt.
