Interim Report

Type of Occurrence:	Accident
Date:	2 August 2016
Location:	Oberschleissheim Special Airfield
Aircraft:	Helicopter
Manufacturer / Model:	Agusta S.p.A. / A 109E
Injuries to Persons:	One person suffered minor injuries
Damage:	Aircraft severely damaged
Other Damage:	None
State File Number:	BFU 16-1082-3X
Published:	November 2016

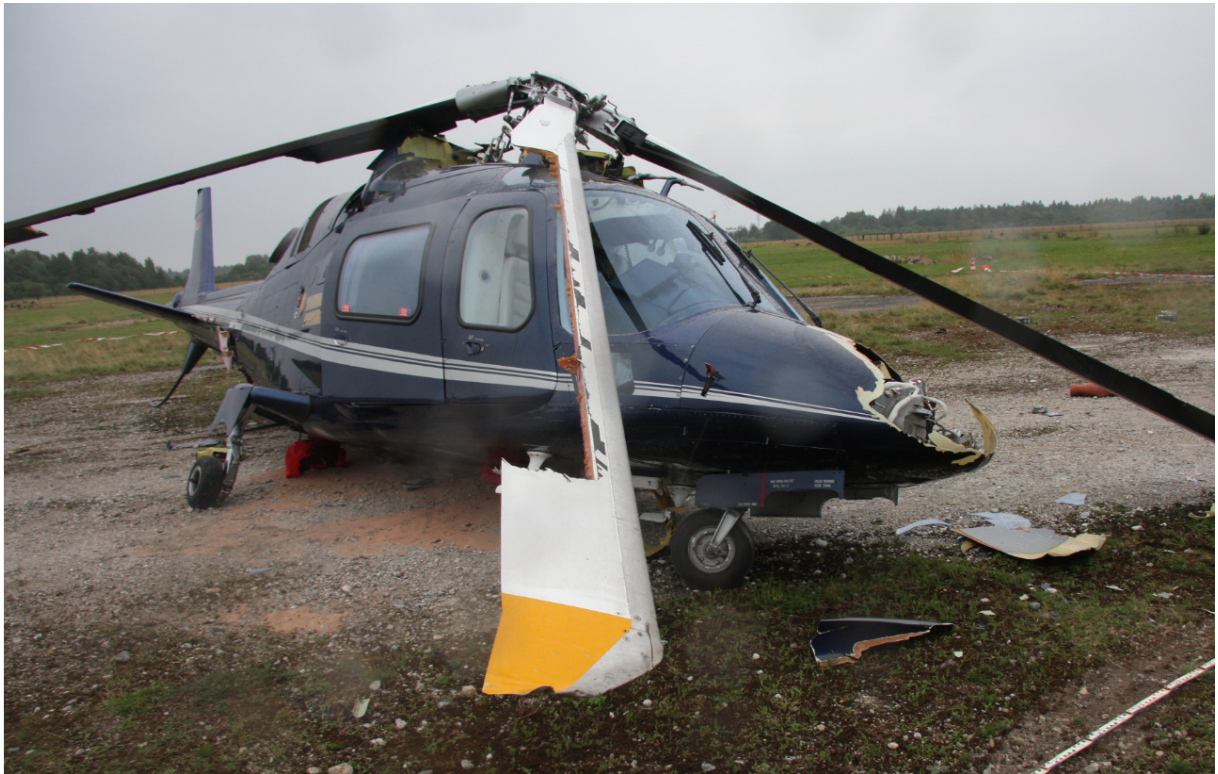
After the helicopter had stood firmly on the ground and the TRI deactivated the single-engine training mode, the helicopter suddenly began to swing vertically. Both pilots concluded it had to be ground resonance. The TRI wanted to stop them and therefore pulled the pitch. But the helicopter responded with increased vertical oscillations and added horizontal rocking motions. Finally the helicopter sprang from the left to the right main landing gear and back again. Due to the resulting tilting the main rotor had ground contact. Subsequently, the fuselage yawed and at about 1515 hrs the helicopter reached its final position lying partly on the fuselage after the engines had been shut off by emergency shut-down. The left main landing gear had been torn off.

Overview damages on the helicopter

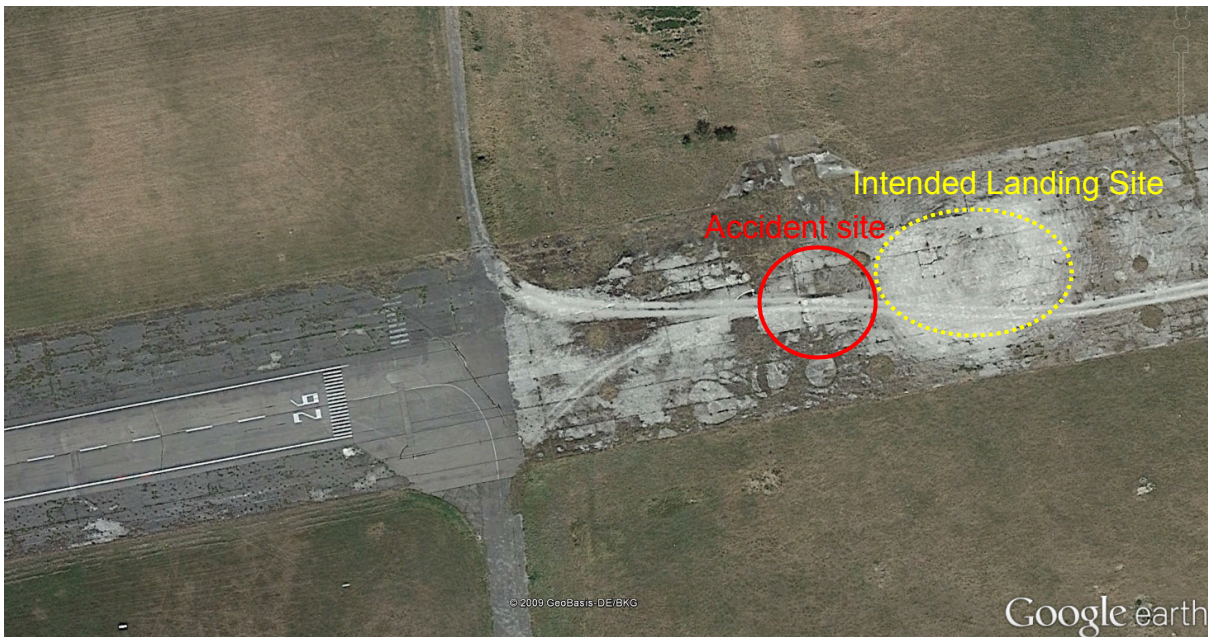
Prior to the beginning of runway 26 parts of the concrete runway surface of the old military airfield still remain. The underground is firm but covered with loose stones, weeds, and larger moss areas.

Overview beginning of runway 26, intended touchdown point, and accident site

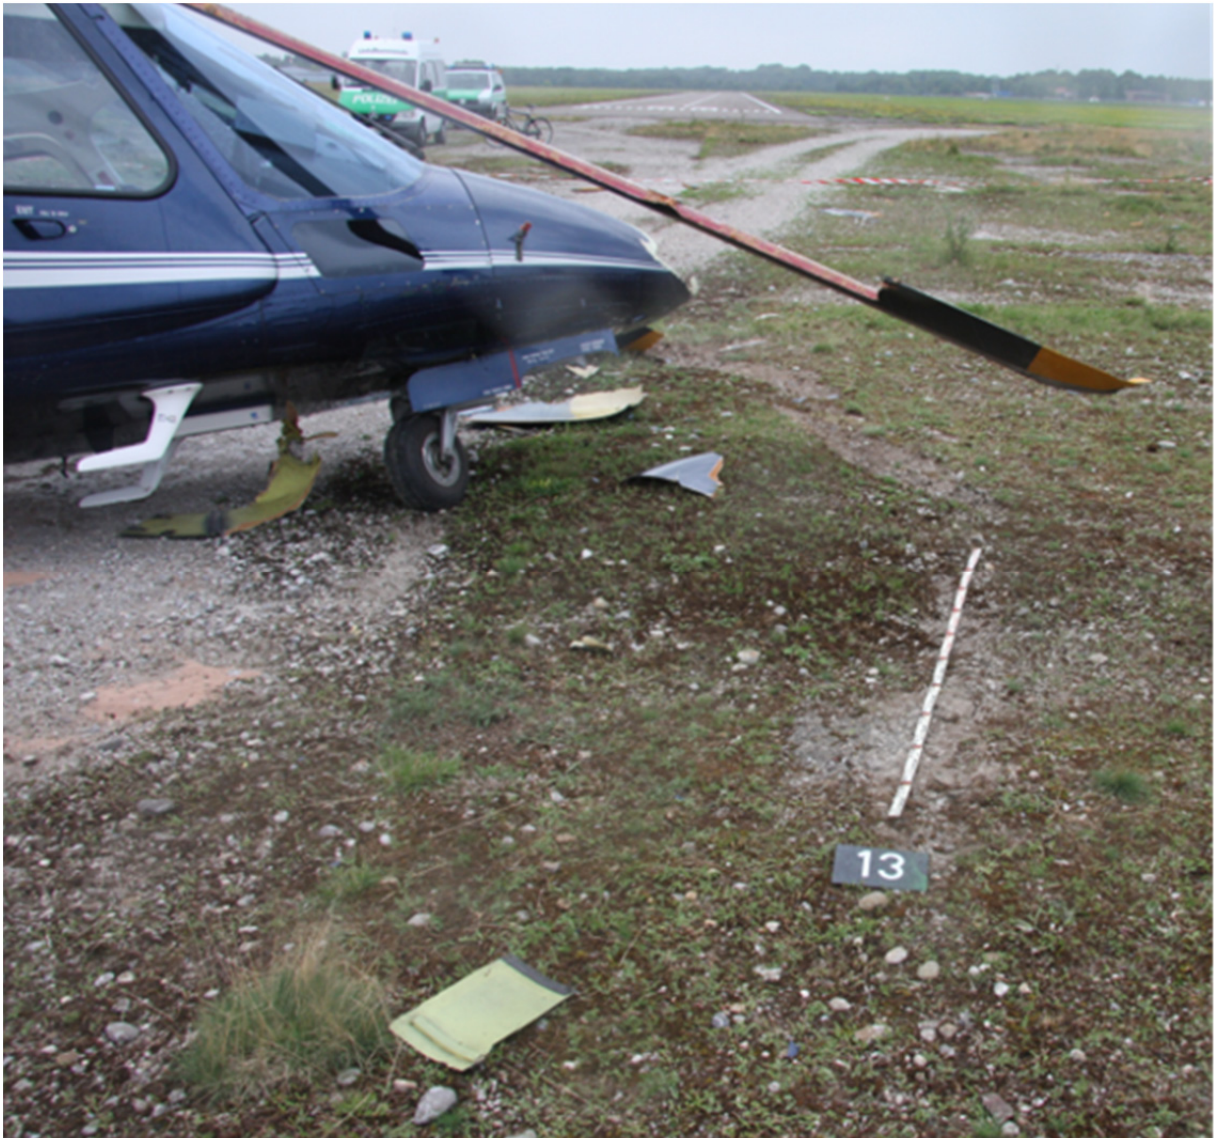
The accident site was located approximately 100 m prior to runway 26 of Oberschleissheim Special Airfield. The helicopter stood upright slightly tilting left towards approximately 320°. The retractable landing gear was extended. The left main landing gear had collapsed outward. The nose landing gear had been twisted to the left. The pin of the nose wheel centre mechanism was not engaged. After the accident, the lever for the nose wheel locking in the cockpit was not completely in the “Lock” position.

Position helicopter, beginning of runway 26, and underground of the landing area

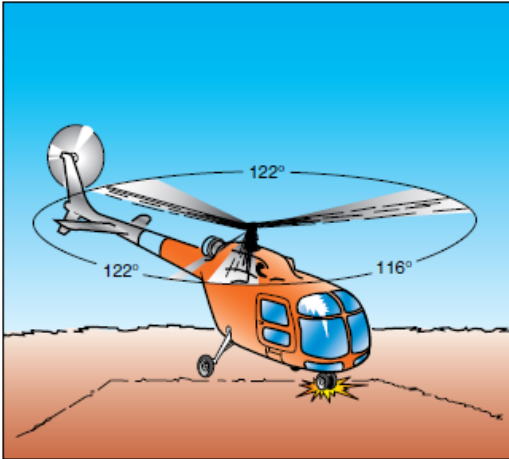
Figure 11-5. Hard contact with the ground can send a shock wave to the main rotor head, resulting in the blades of a three-bladed rotor system moving from their normal 120° relationship to each other. This could result in something like 122°, 122°, and 116° between blades. When one of the other landing gear strikes the surface, the unbalanced condition could be further aggravated.

If the r.p.m. is low, the corrective action to stop ground resonance is to close the throttle immediately and fully lower the collective to place the blades in low pitch. If the r.p.m. is in the normal operating range, you should fly the helicopter off the ground, and allow the blades to automatically realign themselves. You can then make a normal touchdown. If you lift off and allow the helicopter to firmly re-contact the surface before the blades are realigned, a second shock could move the blades again and aggravate the already unbalanced condition. This could lead to a violent, uncontrollable oscillation.
