# Interim Report

Type of Occurrence:	Accident
Date:	27 September 2012
Location:	Warbelow near Gnoien
Aircraft:	Airplane
Manufacturer / Model:	Pilatus / PC-9/B
Injuries to Persons:	Both pilots fatally injured
Damage:	Aircraft destroyed
Other Damage:	None
Information Source:	Investigation by BFU
State File Number:	BFU 3X146-12
Published:	November 2012

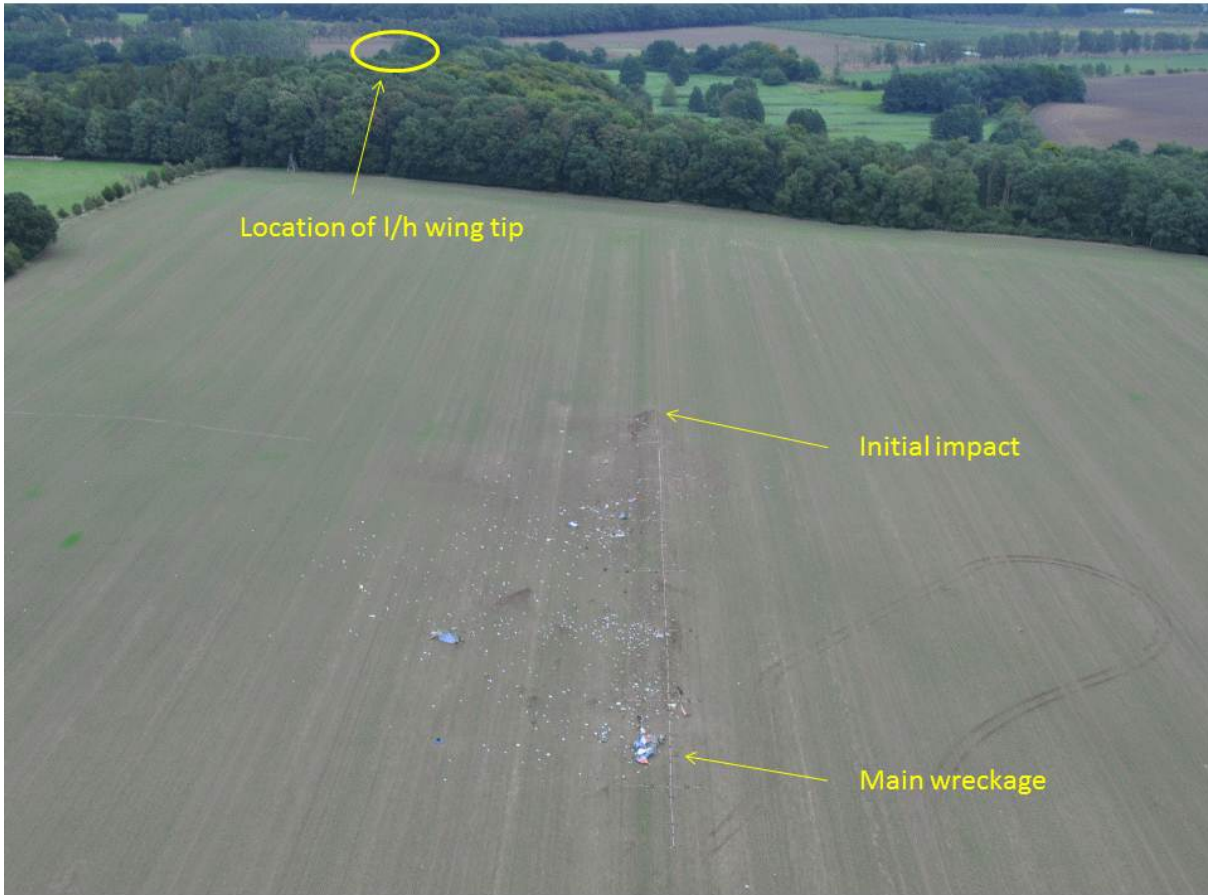
With a heading of about 290° the airplane impacted a tilled field about 225 m north-west of a mixed forest. The initial ground contact occurred with the left wing. In this area the left aileron, parts of the left horizontal tail and one propeller blade were found, among others.

View from the opposite approach direction

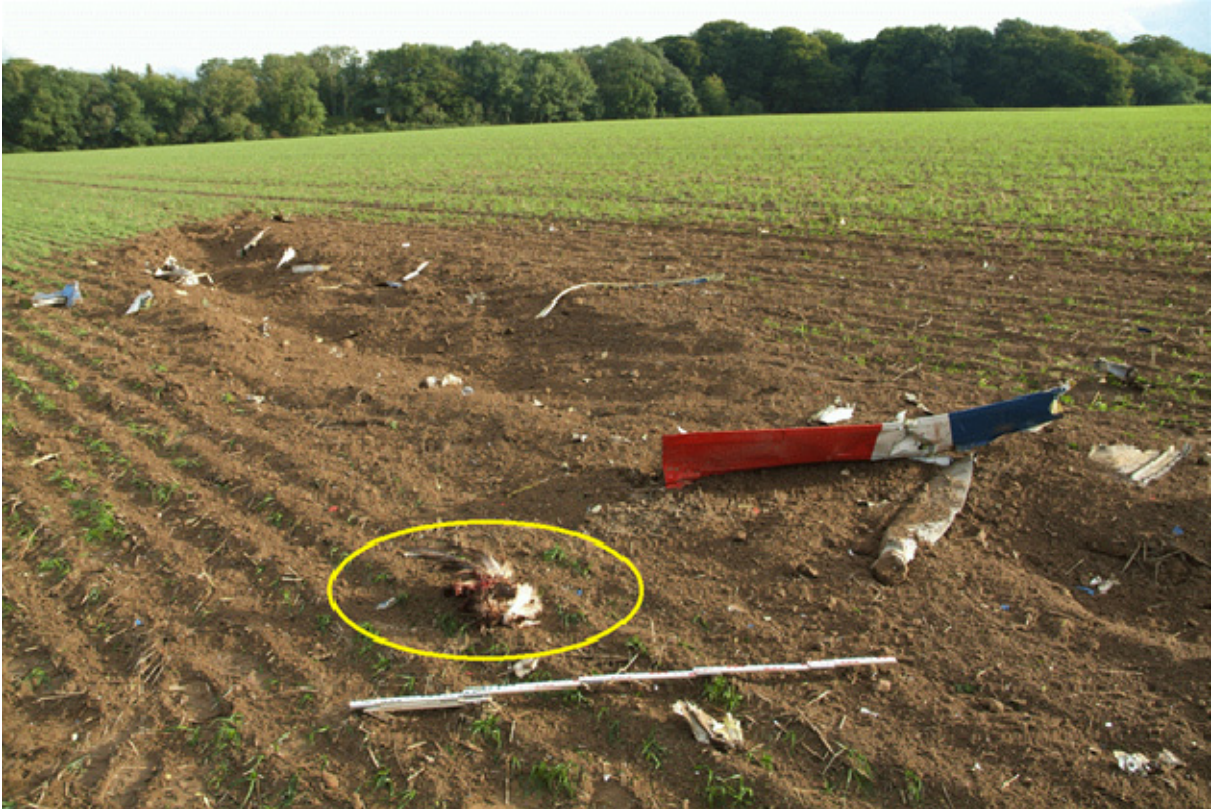
Next to the left aileron a large cadaver part (56 x 20 x 10 cm) of a bird of prey of about 1.26 kg was found. The bird of prey was identified as an osprey.

Accident site, view to the south-east, bird cadaver, left aileron and propeller blade

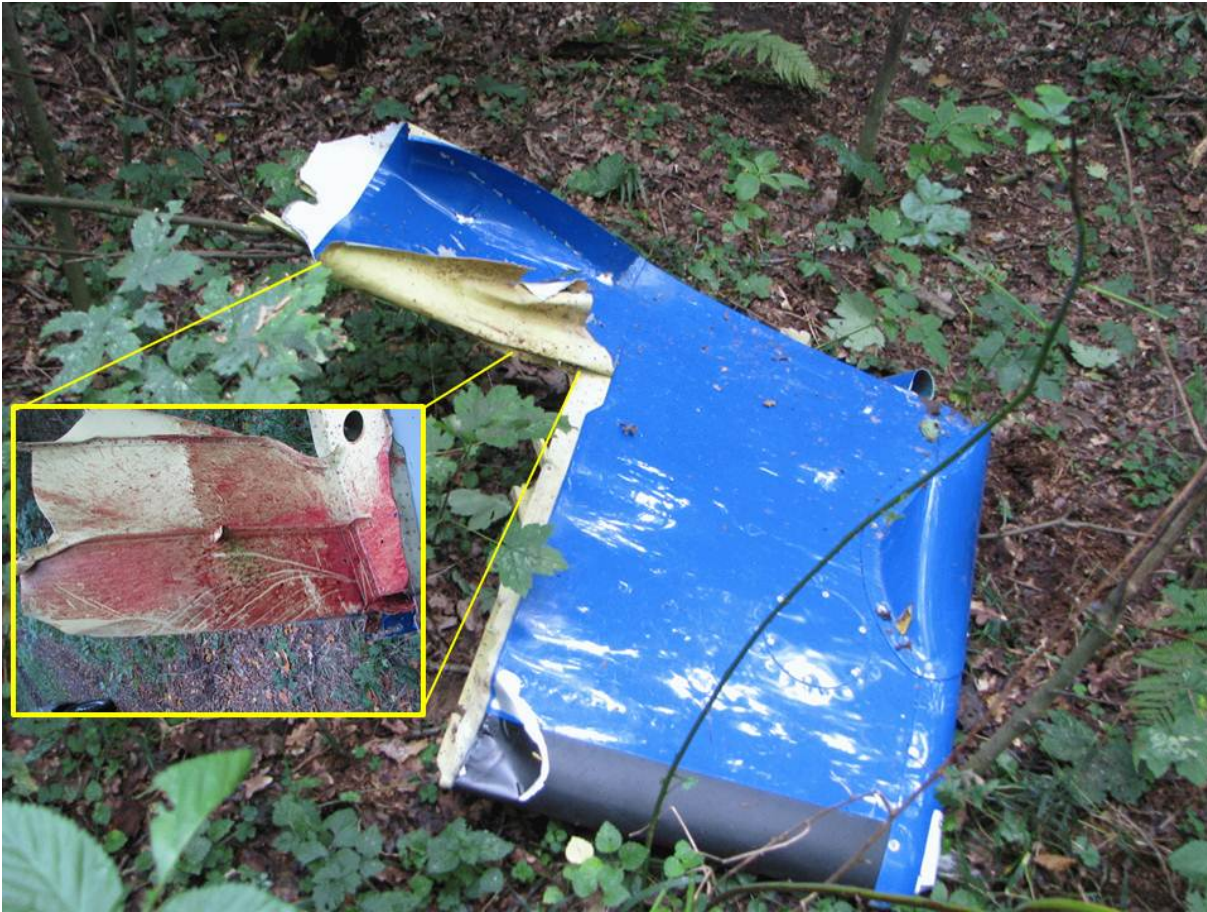
Part of the wing with traces of blood on the inner surface

In a forest about 500 m east of the initial point of impact of the main wreckage a part of the left wing was found. It was the wing tip which had been torn off along a row of rivets about 0.70 m from the tip. The upper surface of the wing leading edge showed a dent which was about 15 x 15 cm wide and about 5 cm deep. The wing covering was severed along a row of rivets which ran along a rib. The main spar was fractured. The inside of the wing upper surface showed traces of blood.
