Interim Report

Type of Occurrence:	Serious incident
Date:	3 September 2012
Location:	Cologne Airport
Aircraft:	Airplane
Manufacturer / Model:	Boeing 737-800
Injuries to Persons:	11 persons with minor injuries
Damage:	None
Other Damage:	None
Information Source:	Investigation by BFU
State File Number:	BFU 5X007-12
Published:	November 2012

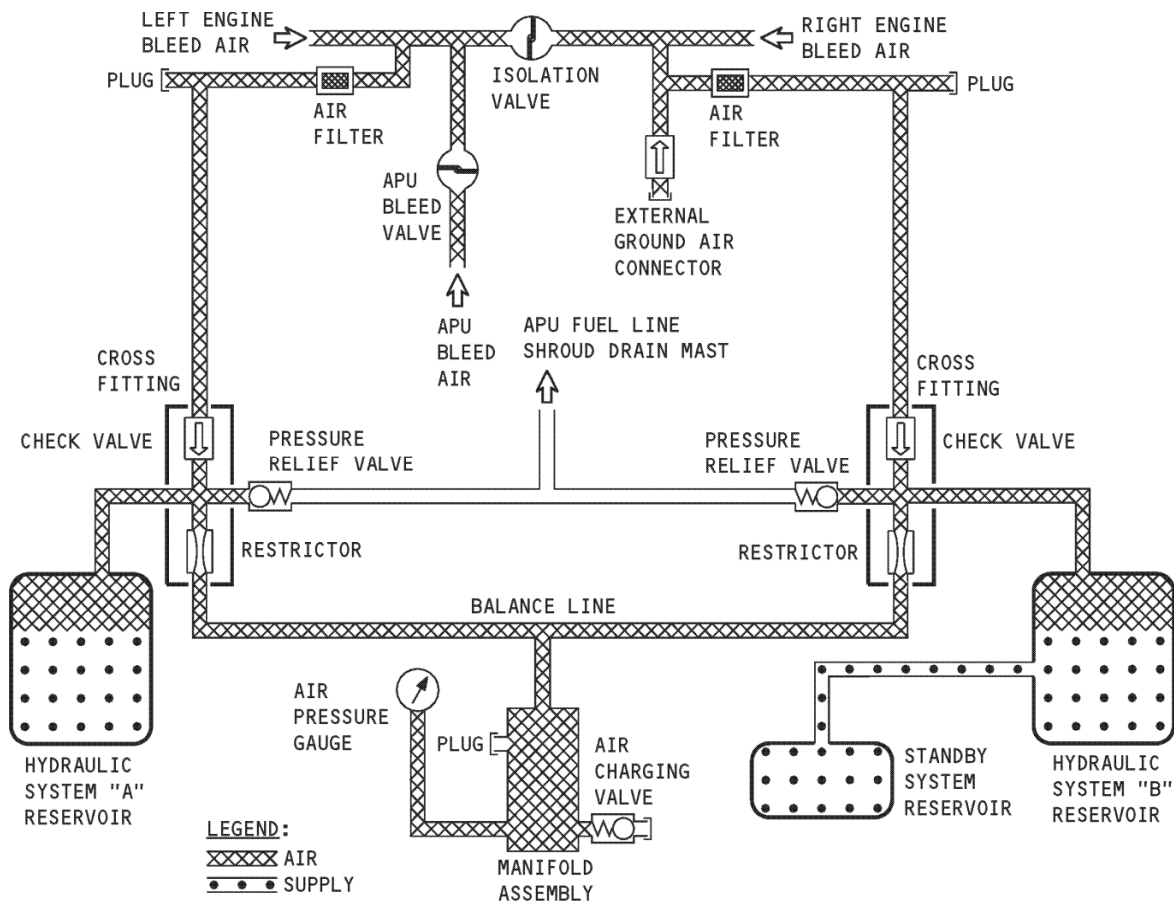
Schematic depiction of the hydraulic reservoir pressurization systems

The Boeing Customer Support issued a Maintenance Tip on 28 June 2004 which was revised on 28 June 2012 (737 MT 12-002) which advises that at a filling level of more than 100% in one of the hydraulic reservoirs hydraulic fluid can penetrate the pneumatic system

and reach the air-conditioning. Hence, Boeing recommends filling the hydraulic reservoirs to not more than 92%.

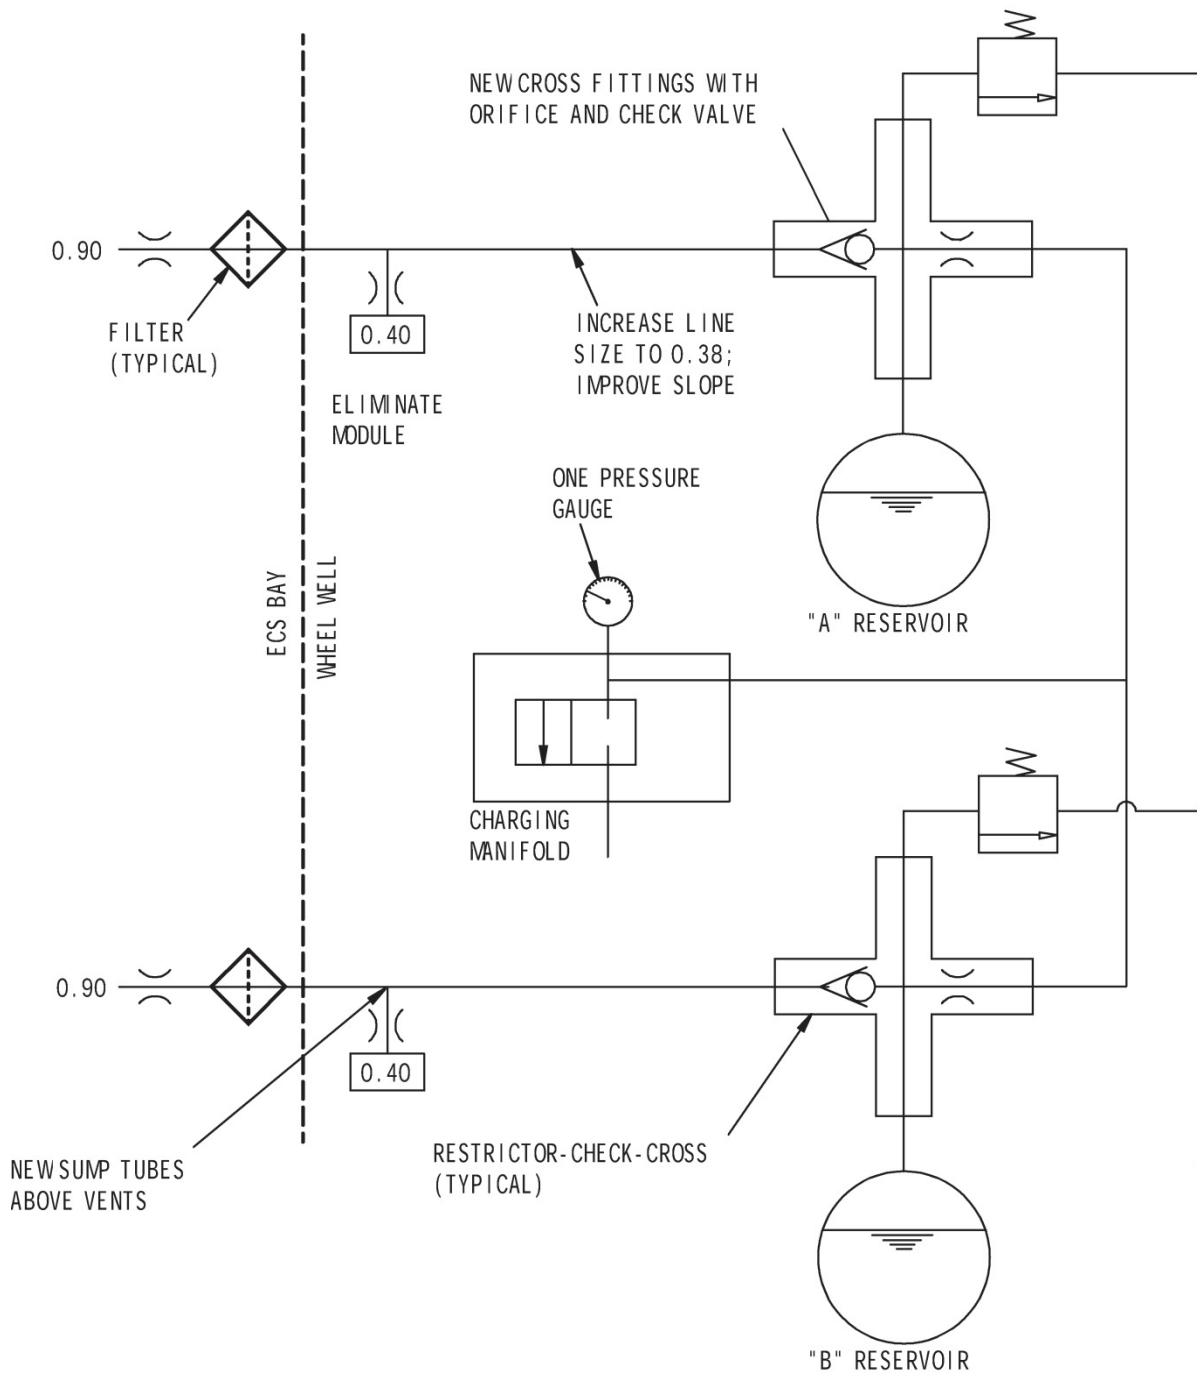
On 23 December 2002 the aircraft manufacturer in his function as design organisation issued a Service Bulletin (SB) regarding the modification of the system. The modification shall prevent loss of pressure due to freezing water within the system during long and in great altitudes conducted flights. The operator stated that the Service Bulletin, Revision 1 of 15 May 2003 had been implemented in the aircraft involved.

Schematic depiction of the hydraulic reservoir pressurization systems

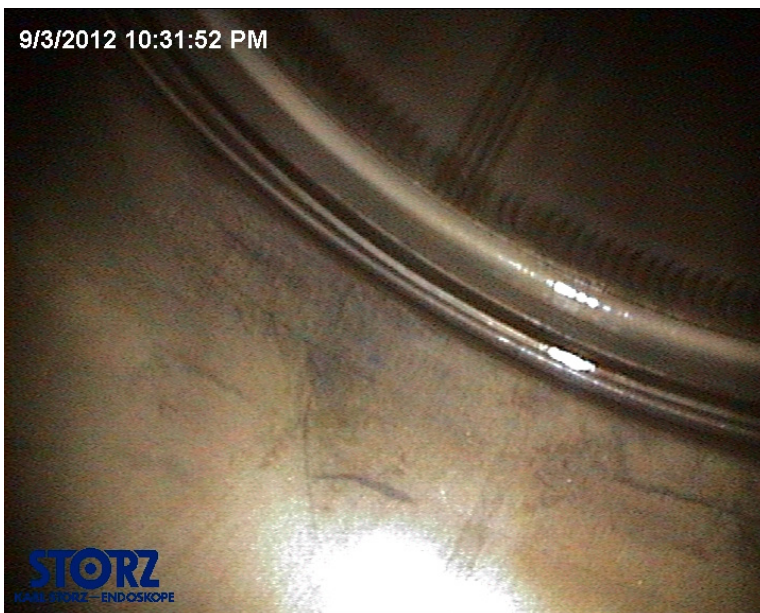
At the day of the occurrence, technicians of the operator's maintenance organisation conducted an examination of the aircraft in the presence of BFU staff. The area of the left engine's high pressure turbine was inspected visually regarding outer oil leakages and with the help of a borescope of inner oil leakages. Extraordinary oil traces could not be found. The examination of the pneumatic manifold using the borescope showed contamination of the entire pipe circumference with hydraulic fluid. The contamination began inside the left pneumatic manifold in the area of the connector for the hydraulic reservoir pressurisation system and continued in flow direction along the pneumatic system. Inside the right side of the pneumatic manifold no contamination was found.

Oil-wetted surface inside the pneumatic manifolds

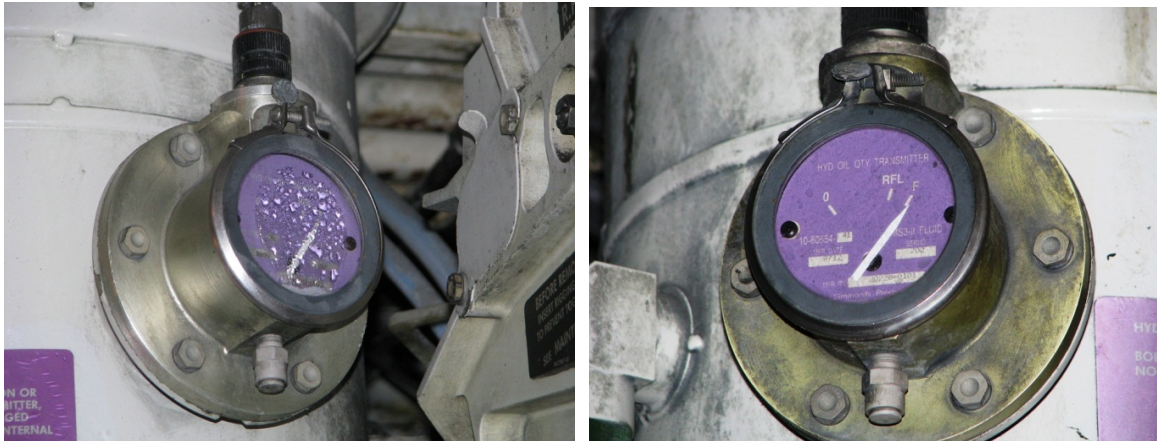
The recording of the data began on 1 September 2012 at 0714:44 hrs aircraft time. The parameter HYD_QTY-A showed values of more than 100% during the entire recording time while the airplane was on the ground.

The filling level indicator of the hydraulic reservoir of system A was close to marking "F". Reading the exact position was not possible because the indication was fogged over from the inside.

The filling level indicator of the hydraulic reservoir of system B was approximately a half indicator width right of marking "F".

Filling level indication of the hydraulic reservoirs of systems A and B

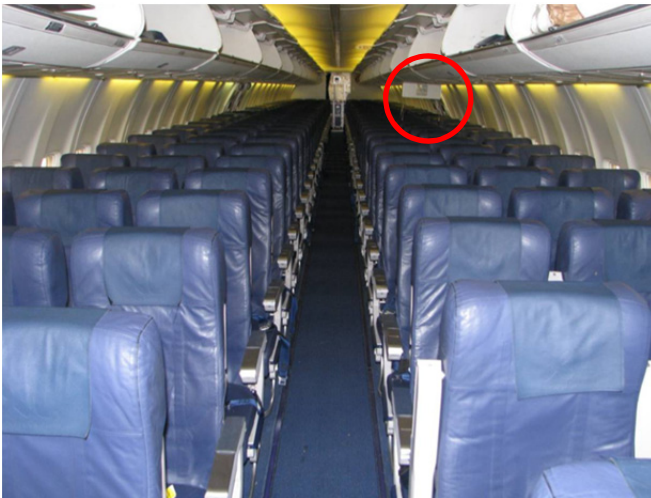
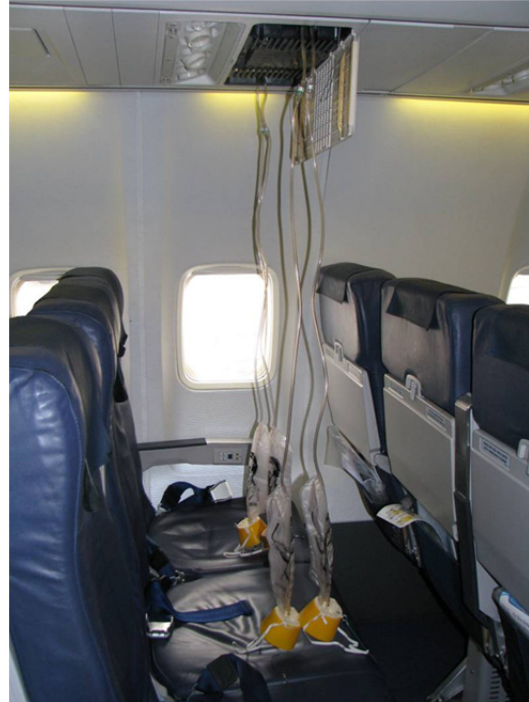
In the cabin the panels for the oxygen masks above seats 13 A, B and C were open. The oxygen masks hung down. The control strip on the oxygen generator showed a dark colouring. The bags on the masks were flat. According to the maintenance personnel this indicates that the generator had been triggered but the masks had not been donned.

Oxygen masks in the cabin
