Interim Report

Type of Occurrence:	Accident
Date:	23 June 2014
Location:	Near Olsberg-Elpe
Type of aircraft:	1.) Airplane 2.) Airplane
Manufacturer / Model:	1.) Learjet Corporation / Learjet 35 A 2.) Eurofighter GmbH / Eurofighter
Injuries to Persons:	1.) Pilot and co-pilot fatally injured 2.) None
Damage:	1.) Aircraft destroyed 2.) Aircraft severely damaged
Other Damage:	Crop damage
Information Source:	Investigation by BFU
State File Number:	BFU 1X002-14
Published:	September 2014

Factual Information

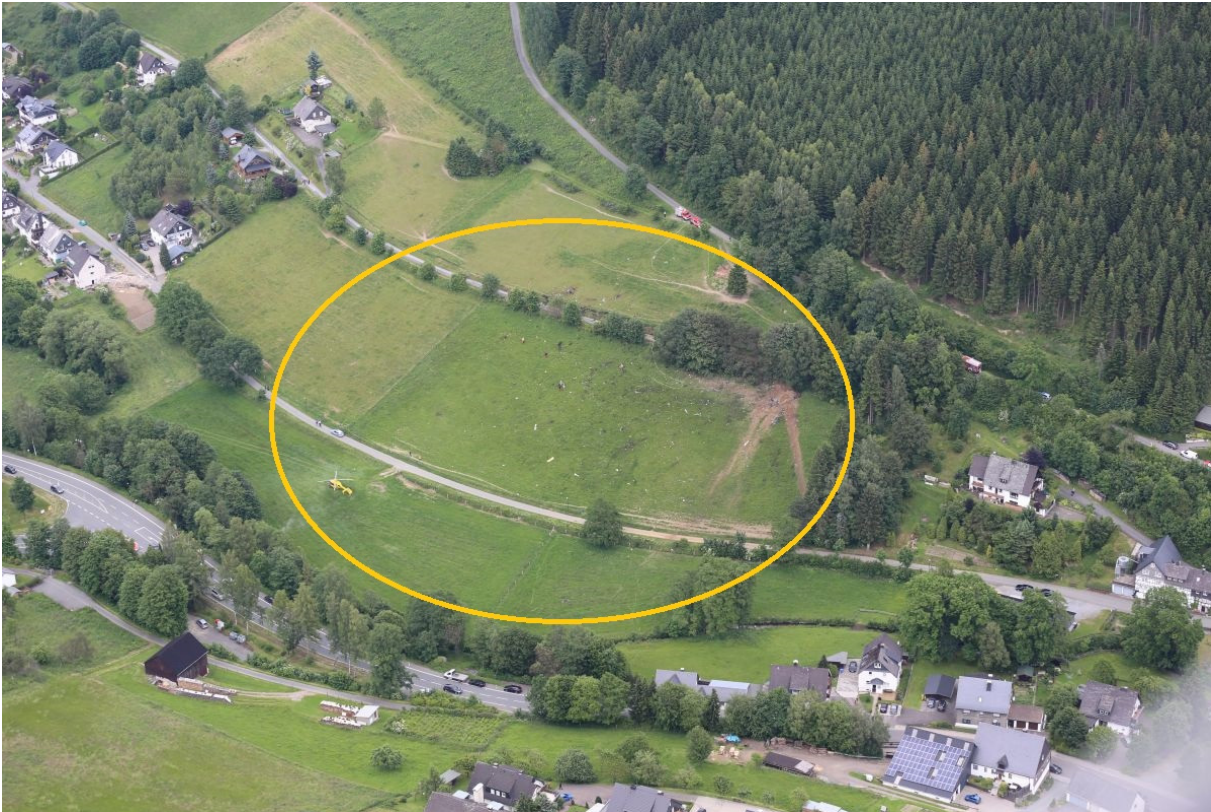
The Learjet impacted a slope, which declines to the west, in an inverted attitude with large nose-down pitch angle. The distance between several buildings and the place of impact was approximately 100 m.

At the impact site the left wingtip tank stuck in the ground. In the area surrounding the impact site the elevator and the vertical tail of the airplane were found. The FDR was found about 20 m and the CVR about 30 m to the north.

The right engine had fractured between compressor and turbine and was found about 75 m downslope from the impact site. In this area the right wingtip tank was found.

Dimension of the accident site of the Learjet 35 A

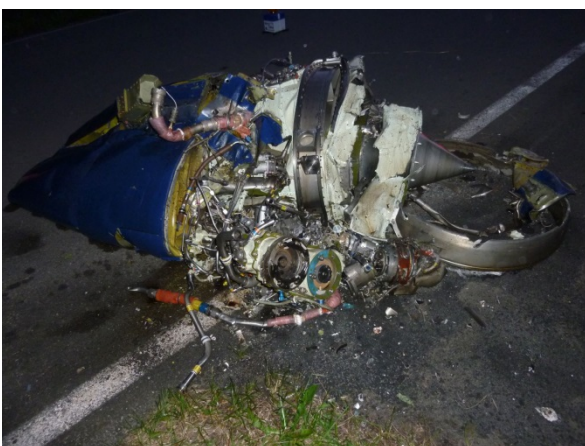
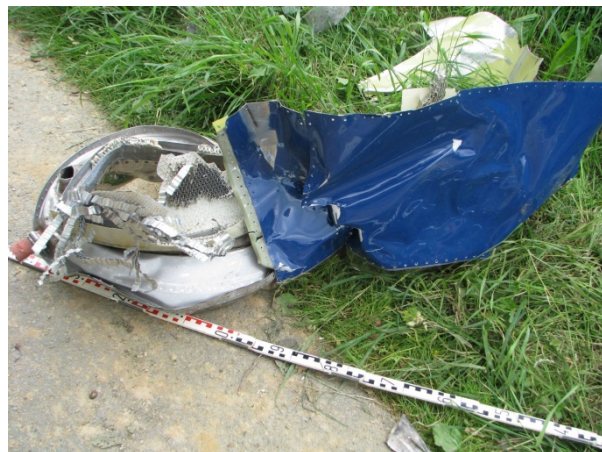
The left engine was found about 1.3 km south of the main wreckage. Parts of the cowling of the right engine were found about 2.7 km south of the main wreckage.

Left engine (left) and the cowling of the right engine (right)

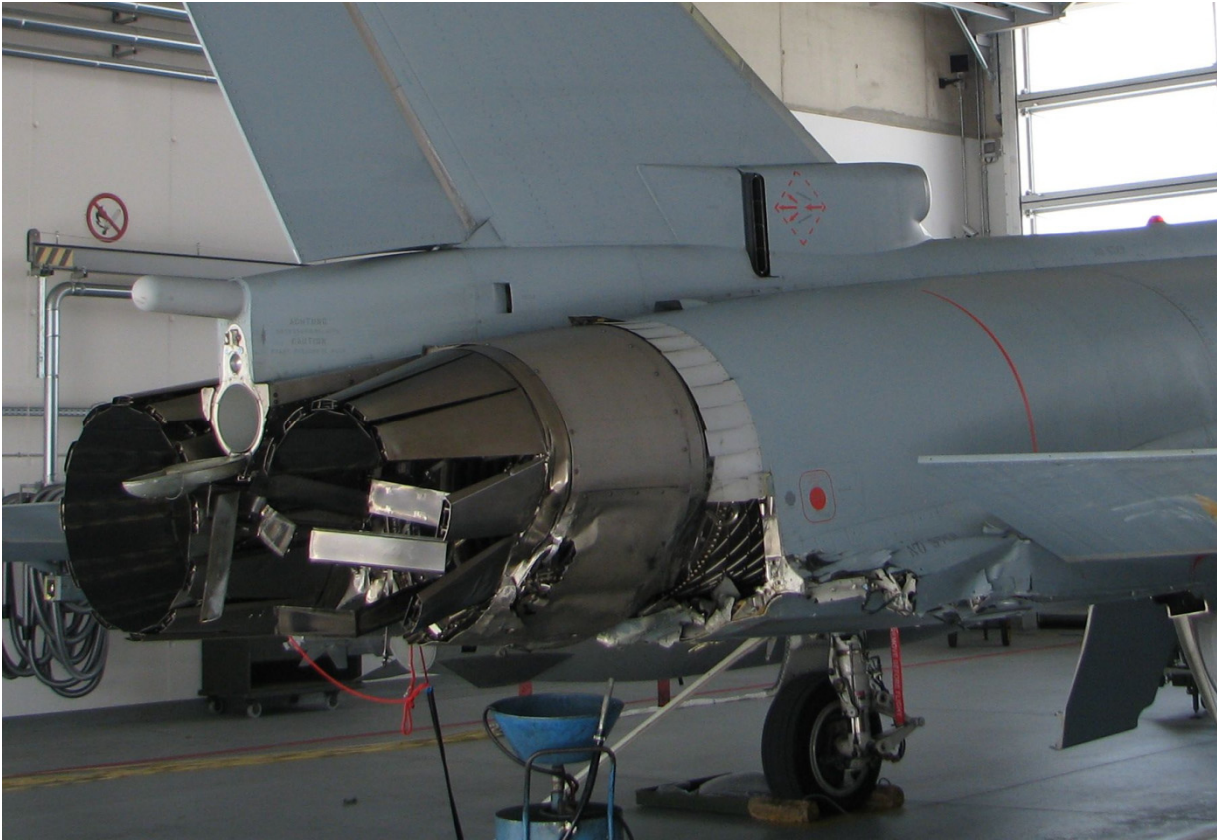
The Eurofighter was examined at Nörvenich Air Base. It was determined that the rail launcher at the outboard wing pylon below the right wing was fractured in the front third and bent towards the fuselage. In the rail a white part of the Learjet fuselage was found. At the aft part of the rail launcher, parts of the insulating material from the Learjet fuselage were found.

The lower surface of the inner elevon and parts of the nozzle of the right engine showed blue paint transfer.

The entire right engine was deformed towards the longitudinal axis of the airplane.

Damages on the tail of the Eurofighter

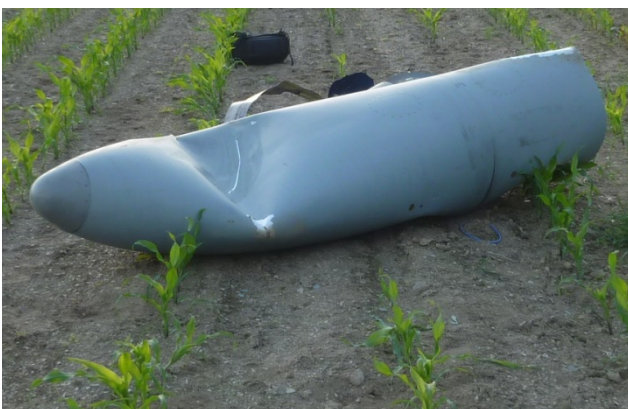
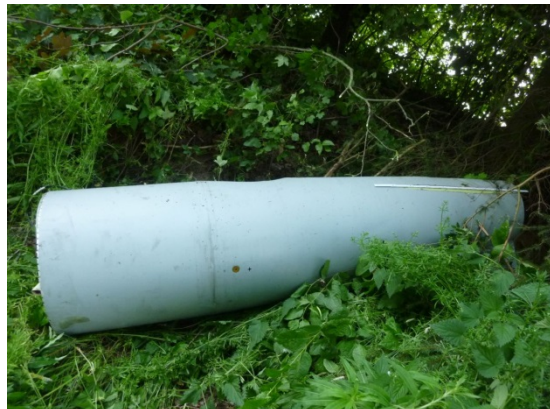
The outboard tank of the fighter had been torn off and separated into two pieces. One of the pieces still carried the jettison. One piece was found 2.1 km and the other 2.3 km south of the main wreckage of the Learjet.

Parts of the outboard tank of the Eurofighter

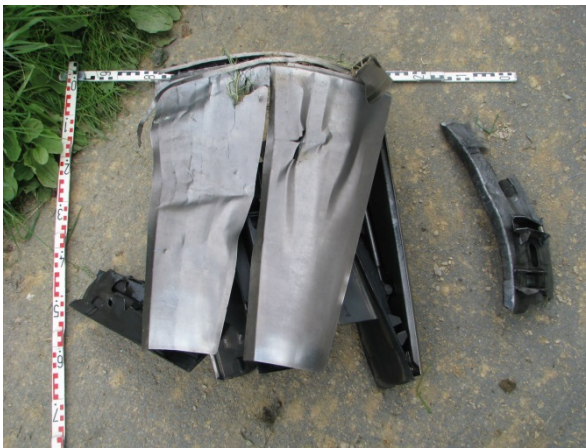
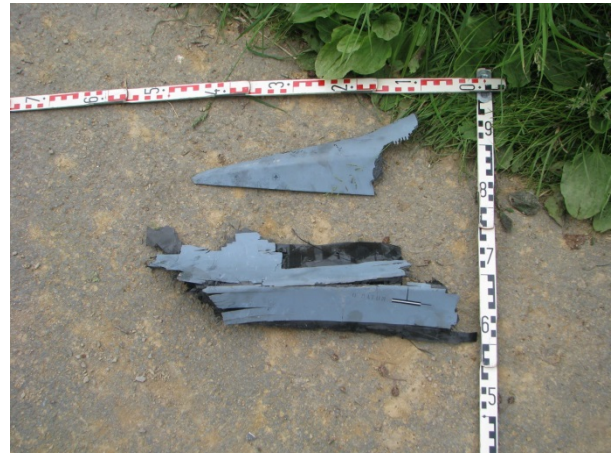
Approximately 2.4 km south of the Learjet's main wreckage the following parts of the Eurofighter were found: pieces of the nozzle of the right engine, carbon composite pieces of the aft fuselage and the cowling of the inner elevon track and carriage of the right wing.

Parts of the nozzle (left); carbon composite structure of the Eurofighter

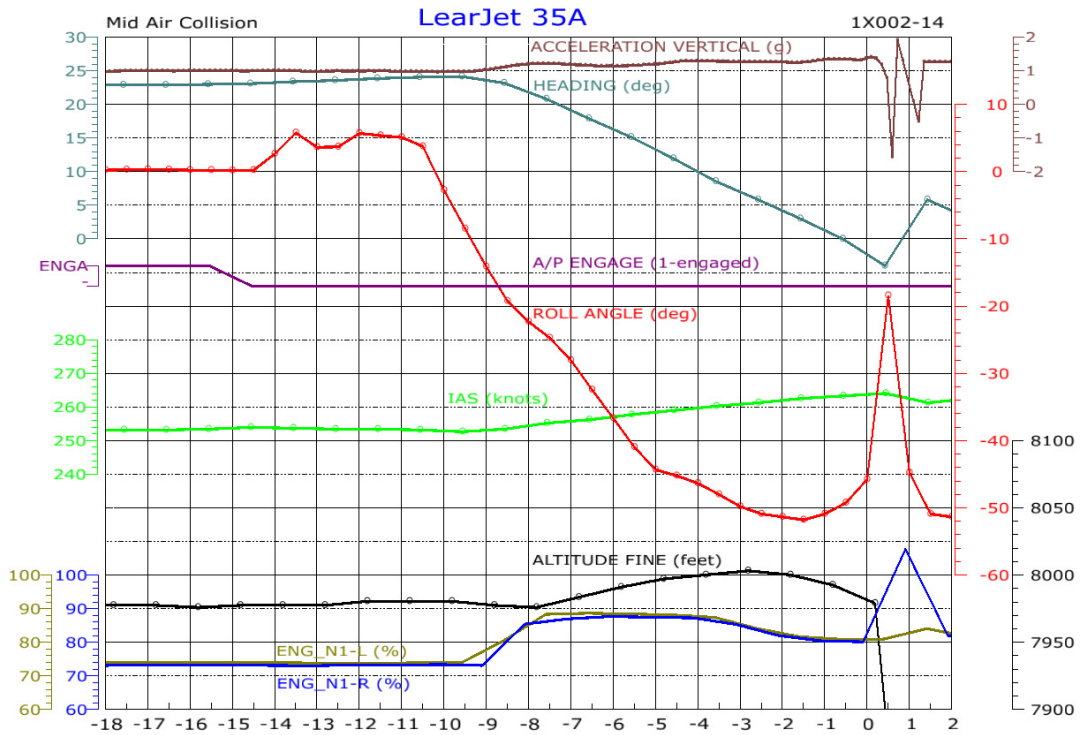
Excerpt flight data recorder Learjet 35 A

Preliminary Data, file: acc_LearJet35A Seconds related to first touch
 Created: July 30, 2014
 Revised: July 31, 2014

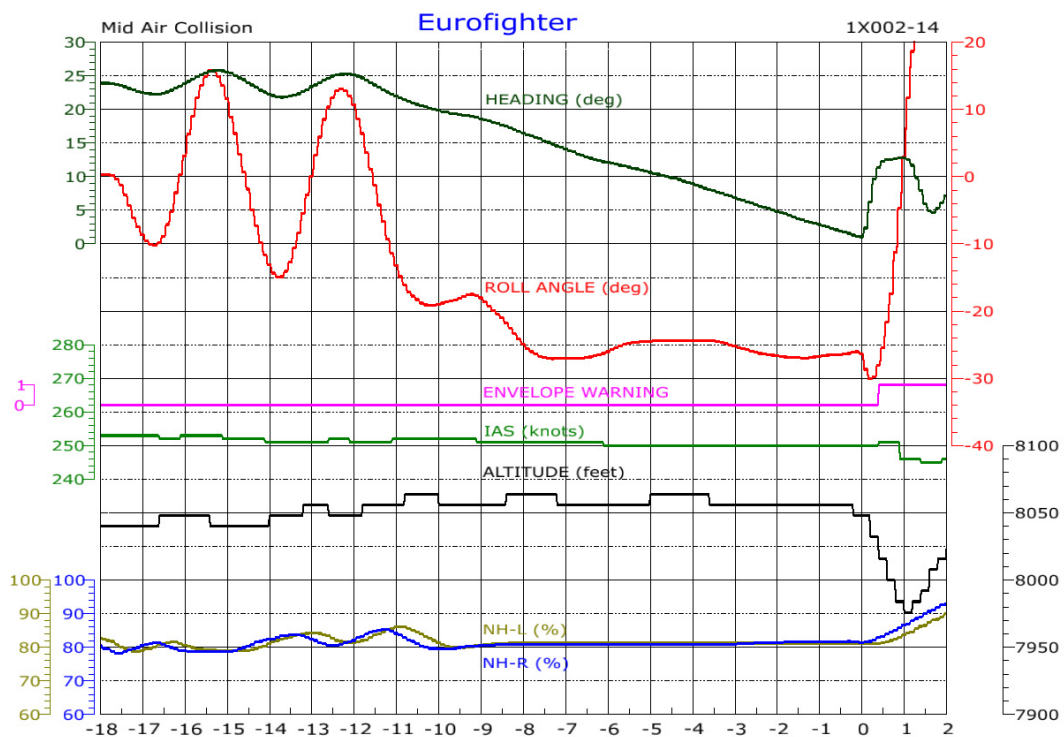
Excerpt flight data recorder Eurofighter

Preliminary Data, file: acc_Eurofighter Seconds related to first touch
 Created: August 21, 2014
 Revised: August 21, 2014
