Interim Report

Type of Occurrence:	Serious incident
Date:	20 October 2015
Location:	Paderborn
Aircraft:	Airplane
Manufacturer / Model:	The Boeing Company / B 737-800
Injuries to Persons:	None
Damage:	Minor damage to aircraft
Other Damage:	Runway edge lighting damaged
Information Source:	Investigation by BFU
State File Number:	BFU 15-1465-EX
Published:	February 2016

During the landing on runway 24 of Paderborn-Lippstadt Airport the Boeing 737-800 touched down left of the runway centre line and veered off the runway. The crew manoeuvred the aircraft back onto the runway after approximately 260 m. No one was injured.

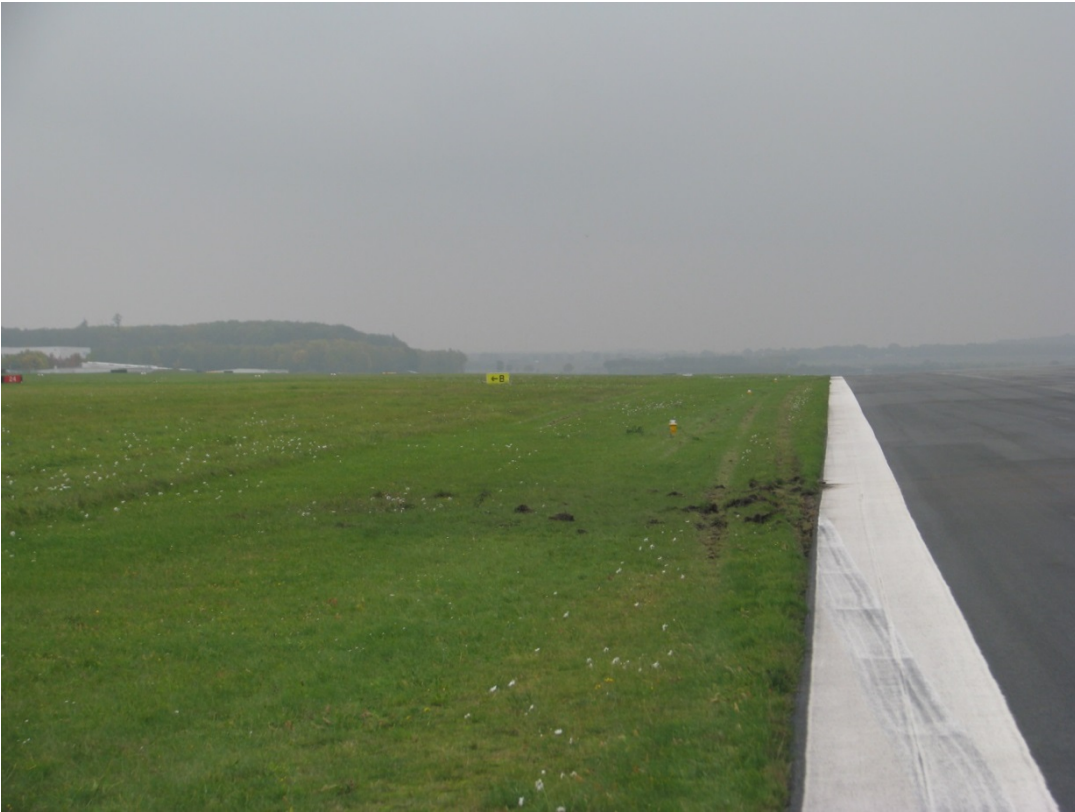
Approximately 630 m after the threshold of runway 24 wheel marks of the right main landing gear were found on the left runway edge marking. Another 47.5 m farther along the trace of the nose landing gear was found in the grass south of the runway. In a distance of 74 m from the first visible wheel marks the impression of the left main landing gear was found in the grass. Over a distance of approximately 260 m the

Wheel marks of the right main landing gear veering off the runway

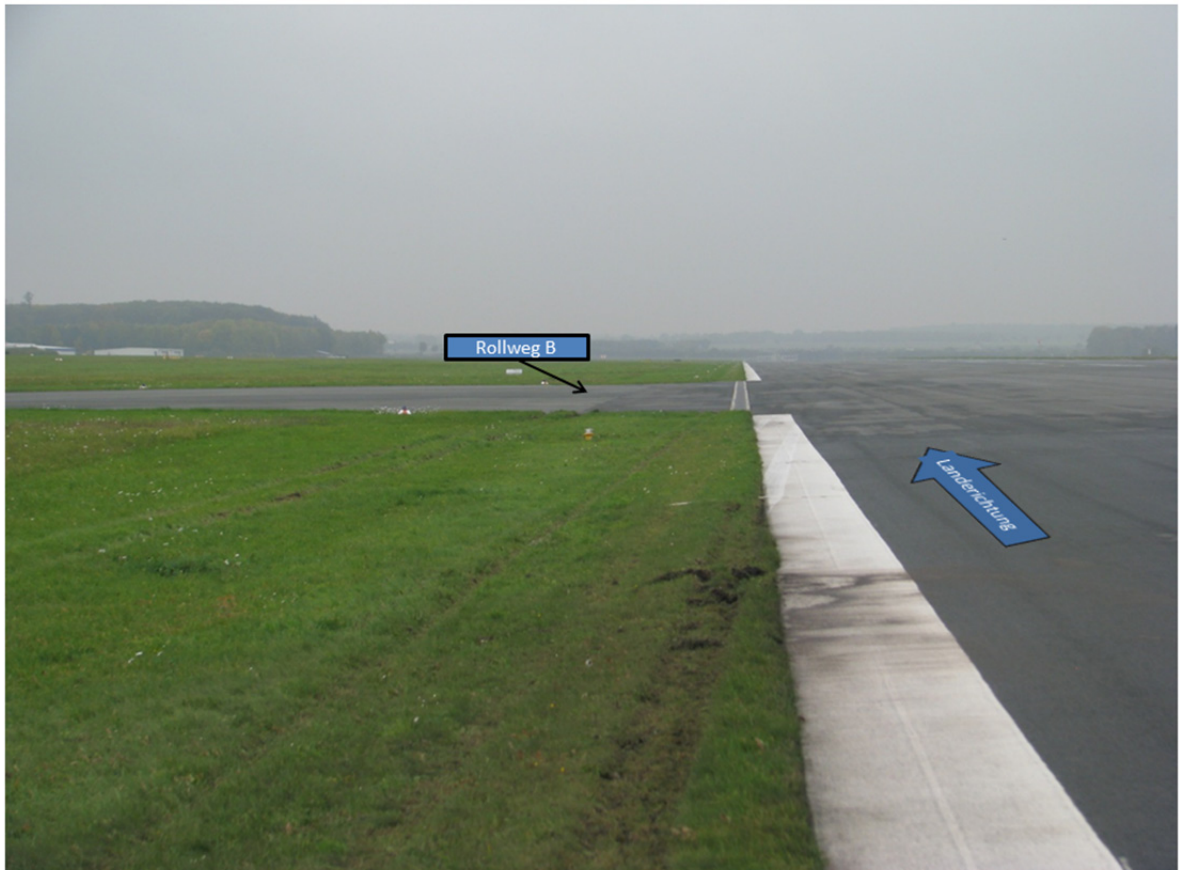
impressions of the three landing gears were visible in the grass south of the runway. Abeam of the intersection of taxiway B the traces of the wheels in the grass ended.

Wheel marks at taxiway B

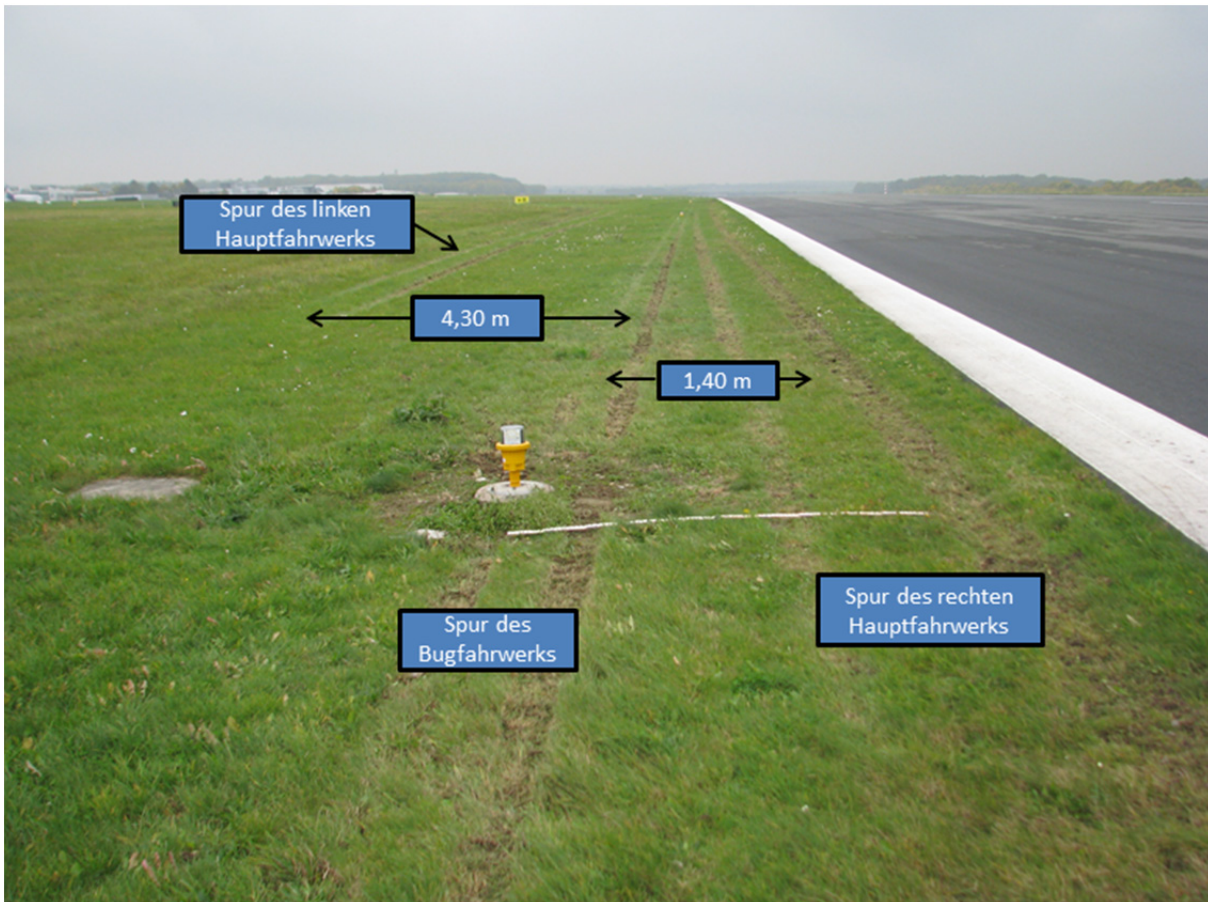
The BFU documented the distances between the individual traces. The distance of the axle pivot point of the right main landing gear to the axle pivot point of the nose landing gear was 1.40 m. The distance of the axle pivot point of the left main landing gear to the axle pivot point of the nose landing gear was 4.30 m.

Distances between the wheel marks of the landing gears
