Interim Report

Type of Occurrence:	Serious incident
Date:	30 September 2017
Location:	Sylt
Aircraft:	Airplane
Manufacturer / Model:	Airbus Industry/A320-214
Injuries to Persons:	No injuries
Damage:	Aircraft not damaged
Other Damage:	None
State File Number:	BFU17-1339-5X
Published:	January 2018

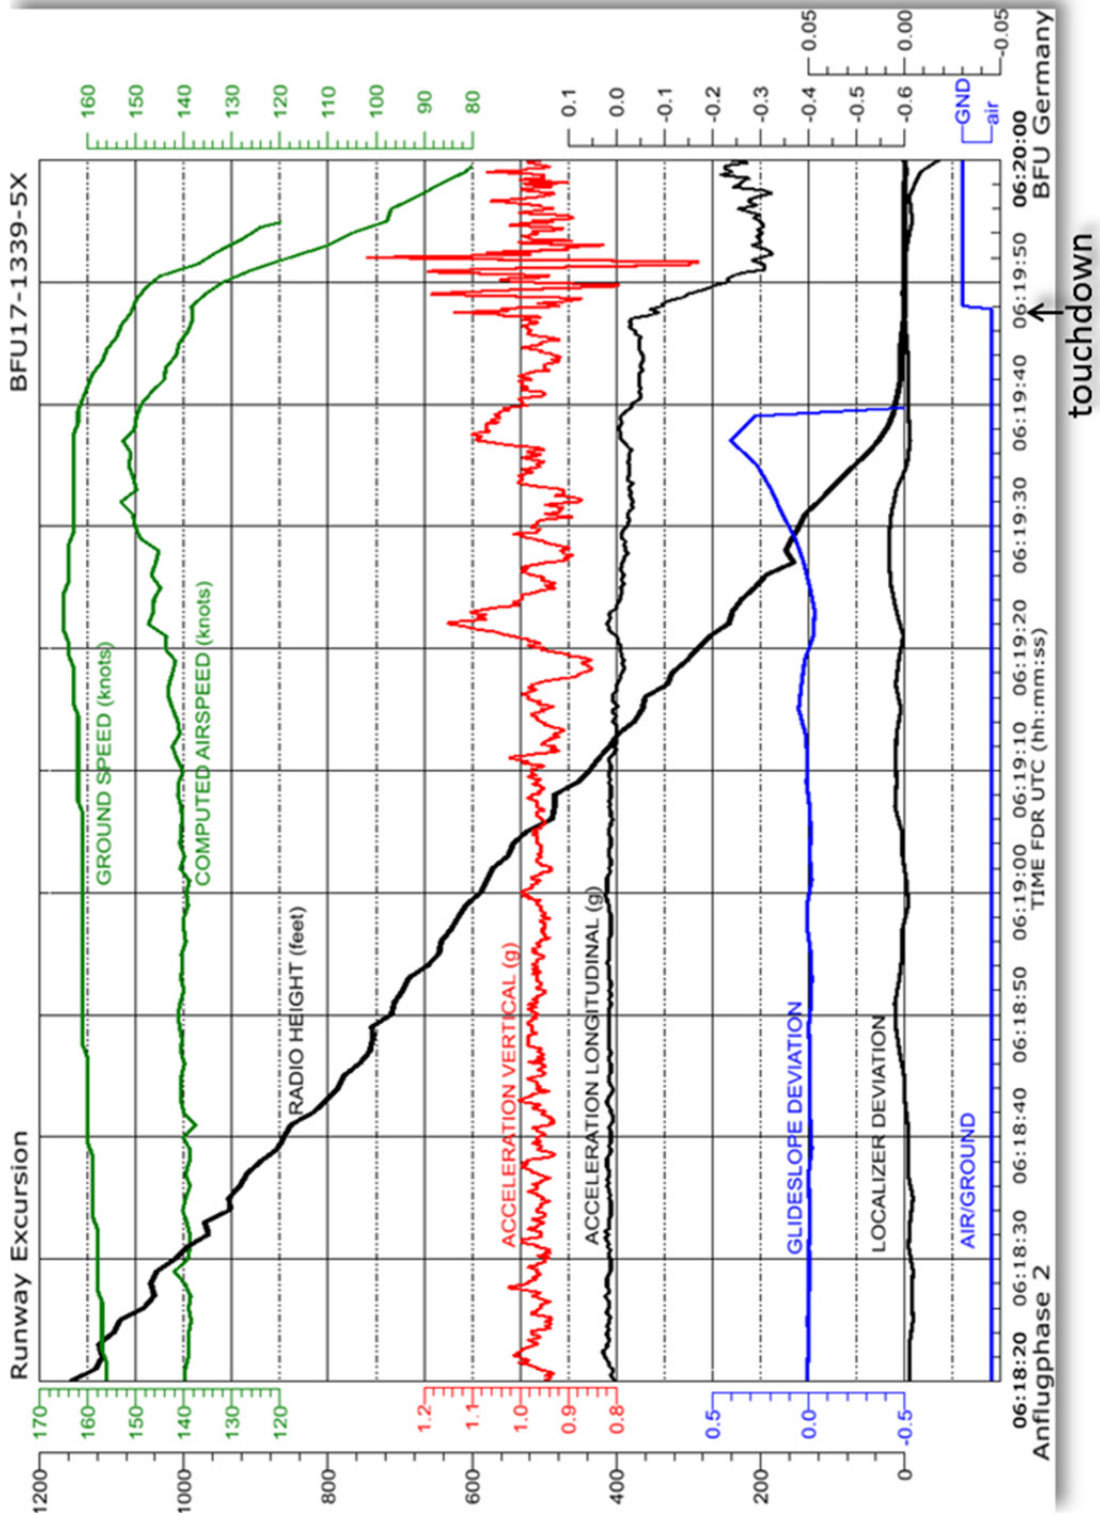
Approach phase

The first two graphs show the approach from about 1,200 ft radio altitude to the touch-down point.

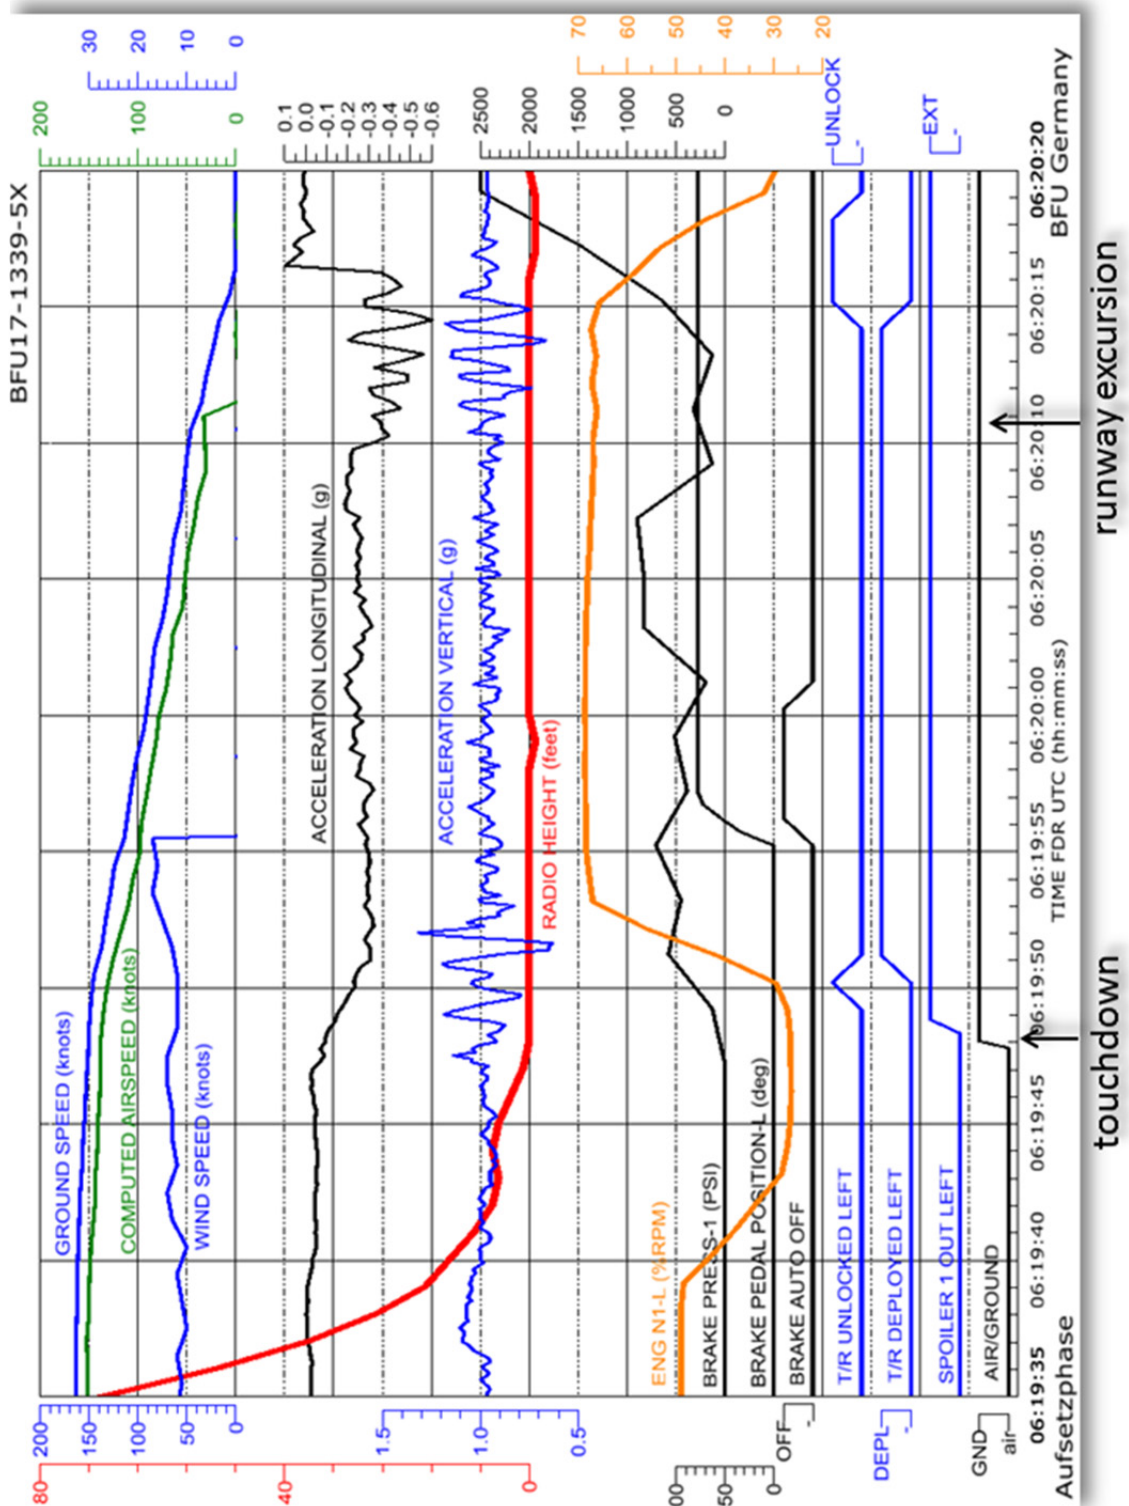
Touch-down phase

The third graph shows the touch-down point with the subsequent runway excursion.

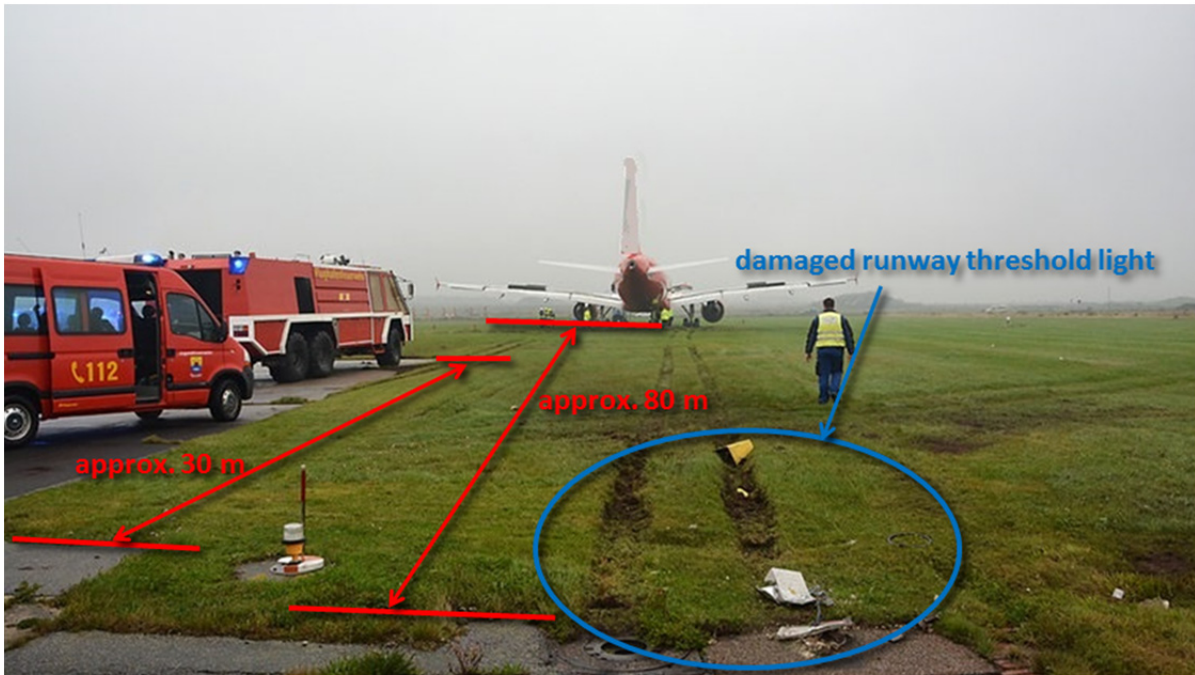
The airplane had come to a stop in the grass about 80 m north of the end of the runway. One lamp of the runway threshold lighting of runway 14 had been damaged.

Airplane position and damaged lighting
