Interim Report

Type of Occurrence:	Serious incident
Date:	23 October 2017
Location:	Near way-point JUIST
Aircraft:	Helicopter
Manufacturer / Model:	Sikorsky Aircraft Corporation / S-76B
Injuries to Persons:	None
Damage:	Aircraft not damaged
Other Damage:	None
State File Number:	BFU17-1441-7X
Published:	March 2018

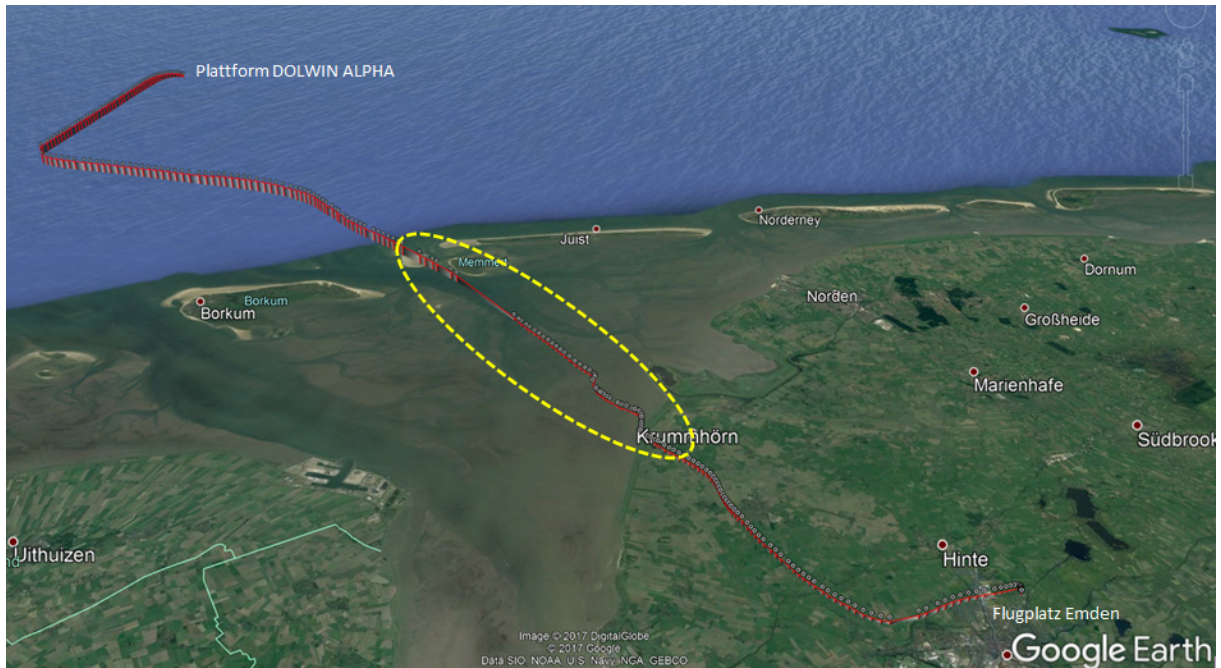
Course of the return flight including descent

Before reaching way-point JUIST the helicopter began to descend. The descent ended in low altitude with reduced speed near the coast line. Then the helicopter climbed again to about 500 ft AMSL and continued the flight to Emden. At 0901 hrs the crew again requested information regarding the prevailing weather at Emden Airfield. The answer was: *"Im Augenblick ist es ein bisschen runtergegangen, few siebenhundert, broken eintausend, overcast tausend-achthundert, der Regen lässt jetzt ganz sachte nach (Right now it has decreased a little bit few seven hundred, broken one thousand, overcast one thousand eight hundred, the rain is gradually slowing down)." At 0905 hrs the crew signed off with Bremen Radar. At 0911 hrs the helicopter landed at Emden Airfield.*

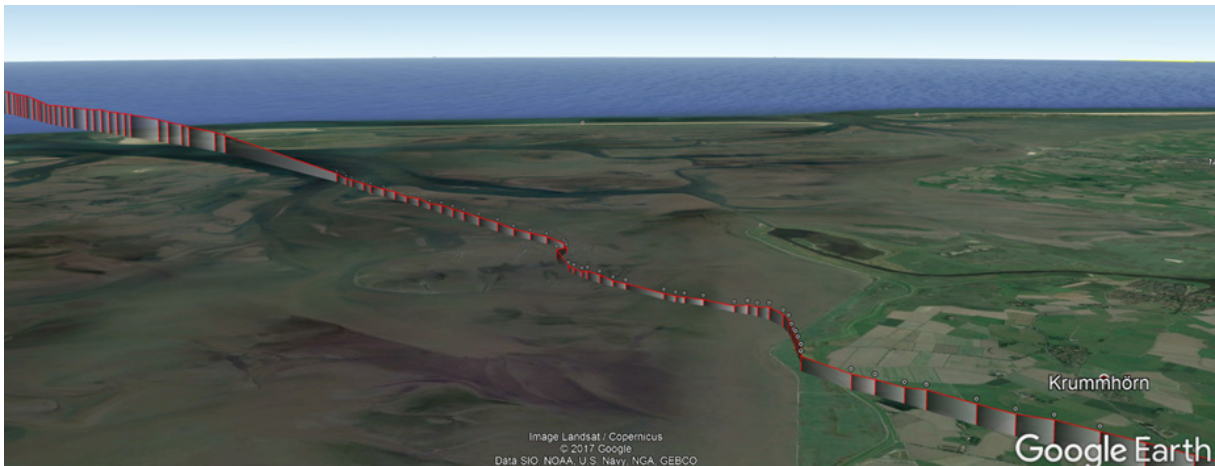
Descent before reaching the coast line

According to the Cockpit Voice Recorder (CVR) recording the PIC allowed the helicopter to continue the descent because no visual contact with the coast line had been established. At that time even in low altitude there was no visual contact with the coast line. At about 0900 hrs the co-pilot said "100 ft GND". A few seconds later the computer voice from the radar altimeter announcing "One Hundred Feet" and an acoustic signal were recorded. There was no verbal comment about the altitude warning. The helicopter continued to descend. Both pilots looked outside searching for the coast line or a brighter place in the grey clouds ahead of them. The co-pilot recognised the low altitude and read the radar altimeter "20 ft GND". He advised the PF accordingly. At the same time the airspeed had decreased to approximately 40 kt. The PF stopped the descent and increased the airspeed. A short time later in low altitude the pilots had the coast line in sight. The flight was continued towards Emden under Visual Flight Rules (VFR) with reduced cruise speed and in low altitude. Due to the limited visibility and low clouds it was decided to fly an approach to runway 07. When the engines were shut off the pilots noticed that the cyclic stick trim switch was not pushed in, i.e. the function was disengaged.

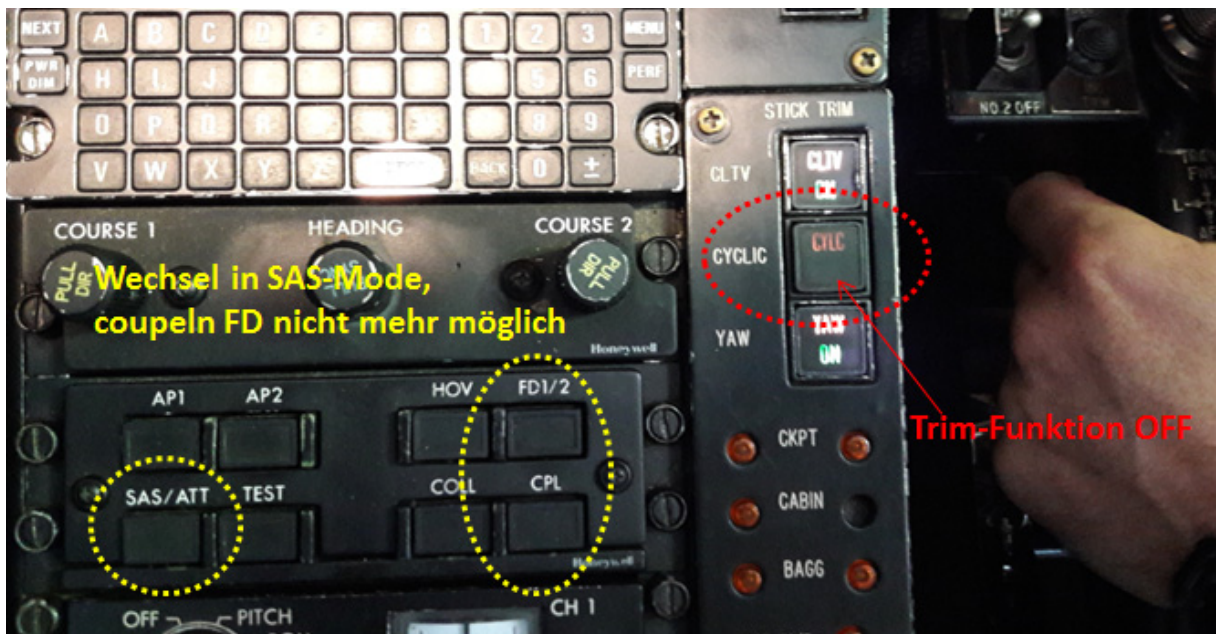
Overview AP and FD panels and the trim push switch

UTIRA and HW751 the FD had decoupled without reason. The two autopilots had changed from Attitude Retention (ATT) Mode to Stability Augmentation System (SAS) Mode. This resulted in the PF having to actively control the helicopter manually. Subsequently, the PNF tried to find and eliminate the cause for the FD failure. Both in vain. After they had enquired about the prevailing weather conditions at Emden Airfield they decided to reduce the flight altitude before reaching the coast line. During descent the helicopter had suddenly encountered heavy rain and significantly reduced visibility. At about 500 ft AMSL the co-pilot had handed over controls to the PIC. He had instructed the co-pilot to extend the landing gear because he wanted to be prepared for a possible off-field landing due to the unexpected bad weather.

The helicopter was equipped with a Honeywell SPZ -7000 Digital Automatic Flight Control System (DAFCS). This system consists of an autopilot function for attitude stabilisation (SAS or ATT modes), and a flight director function for roll and yaw control (ALT, IAS, VS, HDG, Nav or ILS modes). During automatic flight control one or several flight director modes (upper modes) are coupled with the autopilot in ATT mode. If the cyclic stick trim function is disengaged the AP changes from ATT mode to SAS mode. It is not possible to couple the FD in SAS mode.

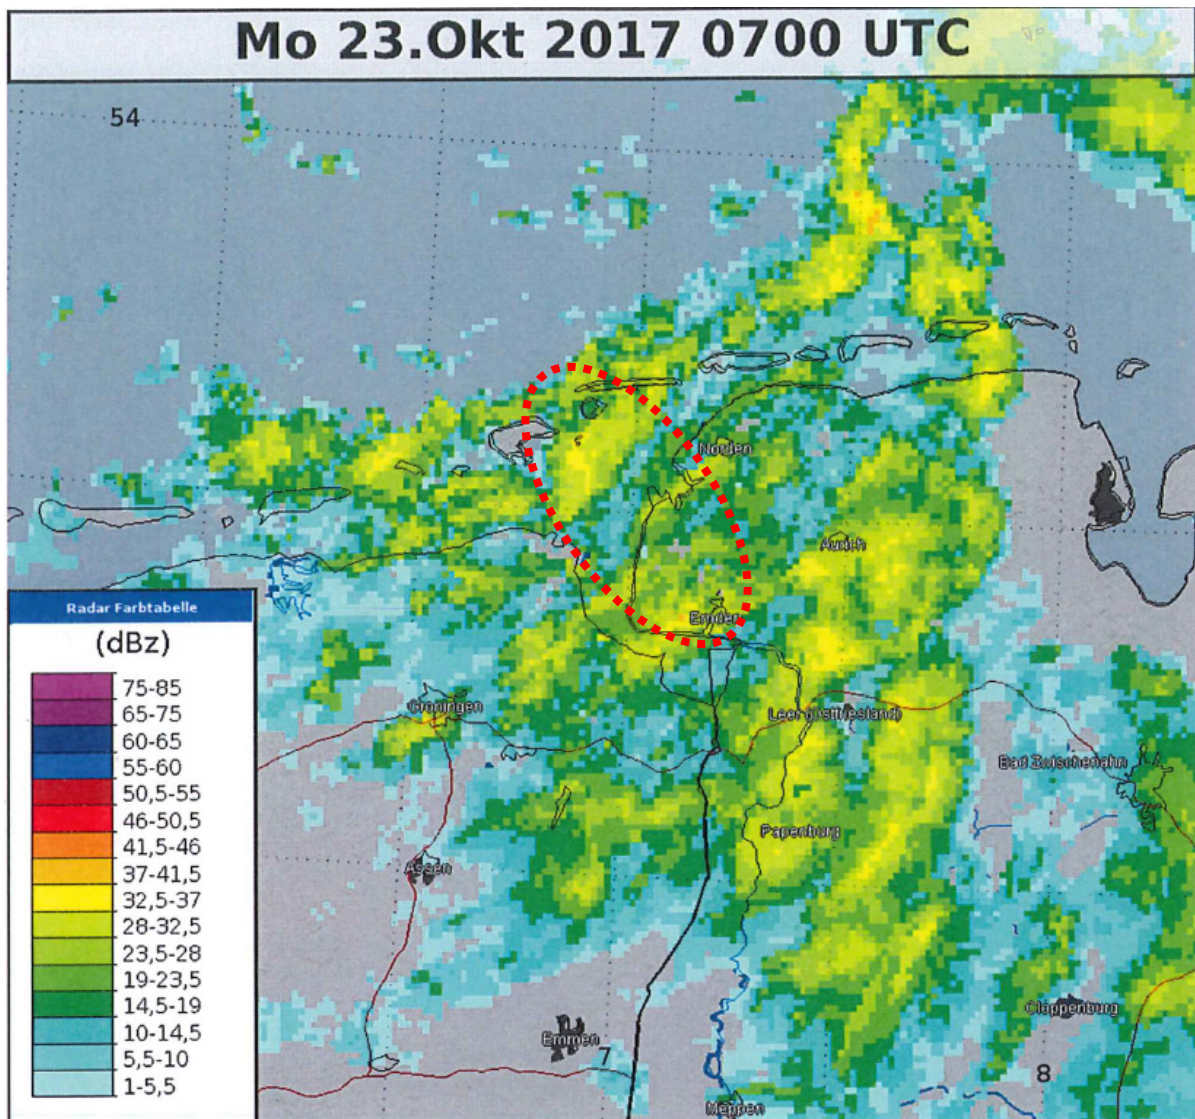
Precipitation radar image at the time of the descent

The PIC stated that the heavy shower and the therefore reduced visibility had occurred totally unexpectedly. He had not considered to changing flight rules and conducting the instrument approach RNAV (GPS) Y RWY25 to Emden due to the unclear situation with the FD.
