Interim Report

Type of Occurrence:	Serious incident
Date:	28 June 2018
Location:	Siegerland Airport
Aircraft:	Airplane
Manufacturer / Model:	Embraer / EMB-500
Injuries to Persons:	No injuries
Damage:	Minor damage to aircraft
Other Damage:	Minor crop damage
Information Source:	Investigation by BFU
State File Number:	BFU18-0878-7X

On 28 June 2018 an airplane Embraer EMB-500 landed on runway 13 at Siegerland Airport during a check flight. The flight crew was not able to stop the airplane on the runway; it overshot the end of the runway by approximately 15 m.

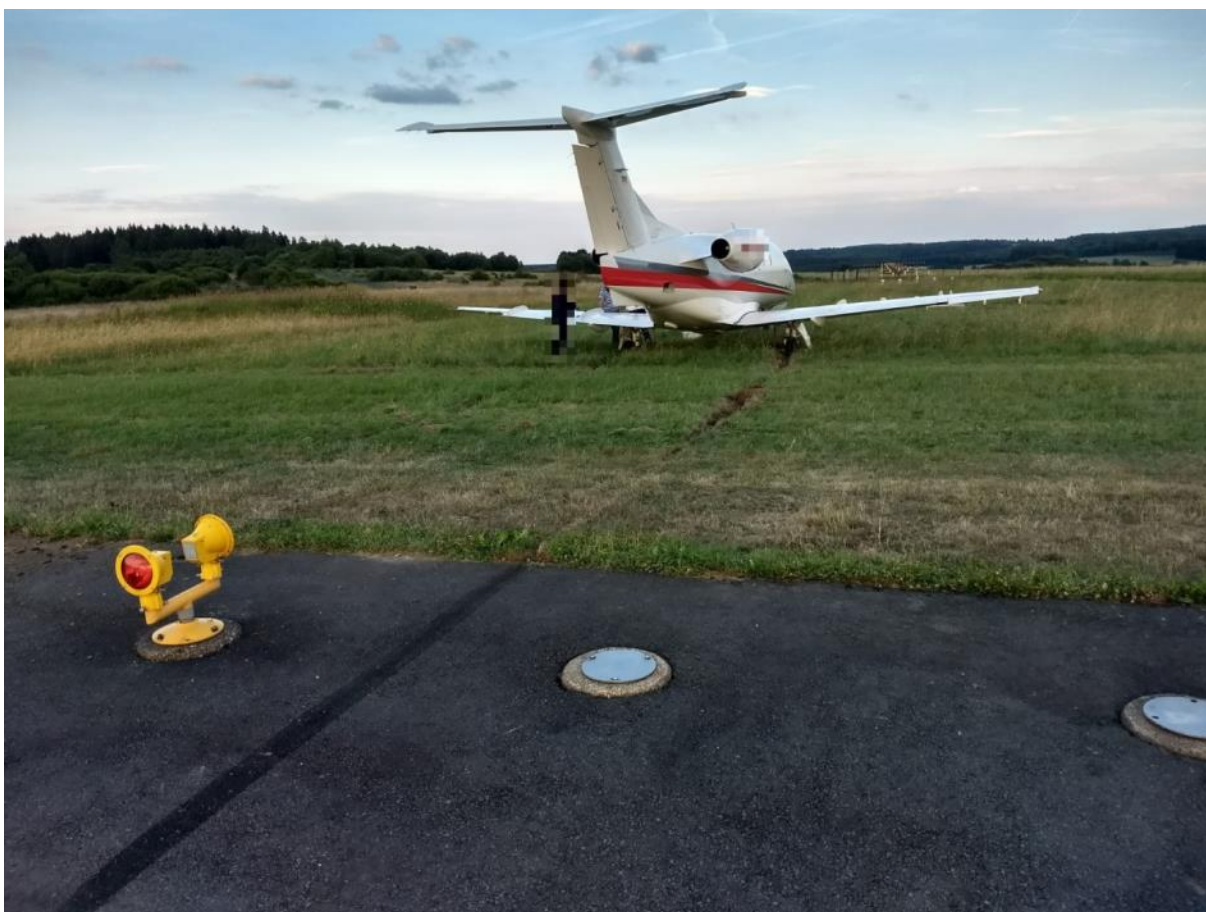
The airplane came to a stop in the grass approximately 15 m beyond the end of runway 13 of Siegerland Airport.

The aircraft stood about 15 m beyond the paved end of runway 13 in the grass. The fuselage was pointing in the direction of the landing direction. The last heading the FDR recorded was 130°. The left main landing gear and its wheels showed minor damage (Fig. 3). On runway 13 a skid mark was found about 200m beyond the intersection with taxiway C. It was interrupted and started again about 60 m before the end of the runway (Fig. 4).

Fig. 2: Aircraft beyond runway 13 in the grass

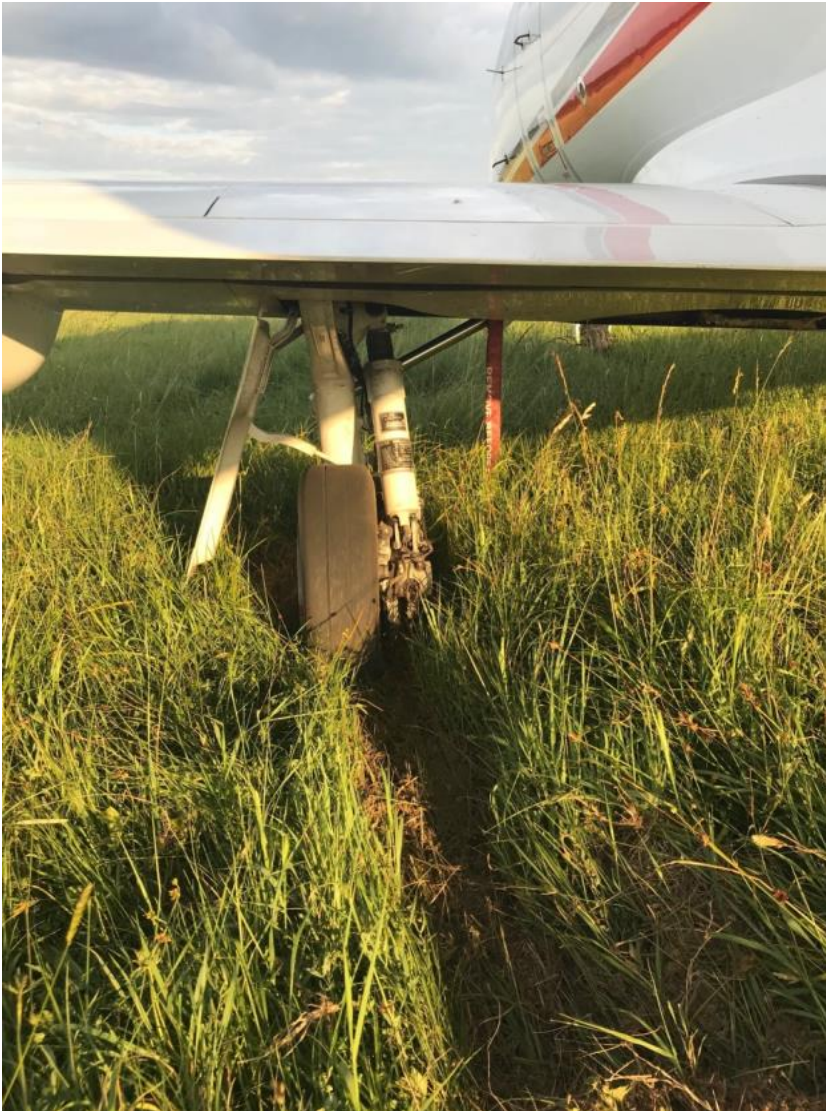
The BCU of the aircraft involved was analysed by the aircraft manufacturer. The data showed a maximum value of 105%. When such a value is reached the BCU switches into Fail Mode and disconnects the hydraulic pressure to the brakes.

Fig. 3: Left main landing gear with minor damage

As a consequence of this event the operator equipped every Embraer 500 with BCU-7.

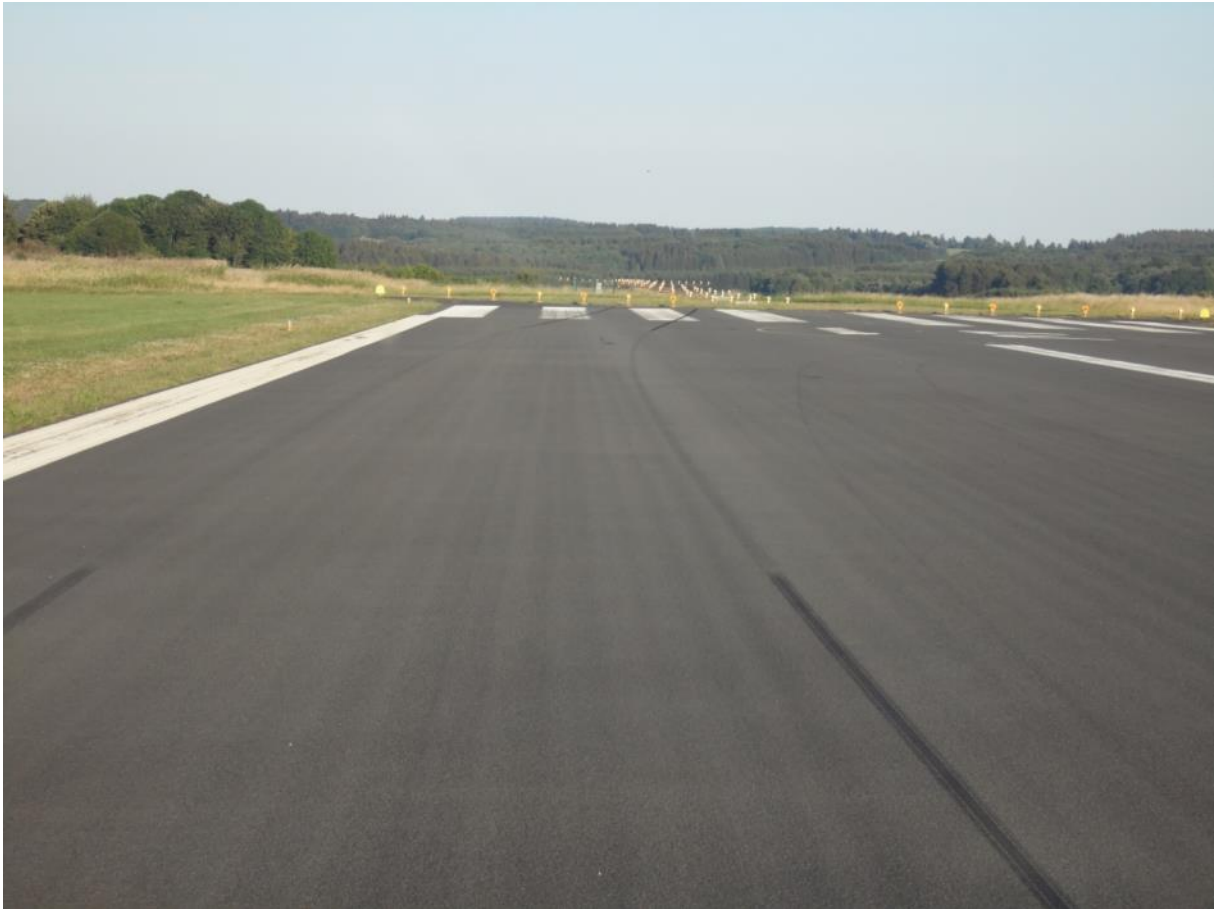
The flight crew stated that the aircraft had touched down in the area of the first white double bars of runway 13 and initially decelerated normally. Suddenly, the brake pressure had decreased for a short time. This had happened twice. The aircraft veered left due to the marginal and erratic braking action. The captain had steered

Fig. 4: Interrupted skid mark on runway 13 of Siegerland Airport

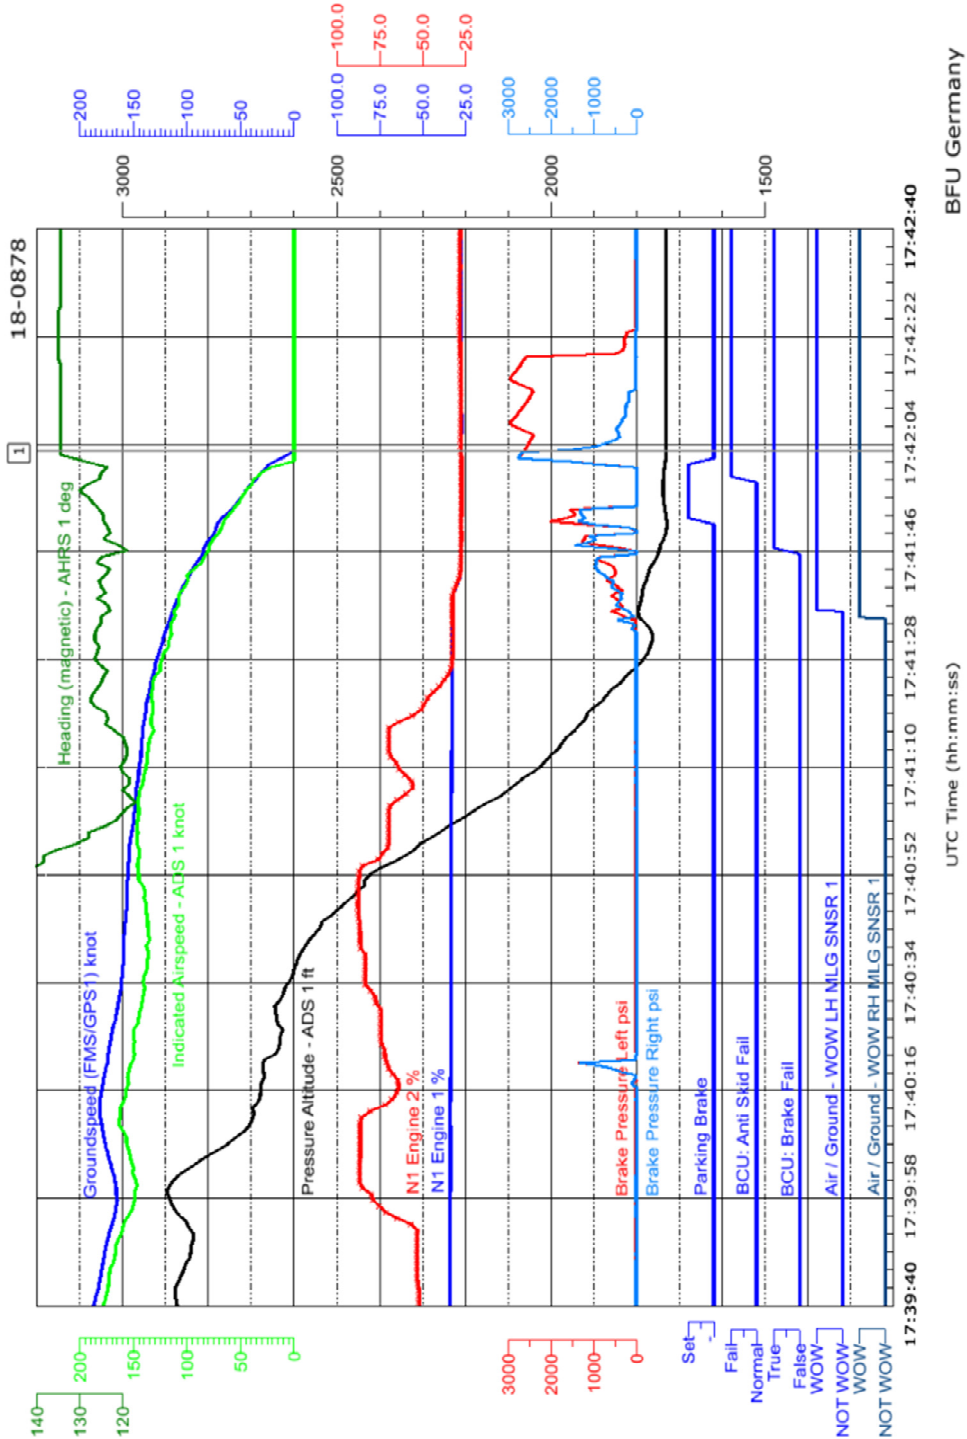
CVDR read-out

At about 1940 hrs the crew was on approach to runway 13 of Siegerland Airport. The captain was Pilot Flying (PF). This approach was conducted with a simulated engine failure. The analysis of the Cockpit Voice Data Recorder (CVDR) showed that until touch-down N1 of the left engine was 35% and N1 of the right engine varied between 85% and 35%. According to the CVDR (Air Ground Signal), at 1941:34 hrs the aircraft touched down approximately 700 m beyond the threshold of runway 13. The ground speed the CVDR recorded at the time of touch-down was about 110 kt. At about the same time the CVDR recorded an increase in brake pressure (left and right). On the left side it increased to 2,000 PSI, on the right to 1,300 PSI. The recorded brake pressure reached 0 twice in short order and then increased again. At 1941:46 hrs, the time of the first decrease of the brake pressure, the CVDR had recorded the master caution "BCU Brake Fail" and 12 s later the master caution "BCU Anti-Skid Fail". Approximately 7 s after the first caution the recorded brake pressure value decreased to 0 and remained there for about 6 s. Over about 13 s it increased to 2,600 PSI (right) and decreased again to 0. Between the time the brake pressure first decreased and then reached 2,600 PSI ground speed decreased from about 80 kt to 0 kt.

The data recorded by the FDR allowed for the calculation of the touchdown point. The aircraft touched down approximately 700 m beyond the threshold of runway 13.
