Investigation Report

Kind of occurrence: accident
Date: 09. August 2000
Location: aerodrome 'Griesheimer Sand'
Aircraft: aeroplane
Manufacturer/type: Cessna Aircraft Company / C 340
Injuries to persons: pilot and two passengers fatally injured
Material damage: aircraft destroyed
Other damage: field damage

Bundesstelle für
Flugunfalluntersuchung
(Federal Bureau of Aircraft
Accidents Investigation)
Hermann-Blenk-Straße 16,
D-38108 Braunschweig

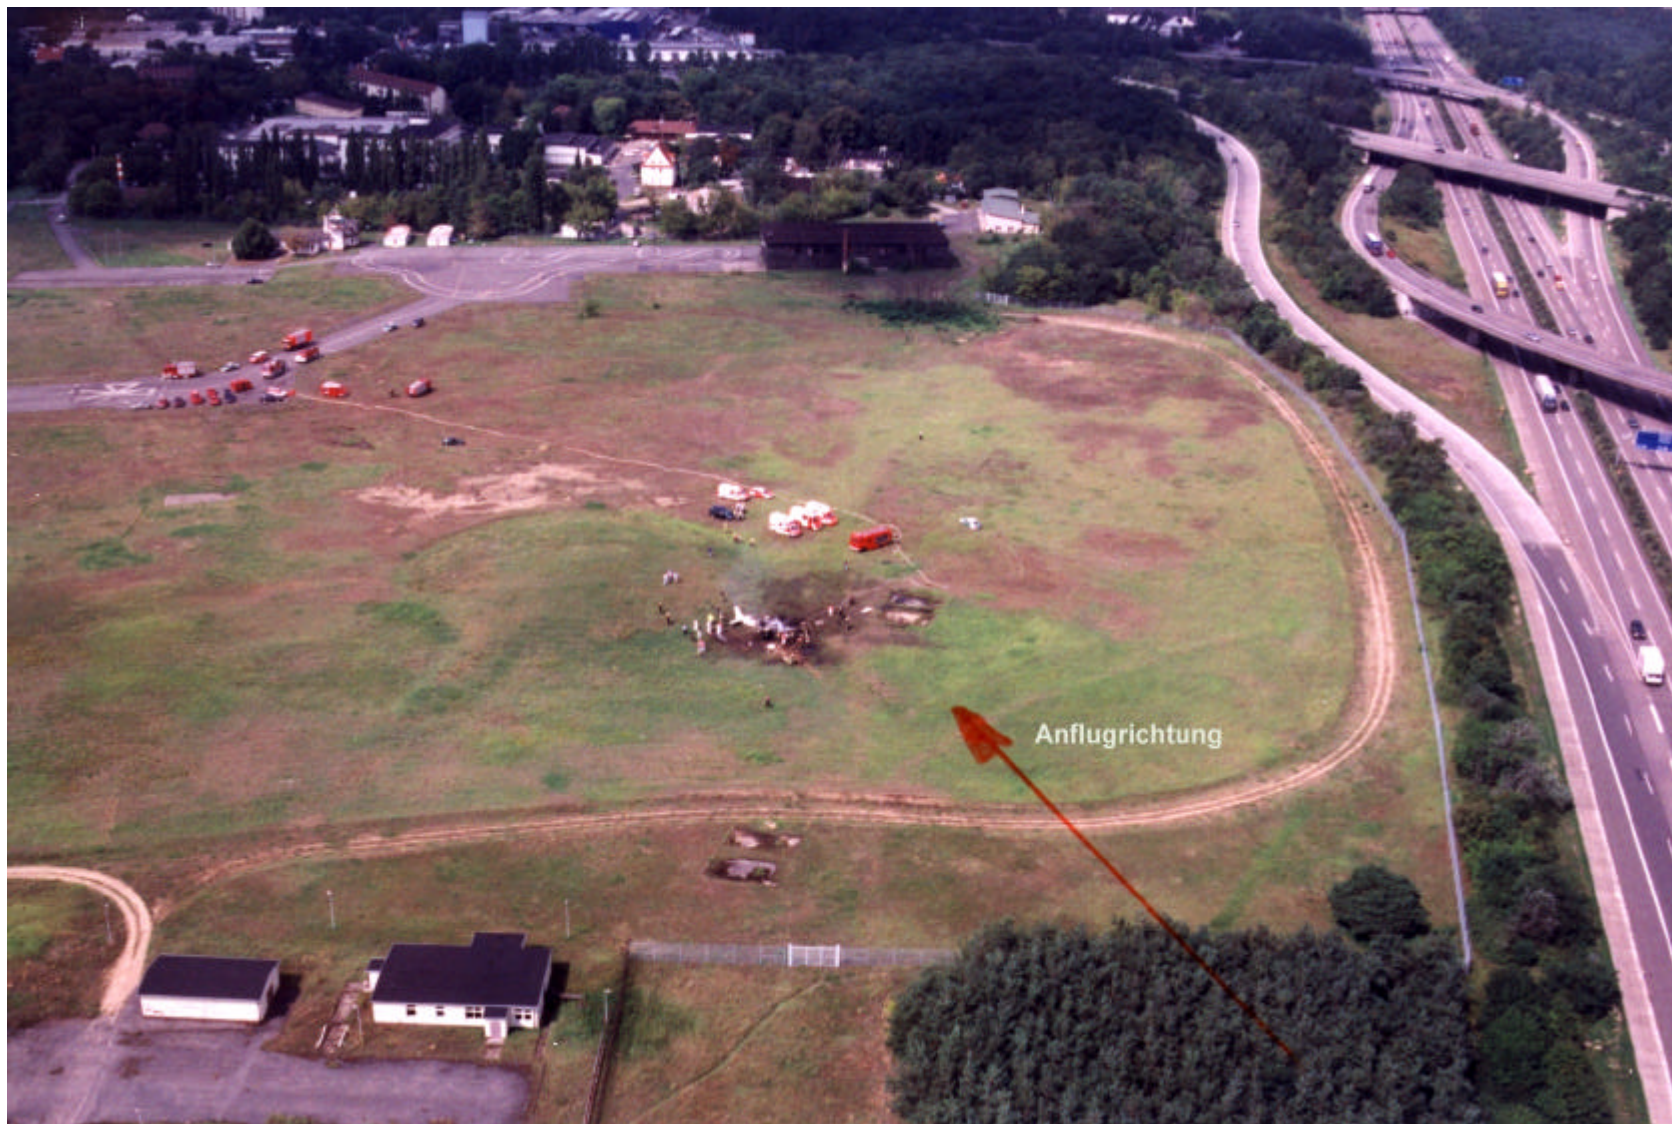
View at the scene of the accident

The aeroplane flew a large turn over Griesheim, in order to land on the former military aerodrome. The aeroplane was rolling heavily at a very low airspeed with an uneven engine noise. Having arrived above the airfield, the aeroplane flew a left turn at a height of appr. 30 m, in order to land on runway 25. The bank angle was reported to have been between 40° and 60°. In this flight attitude the aeroplane stalled over the left wing and crashed with the left tip tank on the ground, it nosed over and immediately caught fire (Attachment 1).

The aeroplane first touched the ground with the left wing tip tank. The tip tank was torn off by the impact and slung 25 m further into the extended direction of flight. The aeroplane turned over the left wing about the yawing axis and crashed vertically on the ground with the power plants and the cabin; during the crash the right tip tank was torn off as well. The fuselage snapped off behind the cabin and the vertical tail crashed into the cabin roof.

Afterwards, the tail unit snapped back again. The aeroplane came to rest in normal attitude with the tail unit pointing northwest. According to statements of eyewitnesses there were several explosions. The cabin and the left wing had completely burnt out (attachment 2). The left power plant had separated. The right wing was in very good condition as well as the rear part of the fuselage and the tail unit. Both propellers had broken off behind the hub. The landing gear was extended. The flaps were in retracted position. The trim tab of the rudder was deflected to the left. Following the accident both fuel selector switches in the cockpit had been found in the position 'CROSS FEED' whereas the fuel selector valves in the wings were in different positions, the left valve was in the 'OFF' position and the right valve was in an intermediate position between OFF / MAIN TANK. The different positions of the fuel selector switches as well as the fuel selector valves show that with the impact the forced fuel assignment had been cancelled. Thus it is not possible to draw well-founded conclusions from the positions found. It could no longer be reconstructed from which tanks the power plants had been supplied during the approach to Egelsbach.

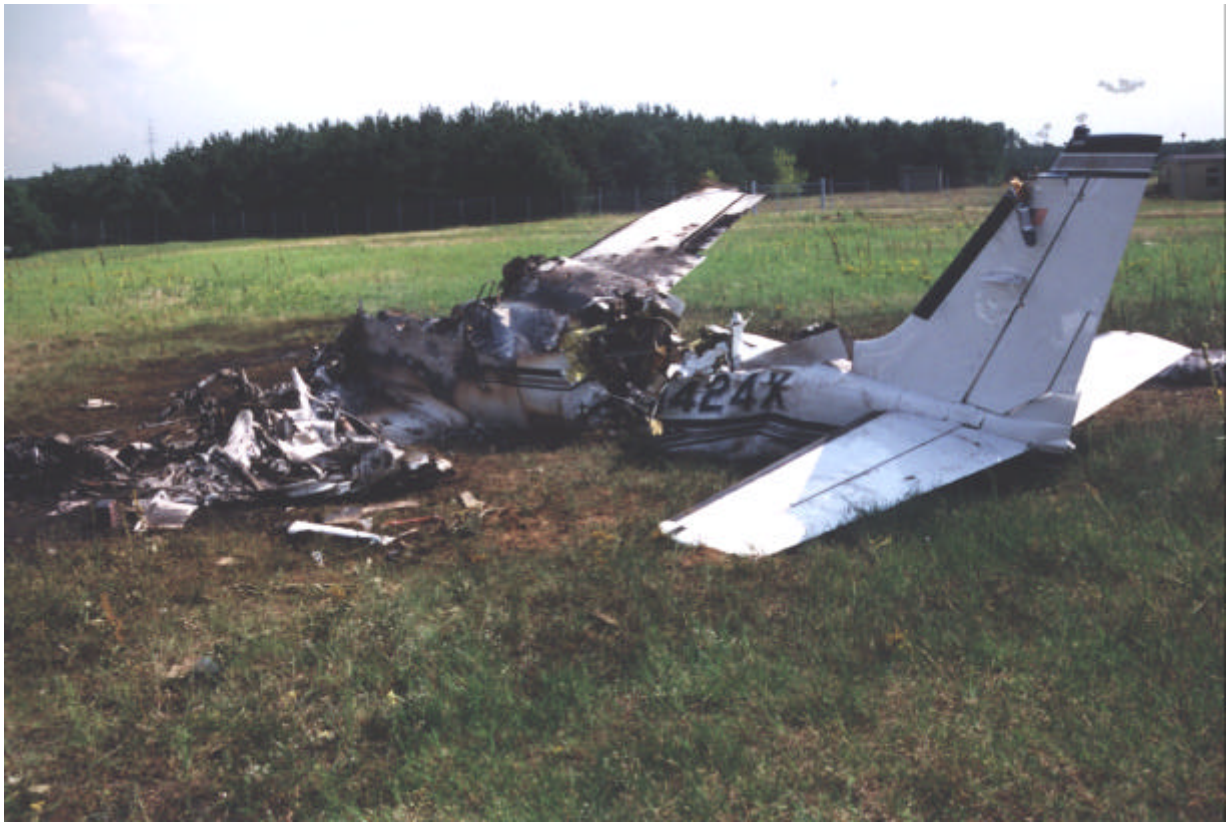
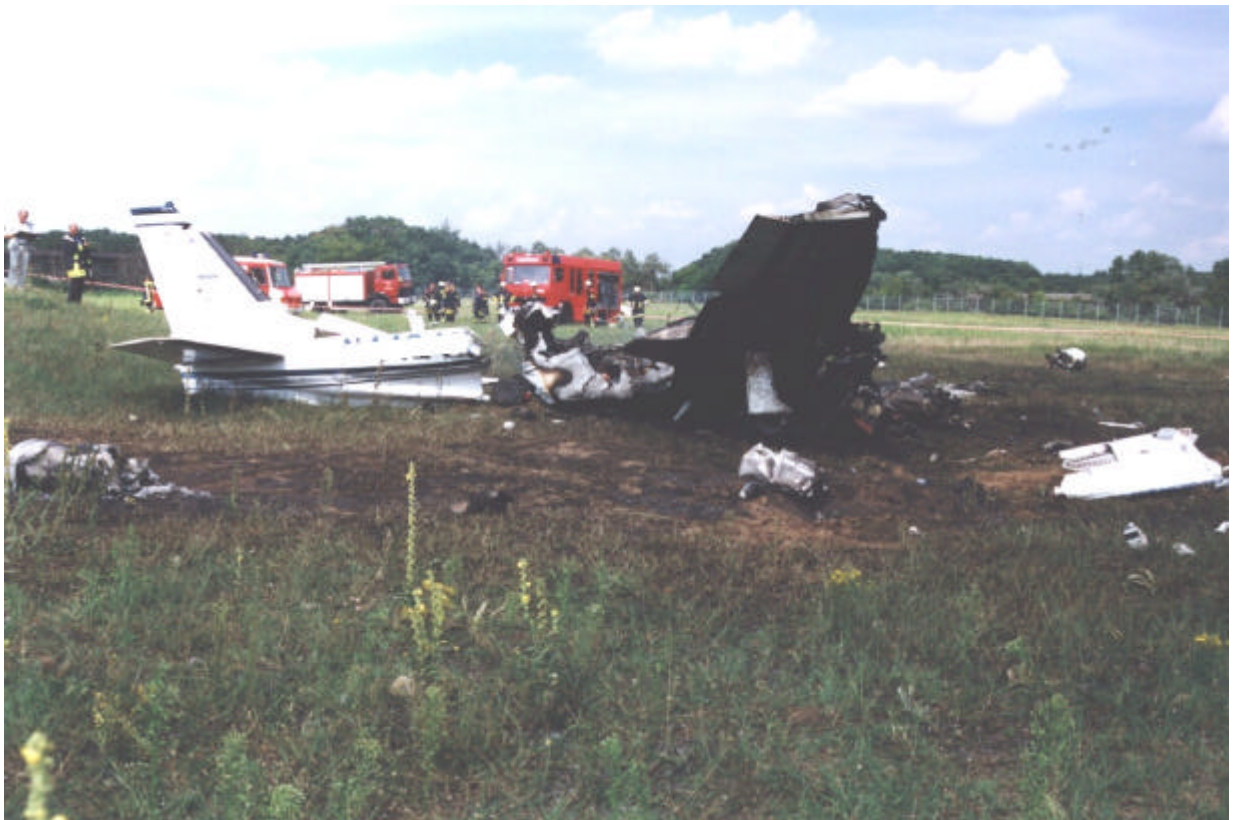
Due to the high degree of destruction in the cabin area and the left wing, the controls in this area could no longer be investigated for function ability. Based on the statements of the witnesses and the course of the flight it is assumed, however, that the controls of the aeroplane were completely intact up to the impact.

During the investigation it was found that the trim tab of the rudder had been deflected heavily to the left, i.e. that the aeroplane was trimmed as if only the right-hand powerplant had been running.

- Both propellers had been torn off and lay separately from the wreckage.
- The left propeller did not show any signs of rotation prior to the impact whereas the blades of the right propeller had clearly visible impact traces.

- The trim tab of the rudder was deflected to the left.
- The cabin area and the left wing had been completely destroyed by the fire.

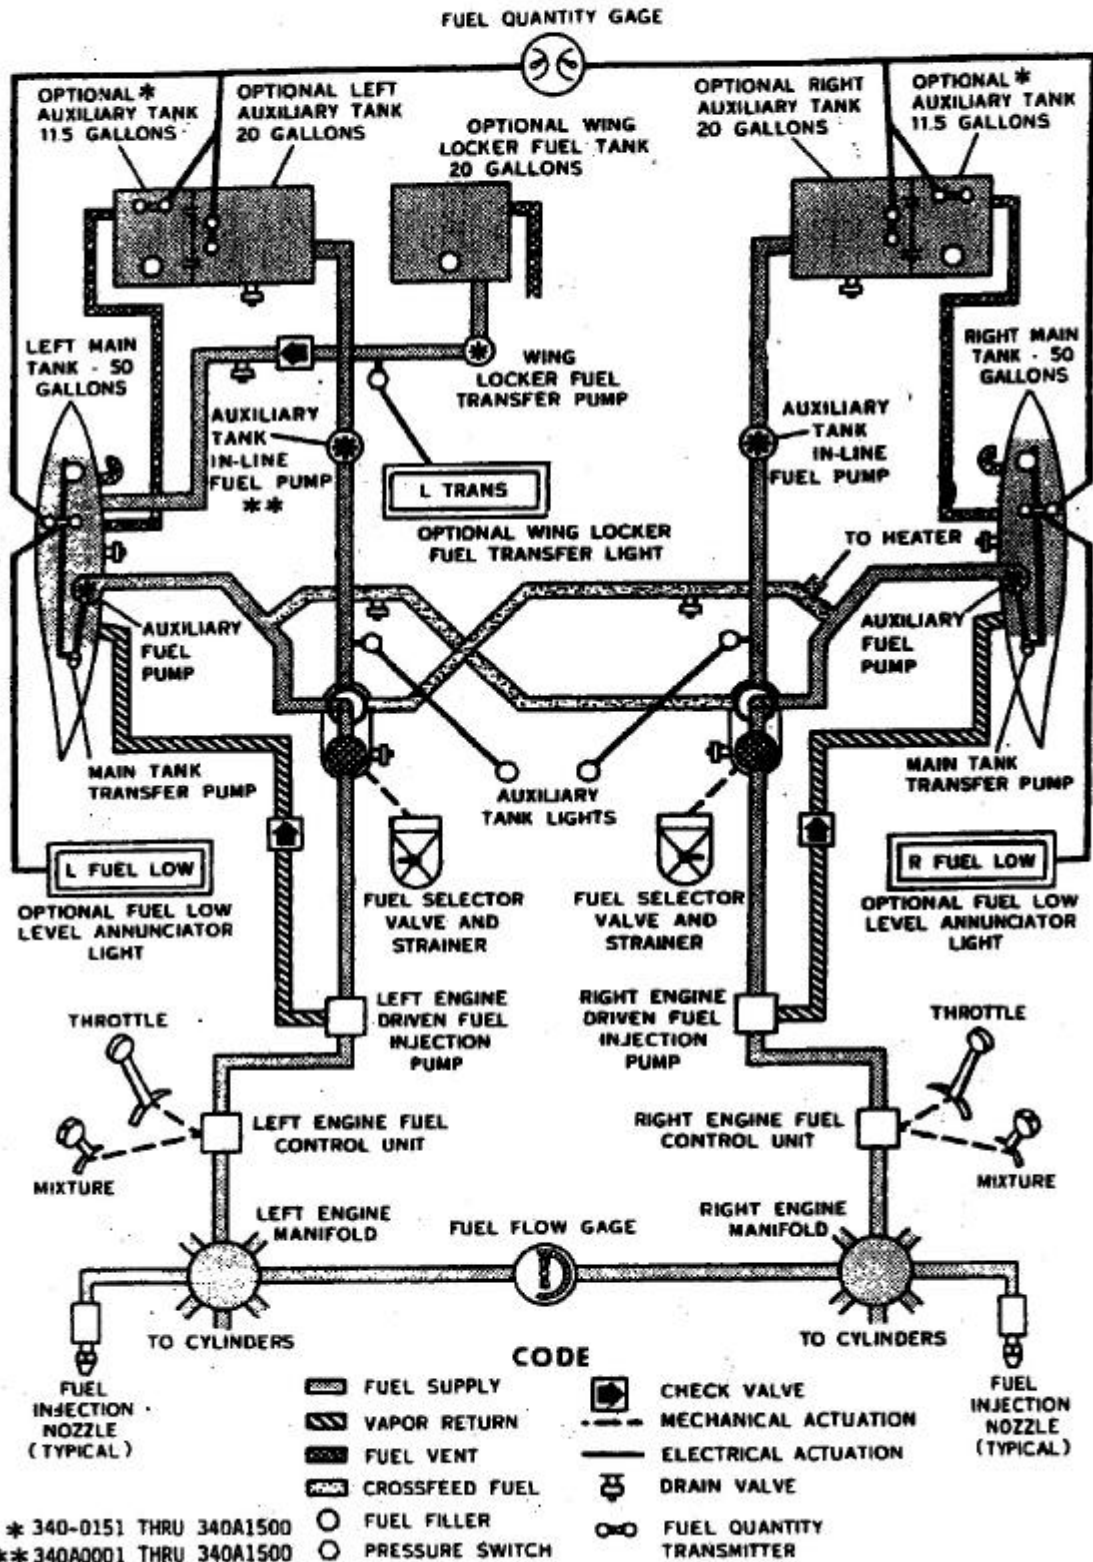
Fuel System schematic of Cessna C 340, with two Auxiliary Tank's and one Wing Locker Fuel Tank on the left side

The aeroplane was equipped with two auxiliary tanks in the wings and a wing locker tank in the left-hand engine nacelle. The main fuel tanks are the wing tip tanks (Attachment 3).

The design of the fuel system with only one wing locker tank in the left wing means that the left wing contained appr. 75,7 litres (20 gal) more fuel than the right side. In addition the aeroplane cabin heating is supplied from the right main tank so that during flight the fuel in the right wing will be consumed first unless the right power plant is temporarily supplied in addition from the left main tank by switching the right fuel selector over to 'LEFT MAIN TANK', in order to compensate for the excess fuel quantity in the left wing.

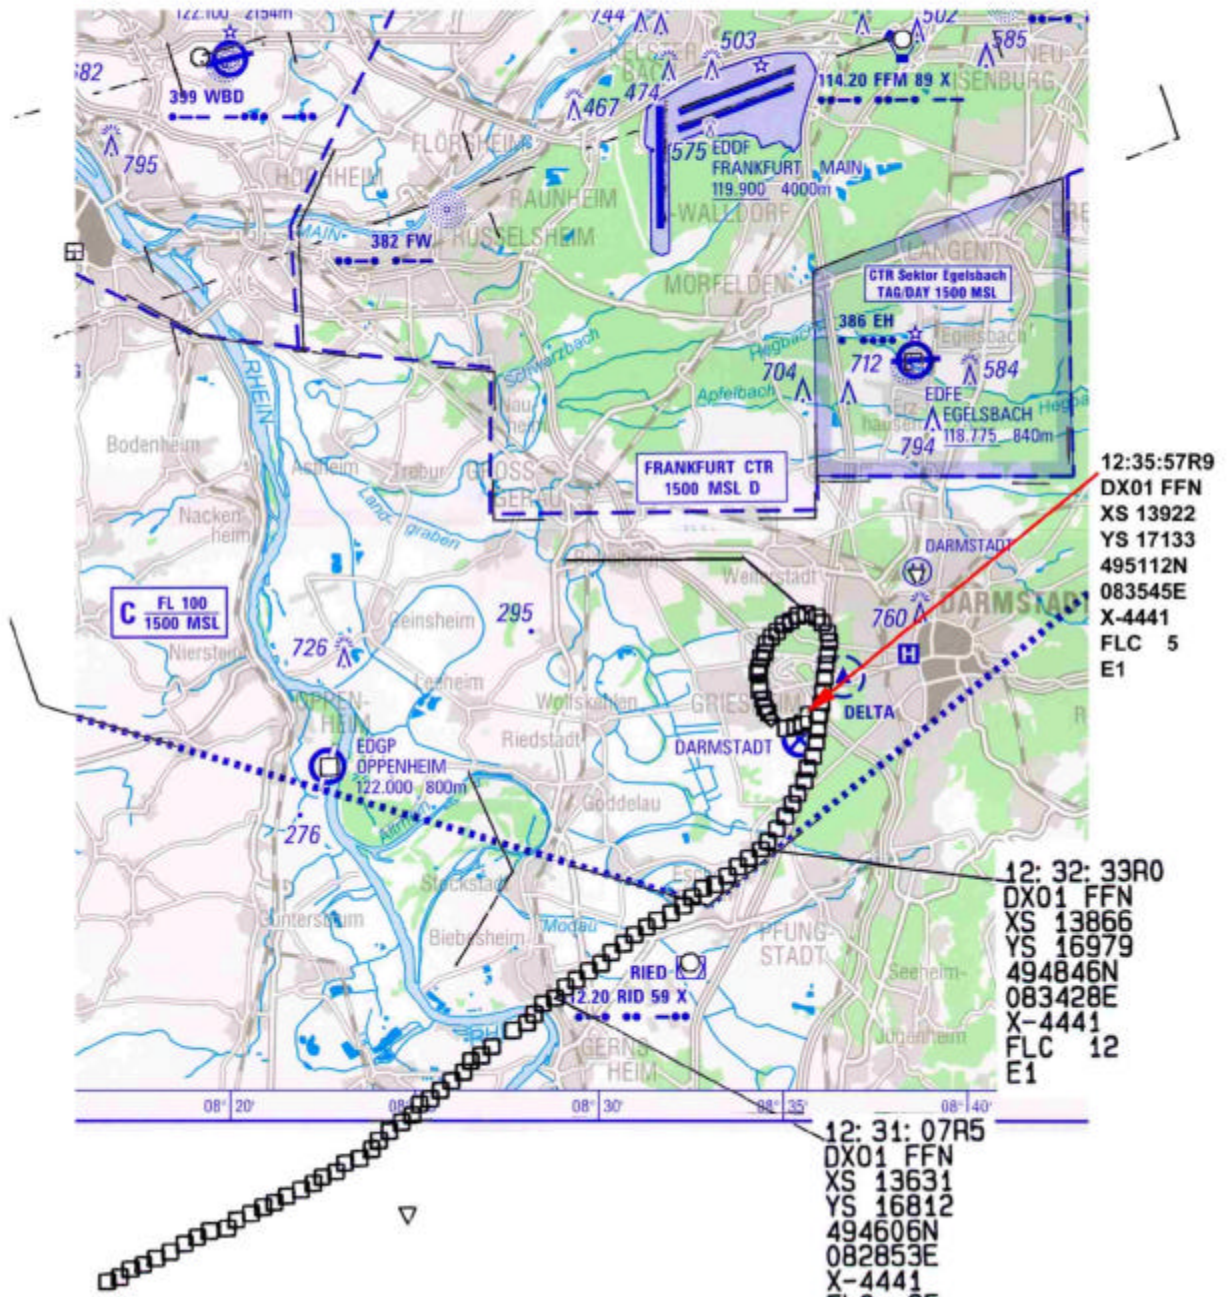
Evaluation of the radardatas

The flight track of the aeroplane had been recorded by the radar station Frankfurt North (FFN). The data transmitted were evaluated with the BFU. First the track went past the later accident site and afterwards in a left turn led back to the accident site. The distance from the aerodrome of destination was approximately twice the distance from the emergency landing aerodrome (Attachment 4).

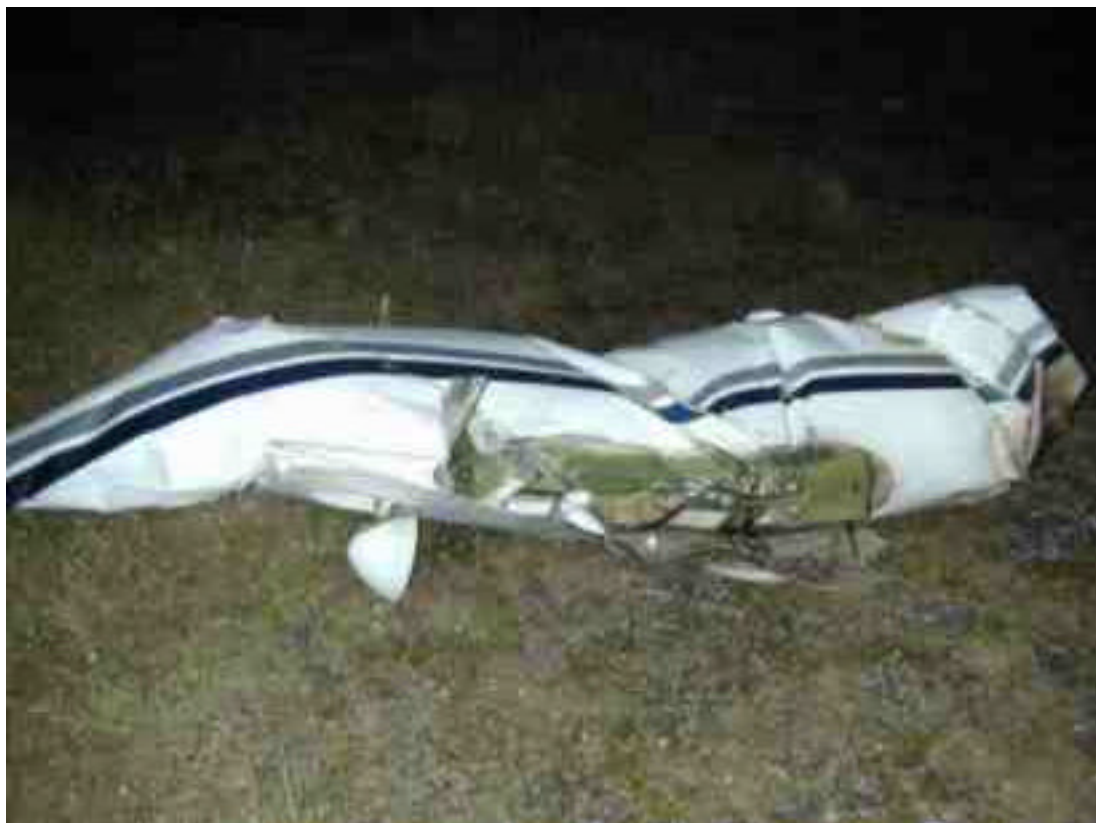
left main-tank

- The main fuel tanks had been torn off and lay separately from the wreckage; they had been submitted only to slight heat effects.
- The left fuel selector switch was found in the position 'RIGHT MAIN TANK' and the right fuel selector switch in the position 'LEFT MAIN TANK'.
- The left fuel selector valve in the wing was in 'OFF' position.
- The right fuel selector valve was in an intermediate position between 'OFF' and 'MAIN TANK'.
- According to the fuel calculation appr. 344 lbs (217 l) of fuel still had to be aboard the aircraft.
- The investigation of the power plants has not revealed any technical deficiency
