# Investigation Report

3X267-02  
August 2012

Type of Occurrence: Accident  
Date: 24 November 2002  
Location: Pritzwalk-Sommersberg  
Aircraft: Helicopter  
Manufacturer / Model: Bell Helicopter Textron Canada  
Limited / Bell 412  
Injuries to Persons: 1 fatal, 3 seriously injured  
Damage: Helicopter destroyed  
Other damage: Slight crop damage  
Source of information: Investigation by BFU  
State File Number: BFU 3x267-02

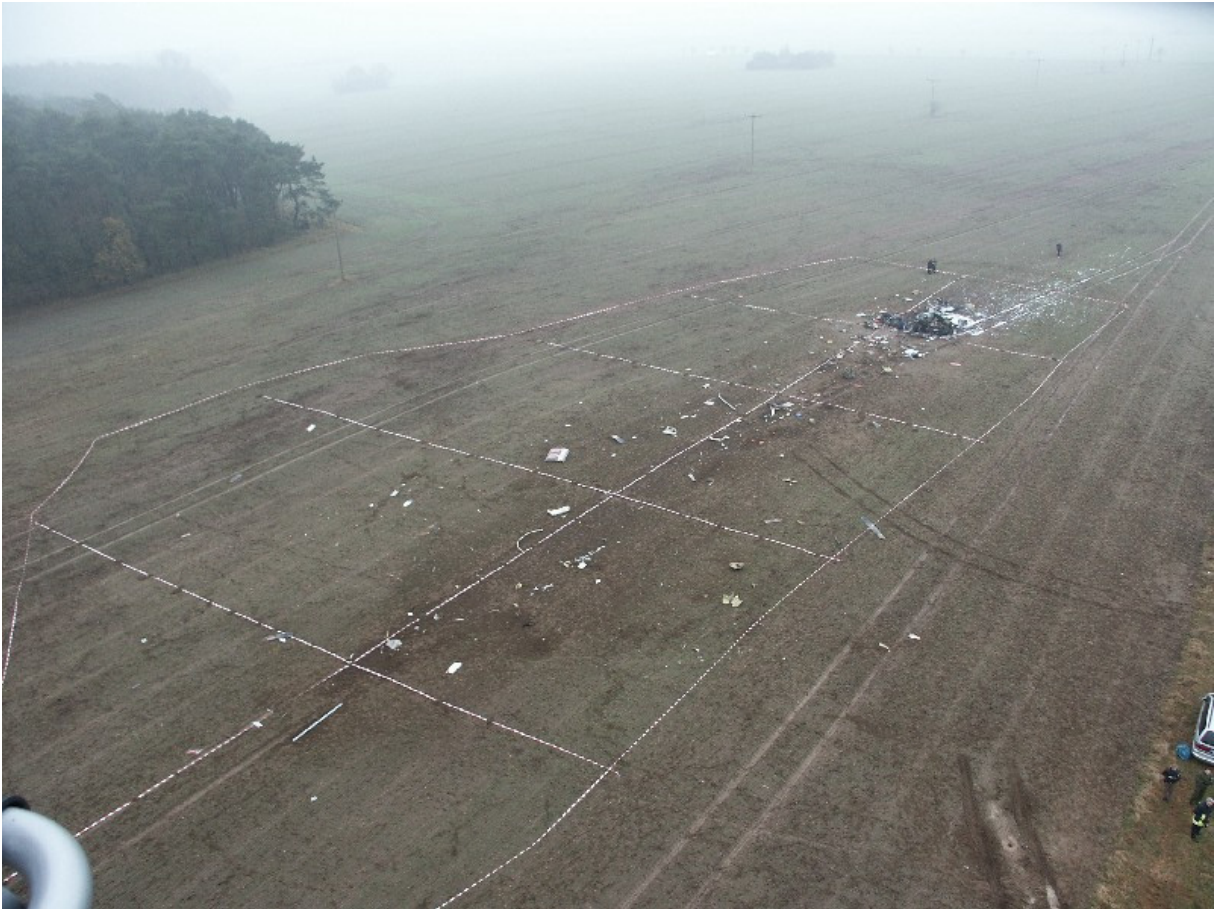
The point of impact was about 300 m west of the planned landing point and 100 m south of the runway centreline. The wreckage was spread along a track of 260° about 80 m long and 15 m wide.

Wreckage Area (looking towards the southwest)

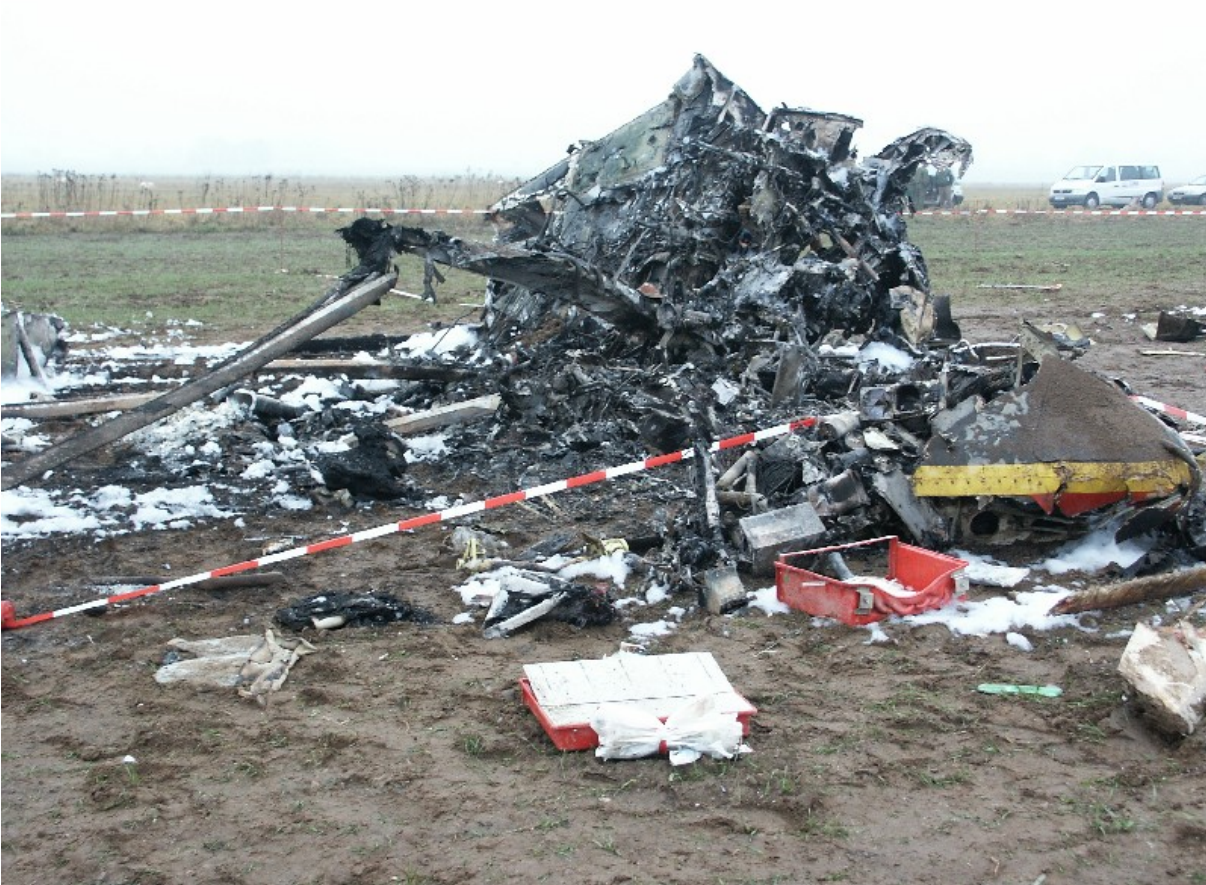
The helicopter right landing skid made first contact with the ground, and then tore off. A few metres behind the landing skid, investigators found impact traces from the fuselage nose and main rotor. Parts of the fuselage nose had penetrated up to one metre into the soil. The scattered wreckage main axis continued to the west with undercarriage cross-tubes, doors and windows, aircraft documents, headsets and other fragments. The PIC's seat was found just in front of the fuselage at the western end of the scattered wreckage. The co-pilot's body was found within the wreck in the vicinity of the cockpit.

View from the front of the burned-out wreck

Immediately after impact, the helicopter caught fire and burned out completely.
