Investigation Report

EX007-0/02
April 2004

Kind of occurrence: Serious incident
Date: 29 November 2002
Location: Dortmund Airport
Aircraft: transport category airplane
Manufacturer/type: Boeing Company / Boeing 737-800
Injuries to persons: no injuries
Damage to aircraft: airplane slightly damaged
Other damage: none
Source of information: investigation by the BFU

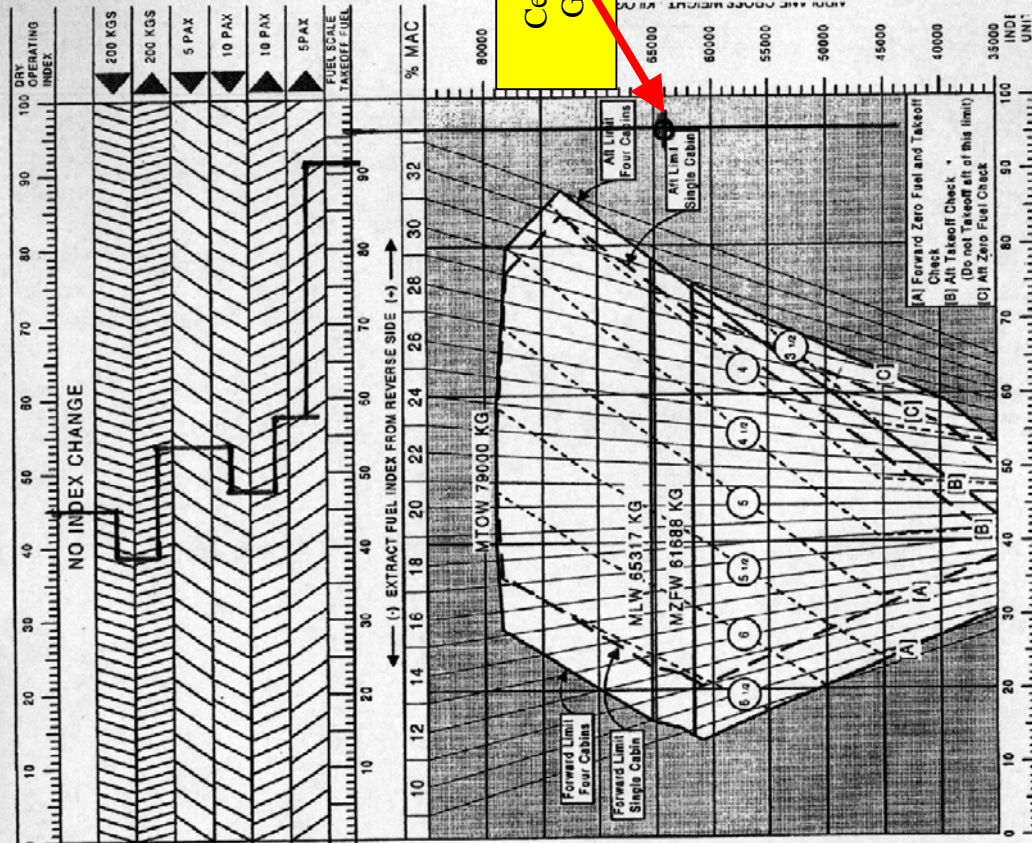
Load & Trim-Sheet of the incident flight with the actual entries

From the Load & Trim-Sheet enclosed the actual masses, the corrected DOI, and the actual passenger distribution in the cabin are to be seen.

The entries in the Load & Trim-Sheet were not correct.

With the move of the passengers not accomplished, the centre of gravity position during the take-off of the Boeing 737-800 was far beyond the allowable rear range.
