# Investigation Report

3X002-0/05  
17 May 2006

Type of occurrence: Accident  
Date: 17 January 2005  
Location: Near Thalheim  
Aircraft: Helicopter  
Manufacturer / Type: PZL-Swidnik / W-3A  
Injuries to persons: Two fatally injured and three seriously injured persons  
Damage: Aircraft destroyed  
Other damage: Damage to forests  
Information Source: Investigation by BFU

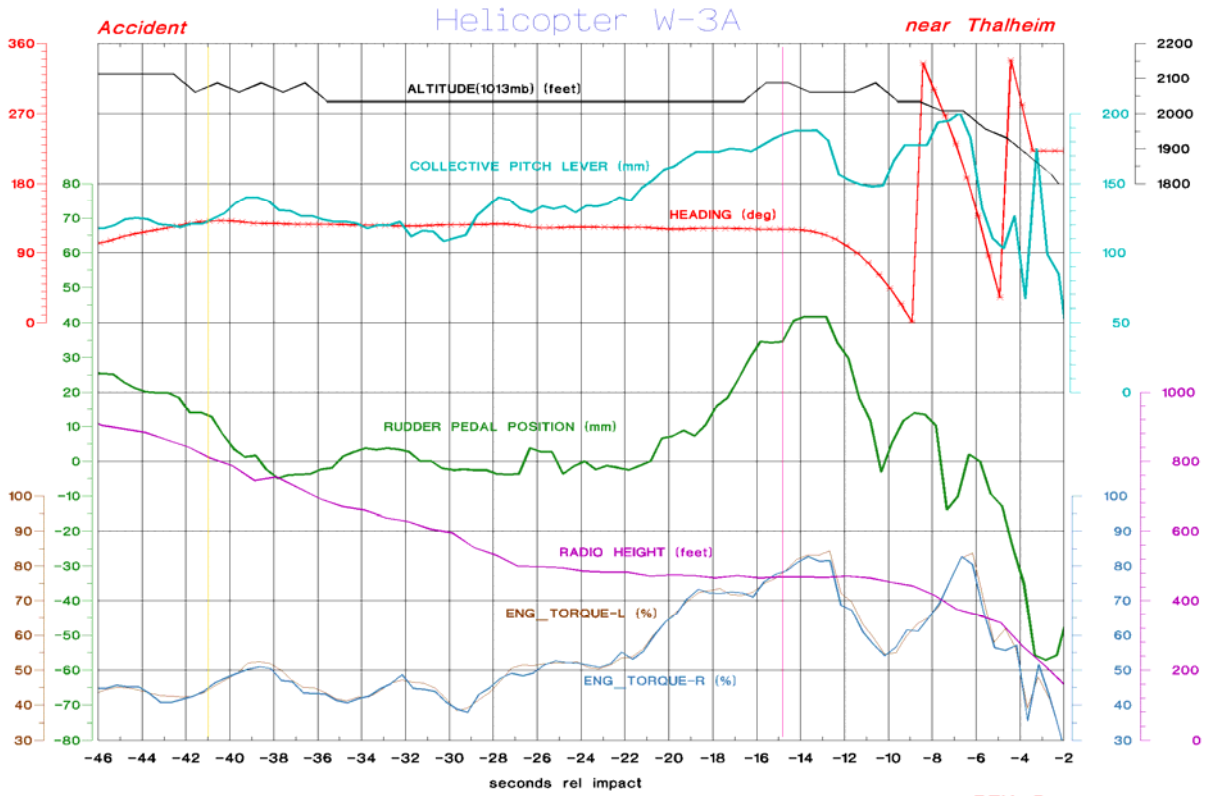
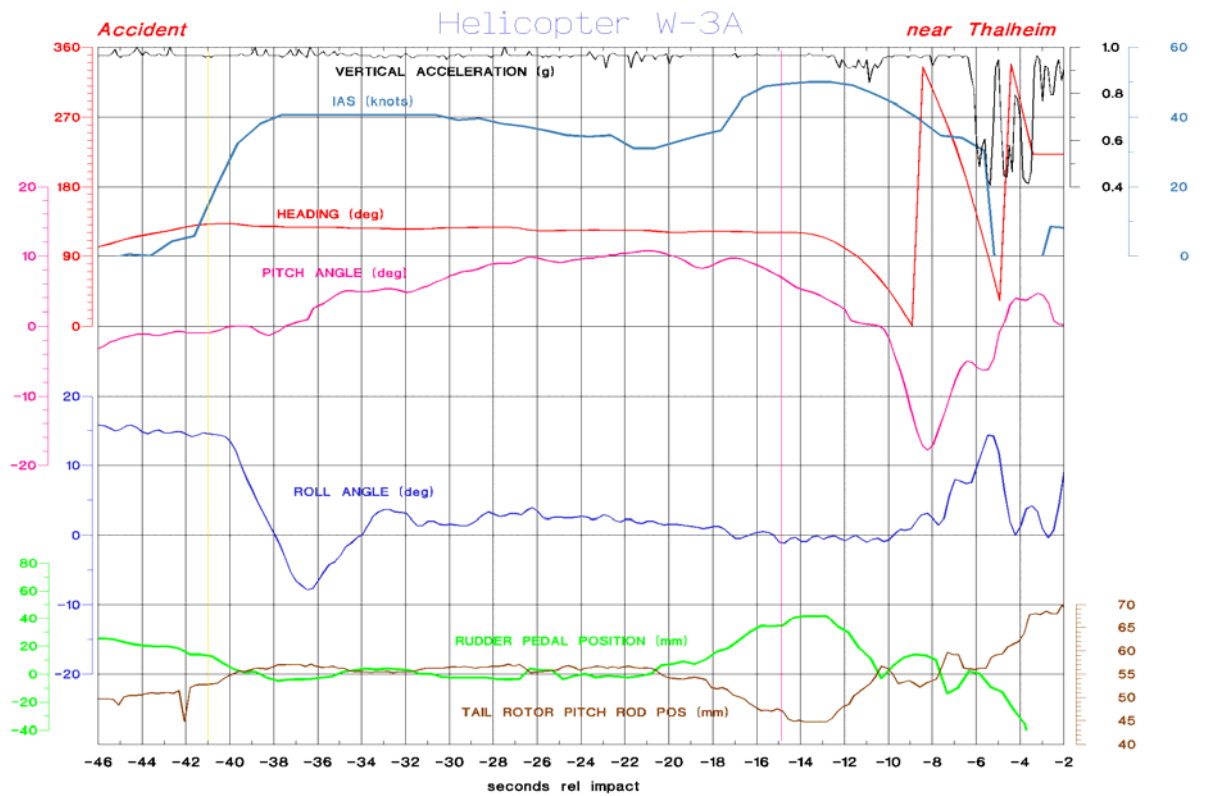
Attachment 1 Recordings of the flight data recorder, the last 44 seconds

After the turn the aircraft flew straight on with a heading of 128° – according to the flight data recorder (FDR) -41 seconds prior to impact (see attachment 1). The altitude was 2,070 ft MSL, the height 800 ft AGL. The indicated airspeed increased to approximately 40 kt. During straight flight the flight mechanic said: " ... and now decrease speed down to 20 kt if possible." Afterwards until -21 s, the longitudinal pitch of the helicopter increased from 0° to +10° and the indicated airspeed decreased to 30 kt. During this time period the pedal movement was close to neutral. Between -21 s and -19 s of the straight flight (see attachment 2), the flight data recording shows an increase in engine torque to approximately 72 %. At the same time the right pedal was depressed. The helicopter flew with a heading of 123° at a height of 475 ft AGL. Between -19 s and -16 s the pedal movement (to the right) increased continuously to 33 mm. All other parameters including the torque values remained almost constant. During the same time the flight mechanic said to the camera operator: "... slower is not possible now".

After -16 s the collective pitch lever was pulled further with a corresponding increase of the torque values and a further increase of the pedal movement. At -15 s the helicopter started to yaw to the left. At -12 s the CVR recorded two dull sounds in quick succession. The yaw rate exceeded at this point 20°/s and increased further. At -10 s the flight mechanic asked: "What now? And the pilot answered: "I don't know".

At -13 s, the pedal movement started to decrease and at -10 s the pedal had reached the neutral position. During the same period the engine torque decreased to 55 %. The attitude initially decreased from +4° to 0° and within the following 2 seconds changed to -18°. The helicopter started to descent. Several intense load changes and abrupt, alternating control inputs were recorded until the impact.

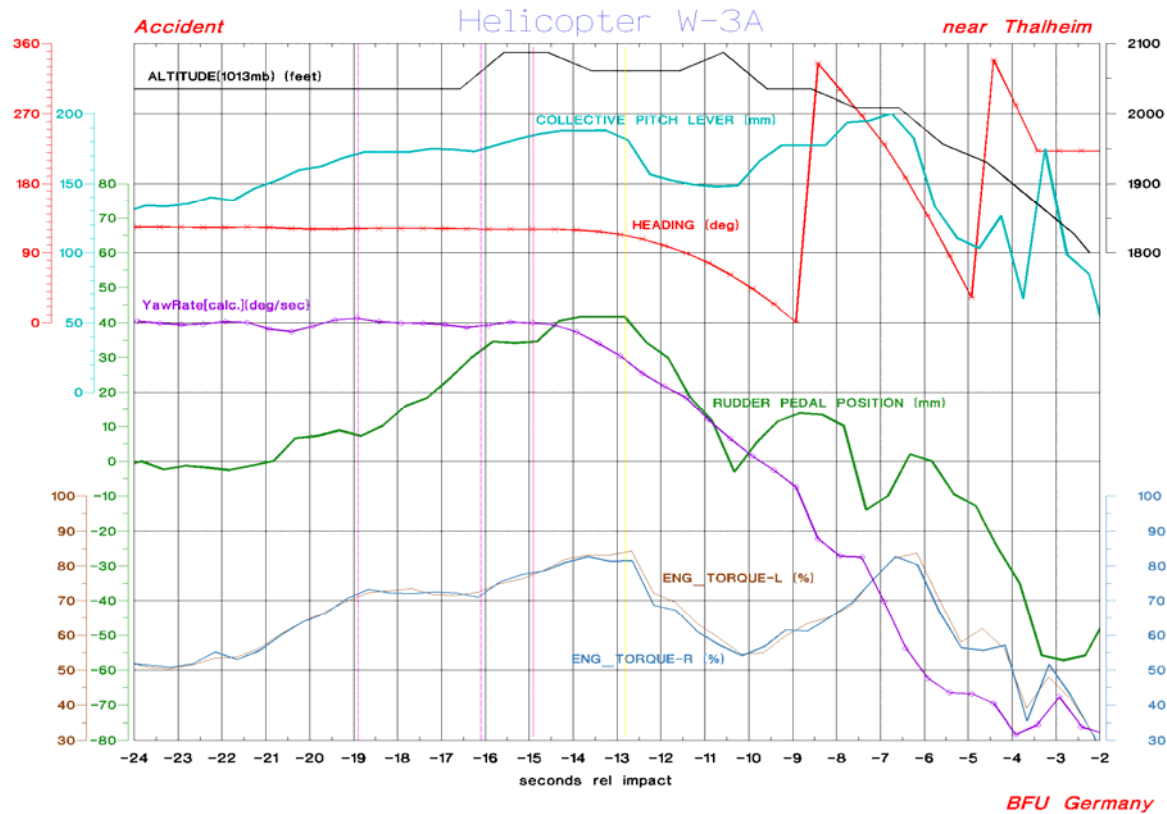
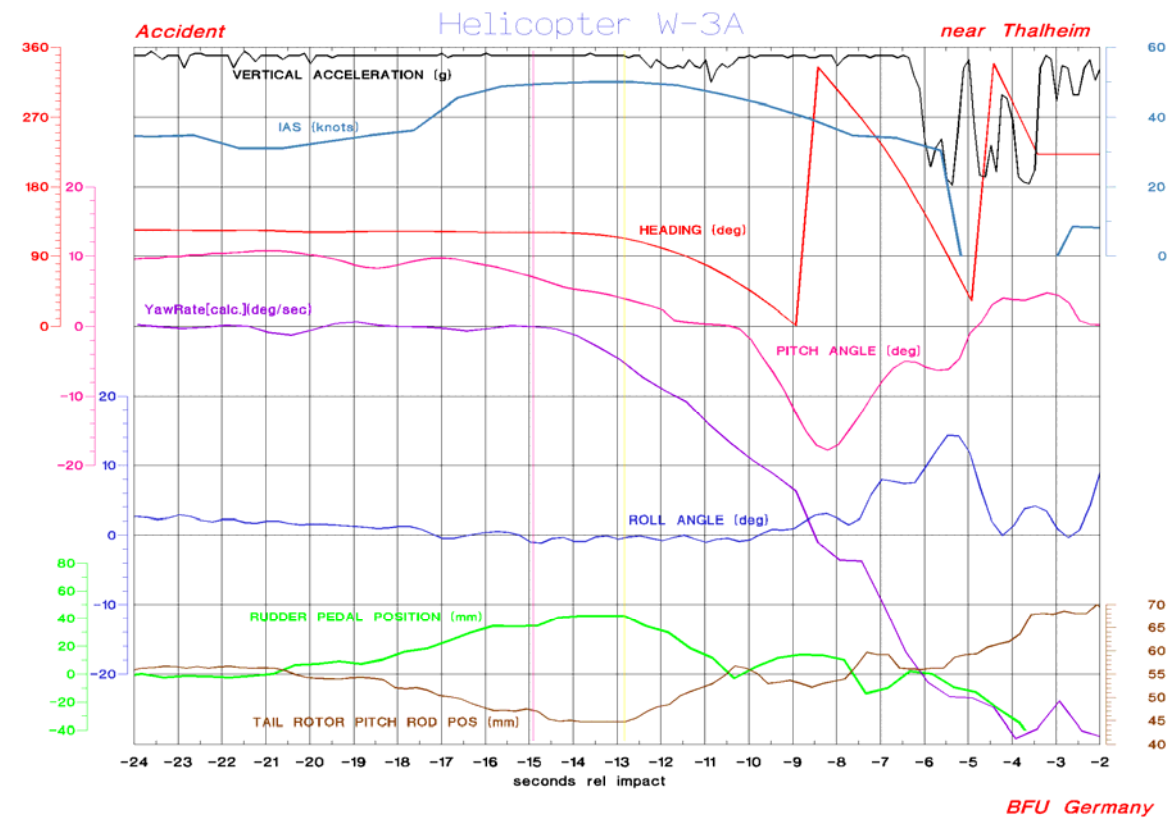
Attachment 2 Recordings of the flight data recorder, the last 22 seconds with the calculated yaw rate

Between -10 s and -7 s the right pedal was pushed down again by approximately 15 mm. The yaw rate increased less during this phase (see attachment 2). The pilot swore several times and the flight mechanic said " Easy, easy, easy ..."

The source of the two dull sounds recorded by the CVR at -12 s could not be determined. However, there were no indications of technical failures at that time. The flight mechanic's surprised expression "What now?" and the pilot's answer "I don't know" refers in all probability to the yaw rate which had at that point increased to more than 20°/s and kept on increasing. Indicated airspeed dropped to a very low value.

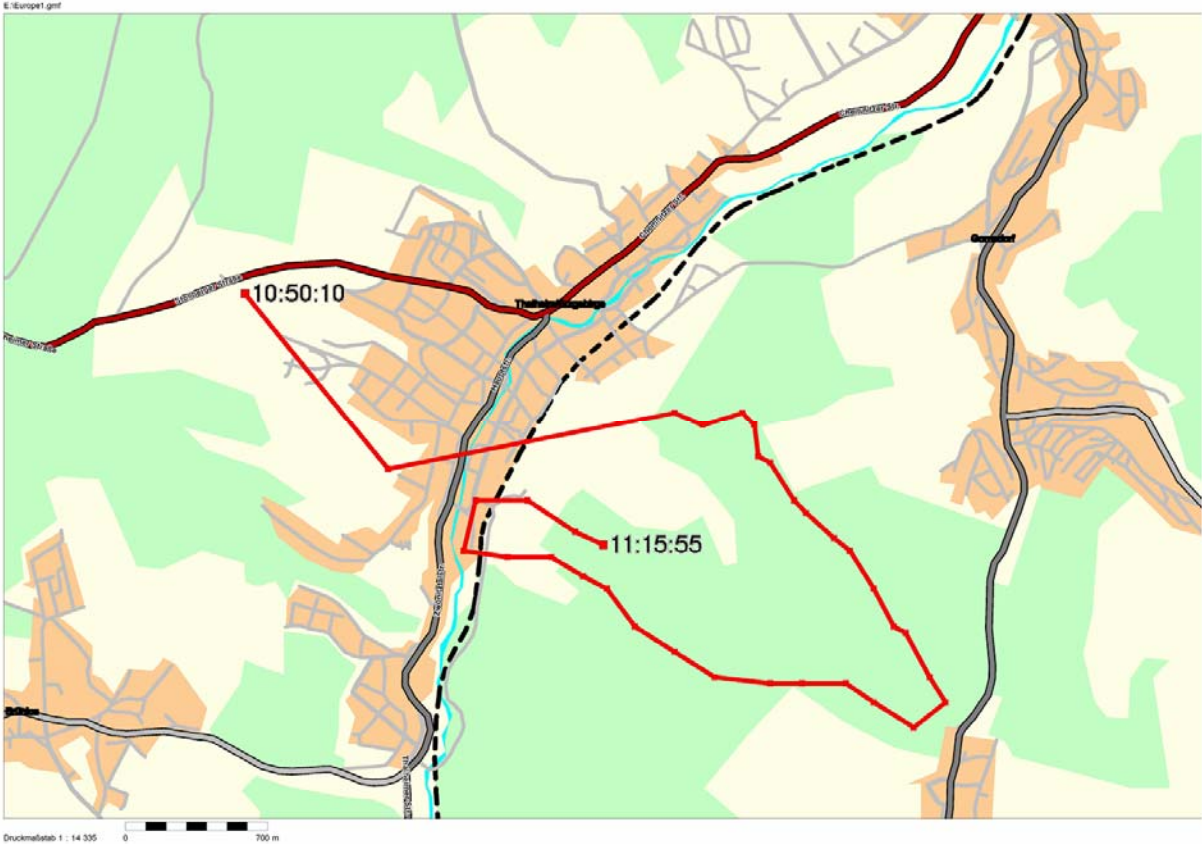
Attachment 3 Reconstruction of the flight path based on radar data

After a briefing the helicopter took off at 11:08 hrs. The helicopter climbed to approximately 2,000 ft MSL and started the search east of Thalheim. According to radar data, the initial flight direction was southeast across woodland. Cockpit Voice Recorder (CVR) data show that the camera operator had activated the digital thermal imager and the flight mechanic had also switched on his LCD display in the cockpit in order to view the thermal image as well. The flight mechanic suggested as search procedure that the pilot "jibe" between the town and a street running east of Thalheim starting in the western area on the edge of the forest. The flight mechanic arranged the procedure to be applied with the camera operator. It was agreed that a small strip at the time was to be searched and that the camera was to point into the 12 o'clock position and should have a large tilt angle. After having crossed the forest the helicopter flew to the right and then west toward the outskirts of Thalheim.
