Investigation Report

EX010-1-2/05
December 2006

Type of occurrence: Serious incident
Date: 14 September 2005
Location: Near Frankfurt/Main
Aircraft: 1. Airplane
2. Airplane
Manufacturer / Type: 1. Gulfstream / G-V
2. Boeing Company / Boeing 737
Injuries to persons: No injuries
Damage: Aircraft not damaged
Other damage: None
Information Source: Investigation by BFU

On 14 September 2005 at 21:15¹ hrs an airprox incident between a Gulfstream G-V and a Boeing 737 occurred with a horizontal distance of 0.7 NM and an altitude difference of 300 ft. Prescribed is a distance of 5 NM or 1,000 ft.

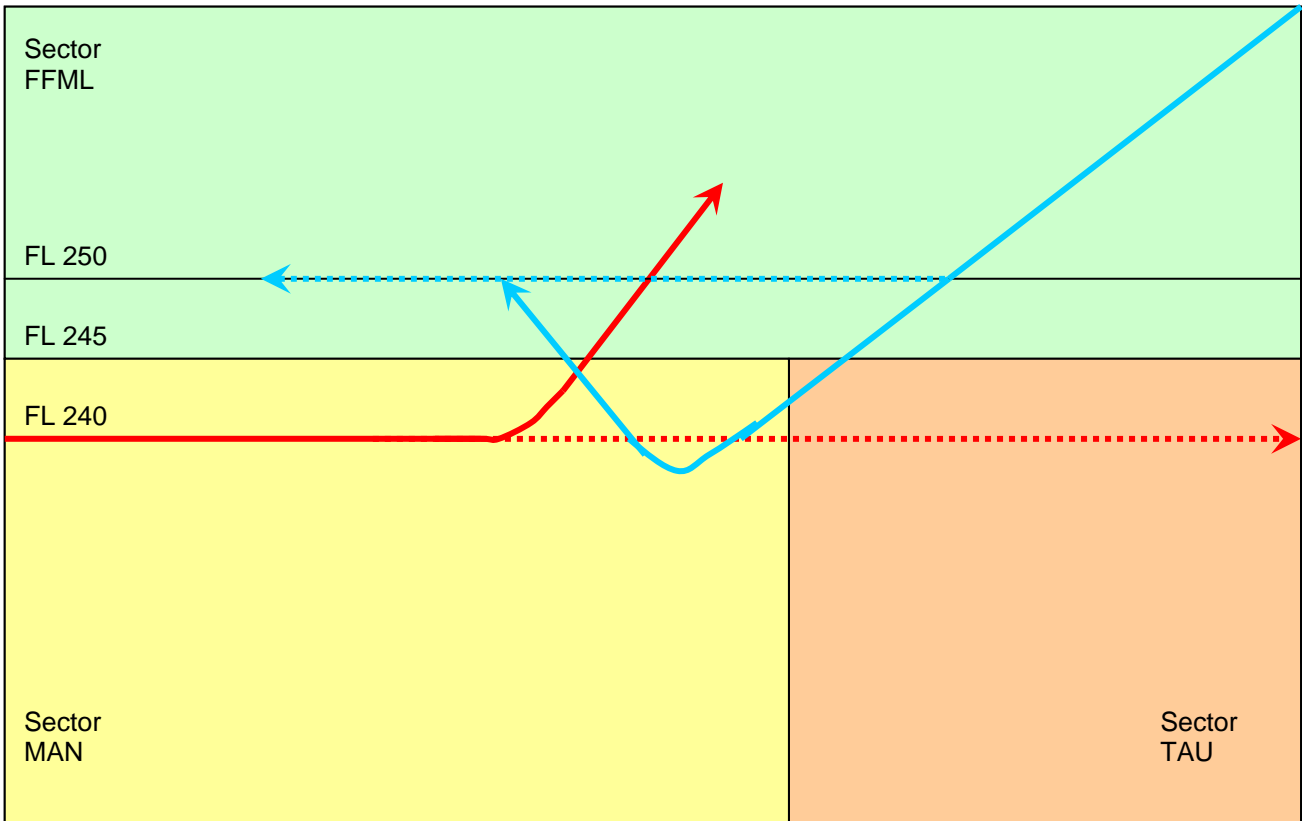
Profile of the flight paths:

The flight path of the two aircraft crossed with a horizontal distance of 0.7 NM and a vertical distance of 300 ft. Both aircraft continued their flights and reached their respective destinations safely.

With a distance of 0.7 NM and 300 ft, the prescribed separation of 5 NM lateral and 1,000 ft vertical was significantly infringed during the airprox. A dangerous situation occurred because of the short distance between the two aircraft.

The prescribed separation of 5 NM lateral and 1,000 ft vertical was infringed at a distance of 0.7 NM and 300 ft.
