# Investigation Report

EX013-1-2/05  
January 2007

Type of occurrence: Serious incident  
Date: 27 September 2005  
Location: Within control zone  
Mönchengladbach  
Aircraft: 1. Airplane  
2. Airplane  
Manufacturer / Type: 1. Piper Aircraft Corporation /  
PA-28-161  
2. Cessna / 680  
Injuries to persons: No injuries  
Damage: Aircraft not damaged  
Other damage: None  
Information Source: Investigation by BFU

An airprox occurred with a horizontal distance of 0.1 NM at the same altitude.

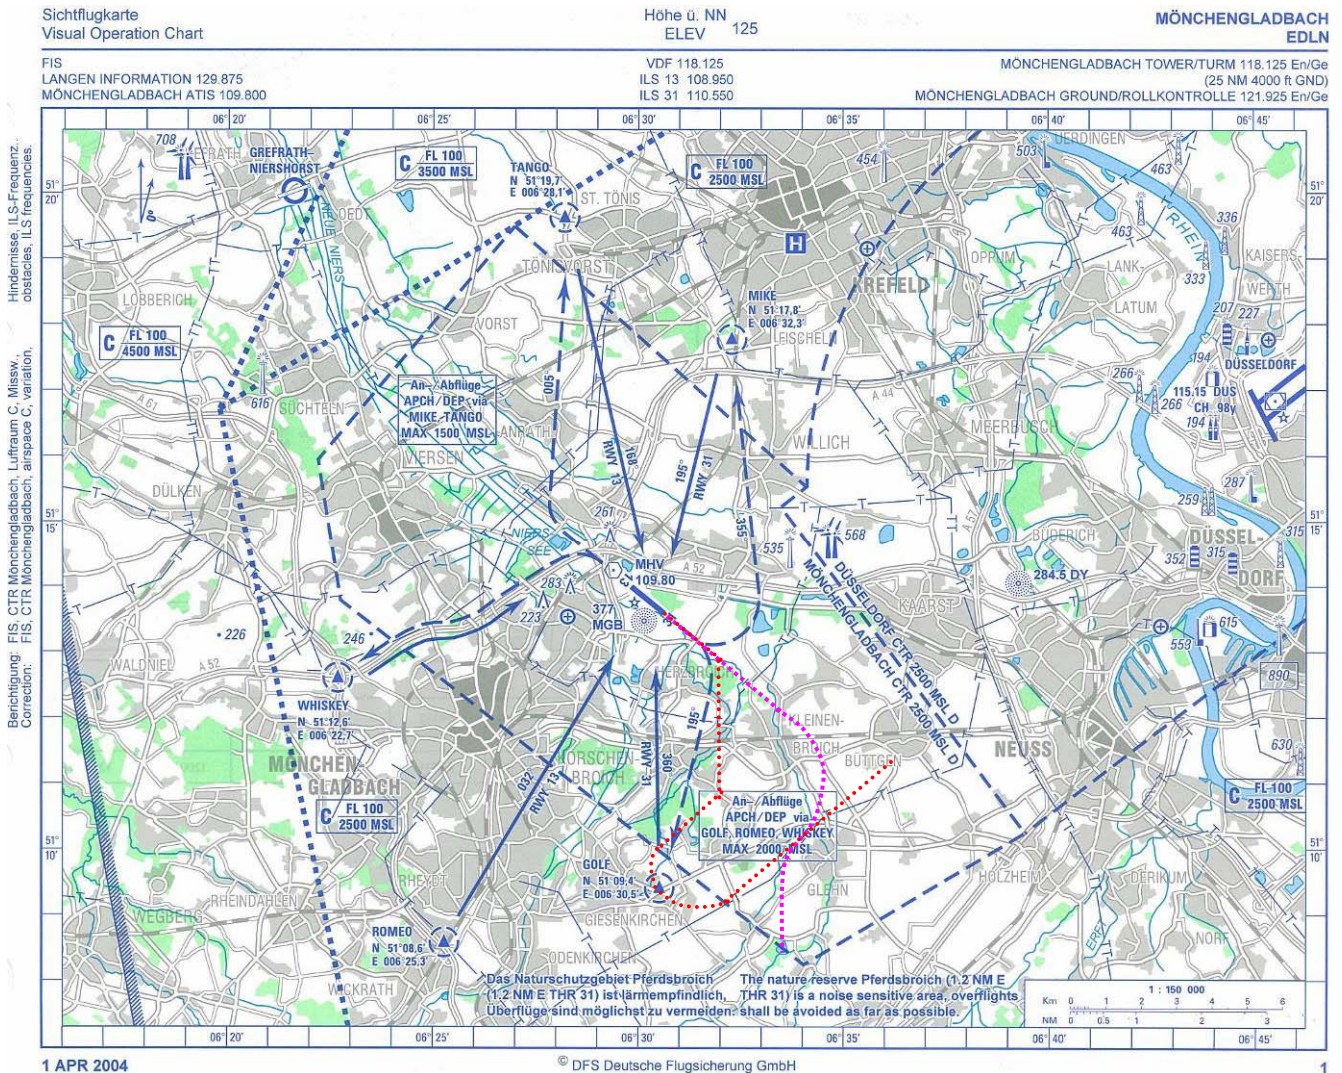
Chart: AIP-VFR of the control zone Mönchengladbach

The ATC radar recordings showed that the flight paths of the two aircraft crossed in the same altitude and with a horizontal distance of 0.1 NM. Both aircraft continued their flights and reached their respective destinations safely.

The pilot of the PA28 used terrestrial navigation without the help of radio or satellite navigation. After he left the control zone his heading was about 050°. The Pilot's statements indicate that the motorway junction Jüchen should have been the reference point and was mixed up. However, a heading change to about 050° would never have taken him to his destination.

As a result of the mix up of reference points (motorway junction), the pilot of the PA28 experienced a loss of orientation which led to the airprox of the two aircraft.
