# Investigation Report

1X001-0/06  
August 2009

Kind of occurrence: Accident  
Date: 12 January 2006  
Location: Freiburg, Germany  
Type of aircraft: Aircraft, fixed wing  
Manufacturer / Model: Beech Aircraft Corporation /  
Beech B300  
Injuries to persons: Two fatal  
Damage to Aircraft: Aircraft destroyed  
Other Damage: Damage to trees  
Source of Information: Investigation by BFU

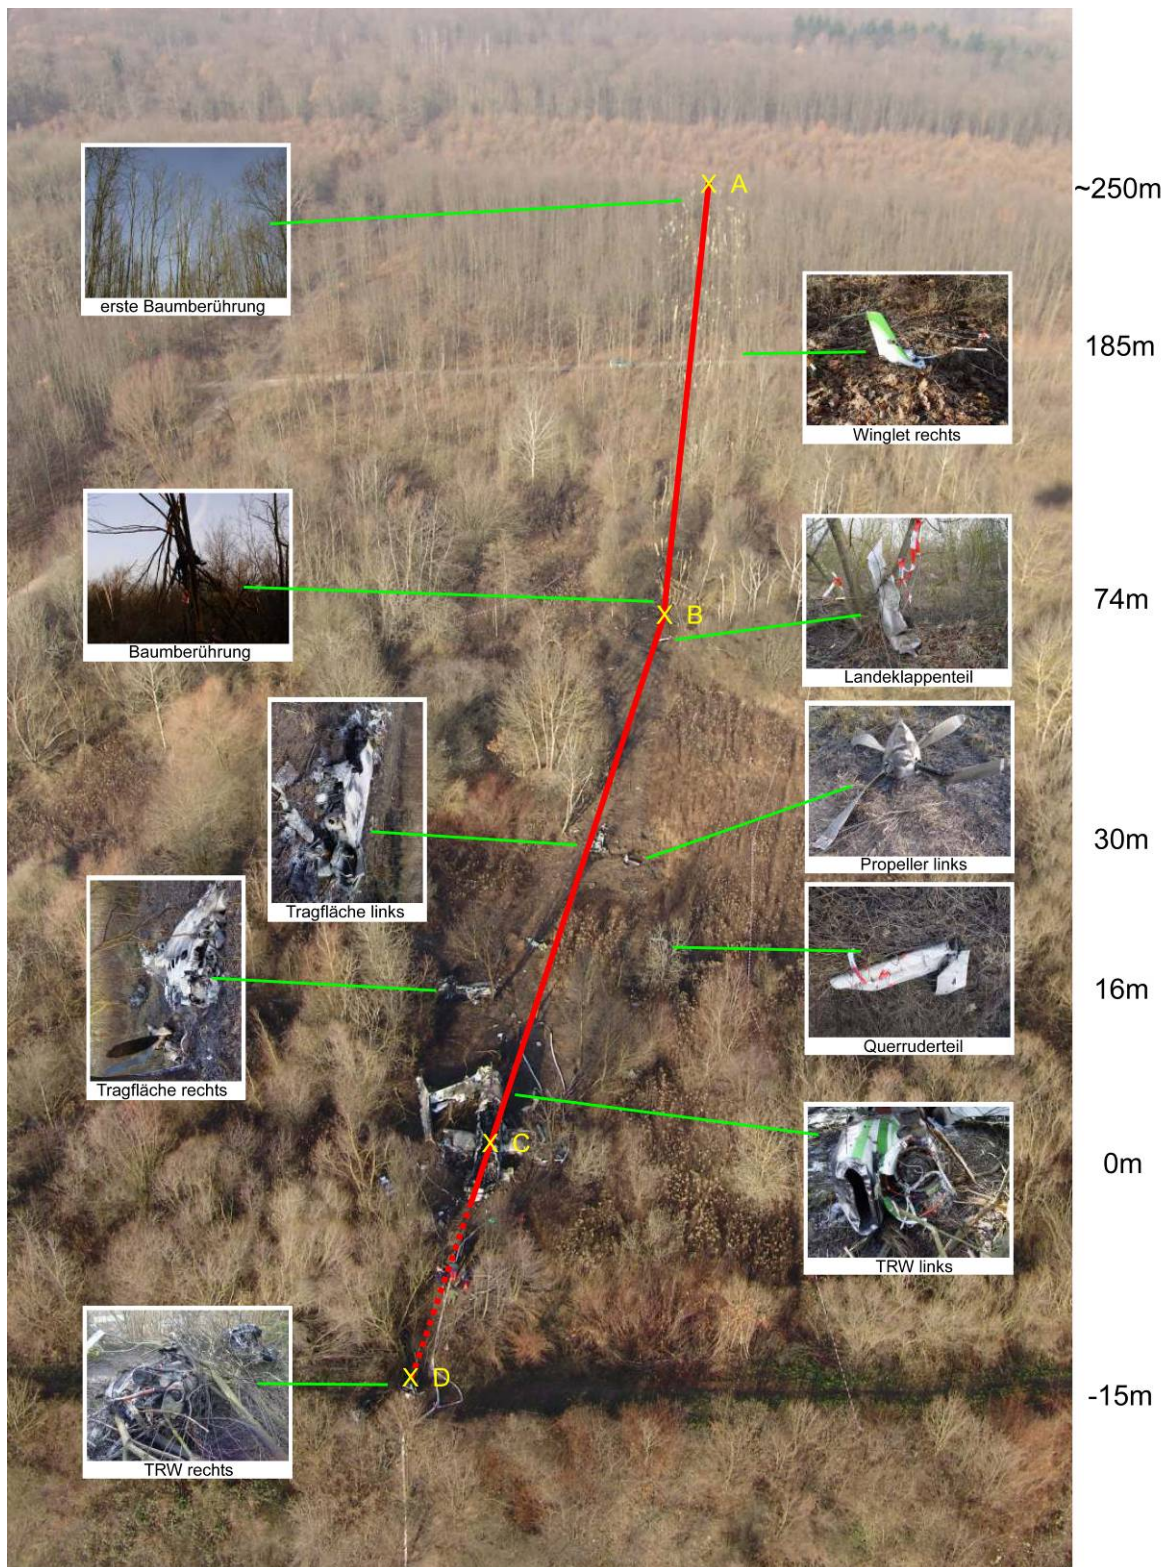
Wreck distribution at the accident site

During its approach to Freiburg Airfield the aircraft first made contact with the tops of a group of trees about 20 m high and 700 metres before the threshold of Runway 16. This initial impact ripped a winglet off the right wingtip, which was subsequently located about 65 m behind the trees; parts of the fuel tank cladding were found about 20 m farther.

After having made contact with the tree tops the aircraft came to a stop on the forest floor about 250 m farther on, and 450 metres from the Runway threshold. On impact, the right engine was torn from the wing and thrown forward about 15 m.
