# Investigation Report

1X002-06  
November 2011

Type of Occurrence:	Accident
Date:	15 May 2006
Location:	Frankfurt / Main
Aircraft:	Transport aircraft
Manufacturer / Model:	Boeing / B747-400
Injuries to Persons:	No injuries
Damage:	Aircraft severely damaged
Other Damage:	None
Information Source:	Investigation by BFU

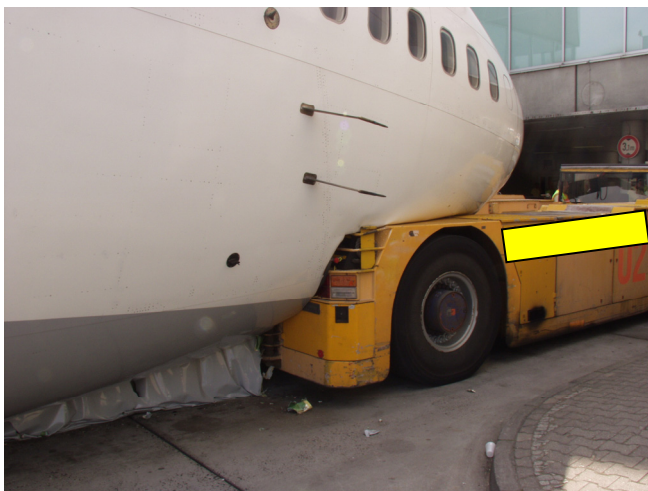
Accident site

The airplane was at gate A23 at Frankfurt Airport. The nose was on top of a tow truck. The fuselage's structure was severely damaged on a length of about 2.50 m. The tow truck's superstructure had penetrated the airplane's outer skin and thereby destroyed beams and stringers in this area. The tow truck suffered minor damage.

The nose landing gear had retracted completely and seemed to be undamaged.

Ground lock pin including the 2-meter-long bar was found at right angles to the fuselage beneath the nose.

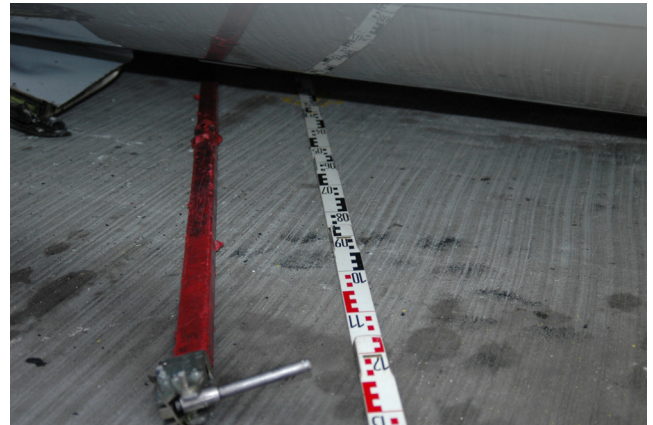
Ground lock pin including bar

The operating lever at the lower part of the bar was slightly bent.

The bar was covered with a red heat-shrinking hose which showed heavy wear marks.

In order to take the aircraft to a hangar a substitute ground lock pin was used. Upon a subsequent attempt to insert the original ground lock pin in the drag brace hole the pin jammed and could only be inserted into the hole by about half its length.

During a function test of the GLP with bar used during hydraulic checks it was determined that the lever at the end of the bar which controls the safety pin was jammed in the pulled back position.

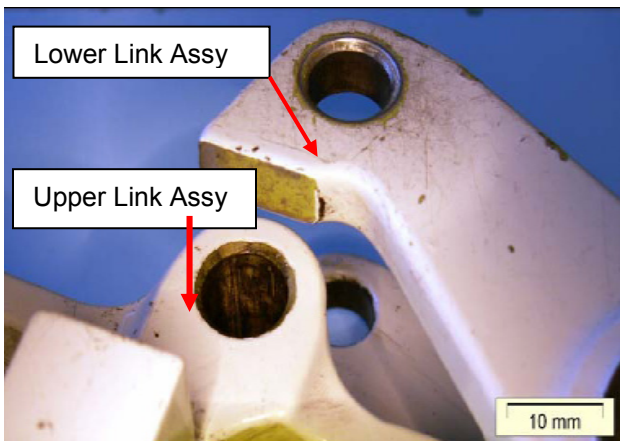
Hole for the GLP on lower and upper link assy

The components do not show any damage relevant to the occurrence. The minor damages on the surface occurred during the occurrence. Positioning and unintended extraction of the ground lock pin did not cause any damage connected with the occurrence.

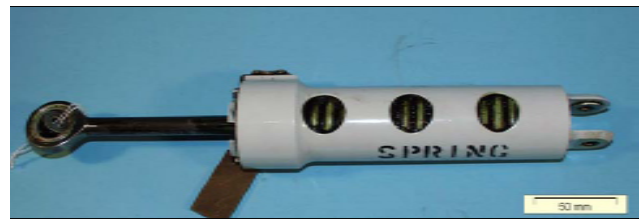
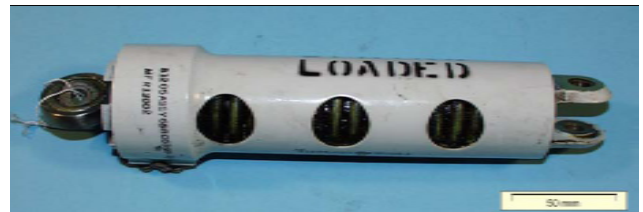
Bungee Assys Right and Left:

The components do not show any damage which could be attributed to intense contact with the bar during the occurrence.

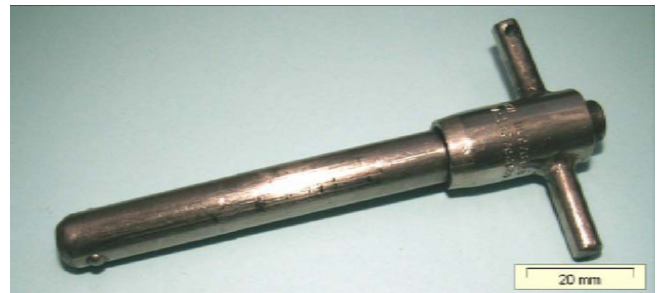
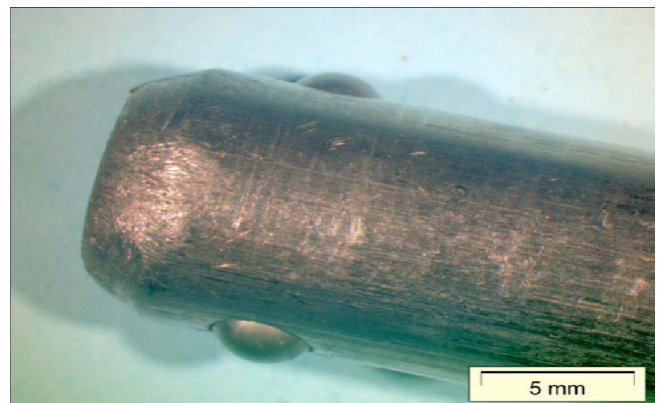
Ground Lock Pin

The GLP functions properly and showed regular signs of wear. The safety globes can be correctly locked and unlocked and do not show any damage. The ground lock pin can be properly inserted into and extracted from the disassembled upper and lower assys.

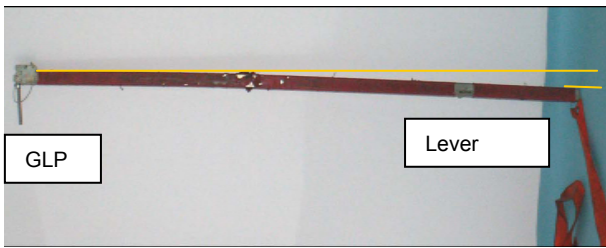
Safety bar

The safety bar is bent and shows damage on the total length of the plastic hose. The ground lock pin locking/unlocking lever is bent and jammed in the unlocking position (safety globes loose). It can only be moved by force (safety globes locked). This condition had existed for an extended period of time as indicated by wear marks on the lever and on the elongated hole in the rectangular tube.

Examination of the safety bar and the GLP showed that long-time use caused abrasive wear so that a correct functionality of GLP including bar was no longer given.

There were traces, however, showing that the lever which locks and unlocks the GLP had been bent long before the occurrence and had jammed in the unlocked position.

Lufthansa Technik AG should principally only use Boeing work equipment. In case modified or self-made work equipment is used a similarly high safety level is to be ensured.

Furthermore, a work order should be established how the respective work equipment is to be used.

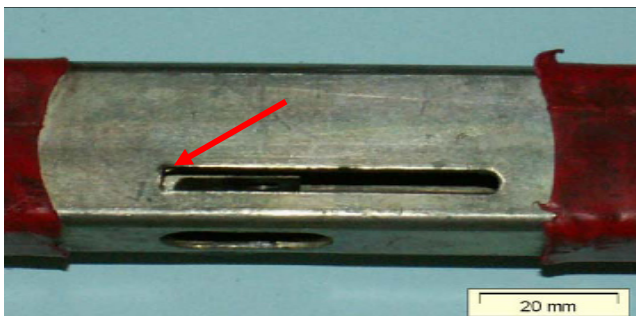
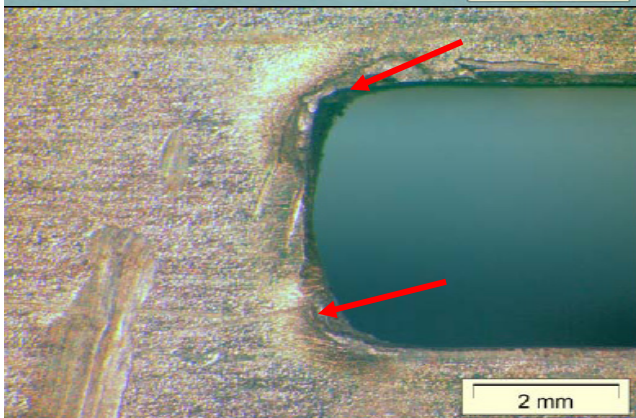
Traces of wear

Detail views show the catch of the lever when the GLP is released and the safety balls are locked. Clearly visible are deformations which are caused during unlocking of the lever. The lever is bent.

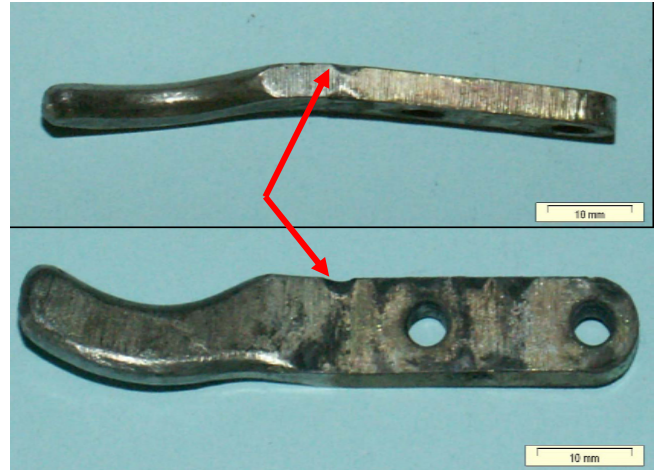
Disassembled operating lever of the safety bar

The cause for the retraction of the nose landing gear was a malfunction in the lever mechanism within the safety bar in connection with the GLP. Hence the GLP remained unlocked in the inserted position.

Implementing Safety Recommendation 02/2006, the operator involved has issued an instruction stating that the short original pin is to be used exclusively.

Additionally, the construction of a new insertion aid was commissioned which will take into account the findings of the laboratory examination of the bar.
