Investigation Report

Identification

Type of Occurrence:	Accident
Date:	19 February 2006
Location:	Close to Dakar / Senegal
Aircraft:	Transport aircraft
Manufacturer / Model:	Boeing Commercial Airplanes / Boeing MD-11/MD-11F
Injuries to Persons:	One crew member seriously injured One crew member and one passenger slightly injured
Damage:	None
Other Damage:	None
Information Source:	Investigation by BFU
State File Number:	BFU 2X004-06

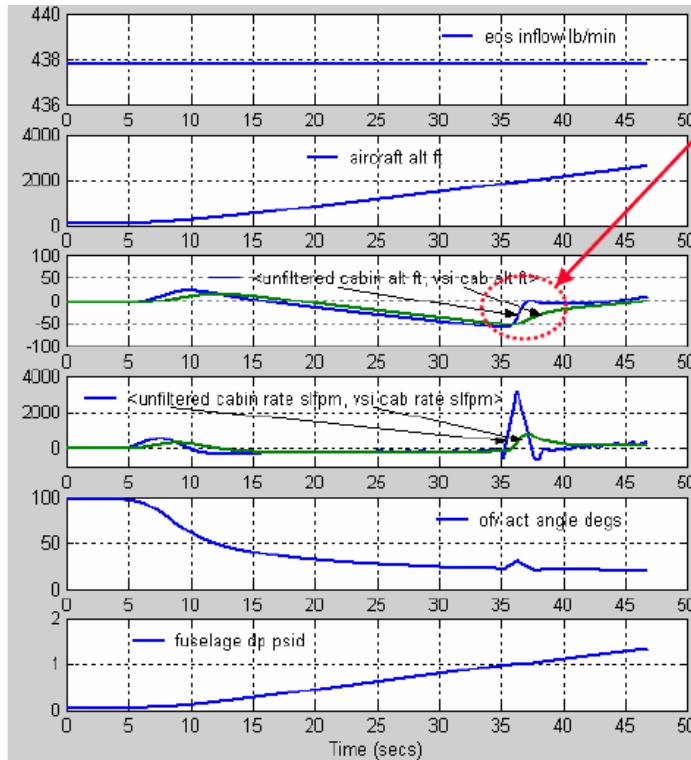
Predicted CPCS response to 100 msec pressure sensor failure

Pressure sensor failure for 100 msec results in an unfiltered cabin altitude bump of ~60 sif

The simulation showed that a 100-millisecond loss of pressure sensor signal caused the outflow valve to open by about 10°. With the simulation it was reproducible that at a differential cabin pressure as it could have existed at the time of the occurrence, a pressure bump of 6,000 ft/min (unfiltered cabin rate in slfpm) was possible.

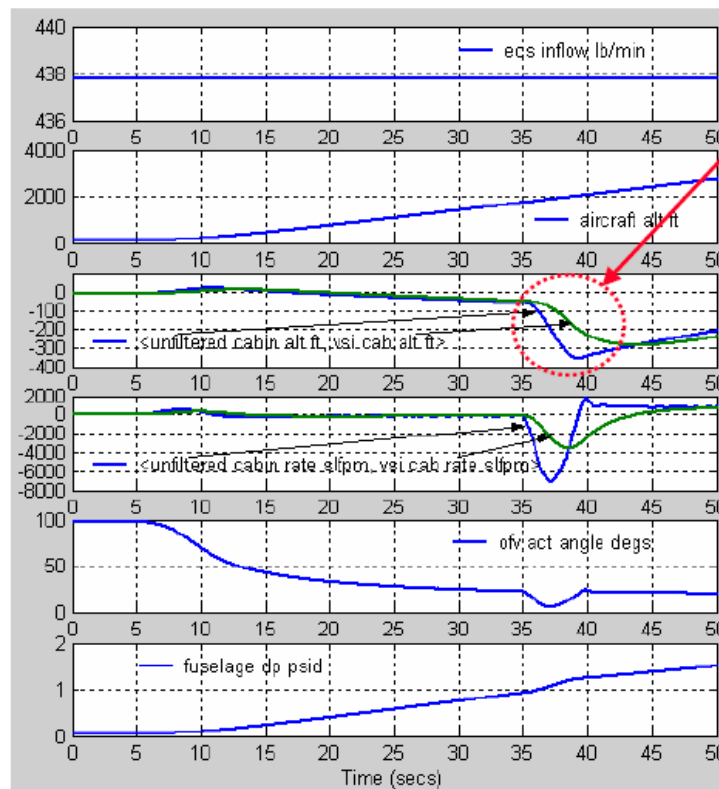
Predicted CPCS response to 2 sec pressure sensor failure

Pressure sensor failure for 2 secs results in an unfiltered cabin altitude bump of ~300 sif

The simulation by the manufacturer where initially the pressure sensor failed for 100 ms and then for 2 s resulted in perceptible physiological effects on the ears as was described in the graph *Aerospace Recommended Practice 1270*. According to which permanent, organic injuries are not caused with these failure times.
