# Investigation Report

Type of Occurrence:	Accident
Date:	13 September 2006
Location:	Frankfurt / Main
Aircraft:	Airplane
Manufacturer / Model:	Fokker BV / Fokker F 28 MK 100
Injuries to Persons:	None
Damage:	Aircraft severely damaged
Other Damage:	None
Information Source:	Investigation by BFU
State File Number:	BFU AX002-06

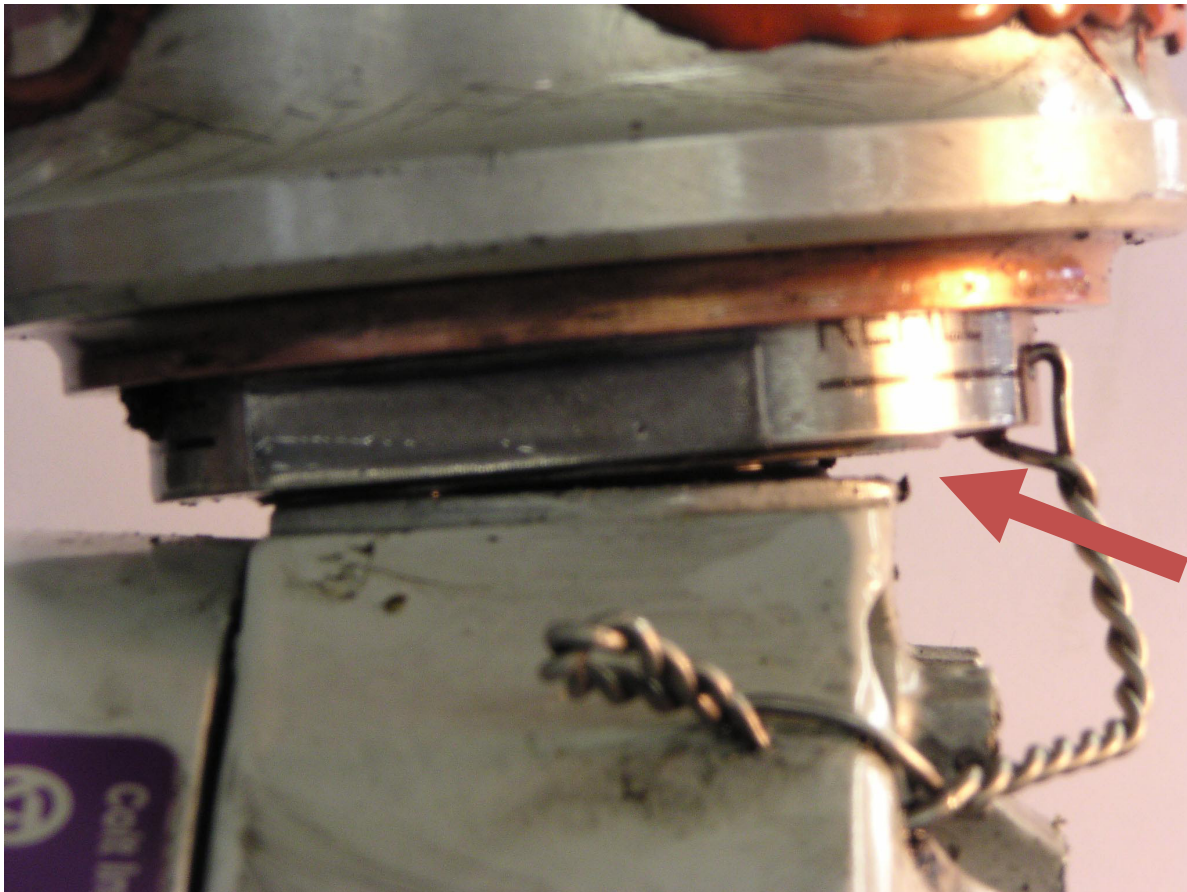
Under the direction of the BFU an in-depth examination of the shimmy damper was conducted at one of the manufacturer's facilities. It was determined that the housing of the hydraulic oil reservoir showed minor traces of deformation and scratches. The screw connection between the oil reservoir and the shimmy damper was secured with a 1.2 mm strong lock wire. The lock wire was installed in the required direction. The reservoir could be turned manually in either direction within the space restricted by the lock wire length. Between the damper housing and the hydraulic reservoir one-sided gap of about 1.75 mm was found.

Connection hydraulic reservoir – damper housing with one-sided gap of 1.75 mm; Photo: Fokker Services BV

An examination of the shimmy damper, onto which the reservoir had been fitted manually, to determine pressure and leak tightness revealed a leakage between damper housing and hydraulic reservoir.

After the hydraulic reservoir was removed it became evident that the steel reservoir adapter was fitted askew into the damper housing.

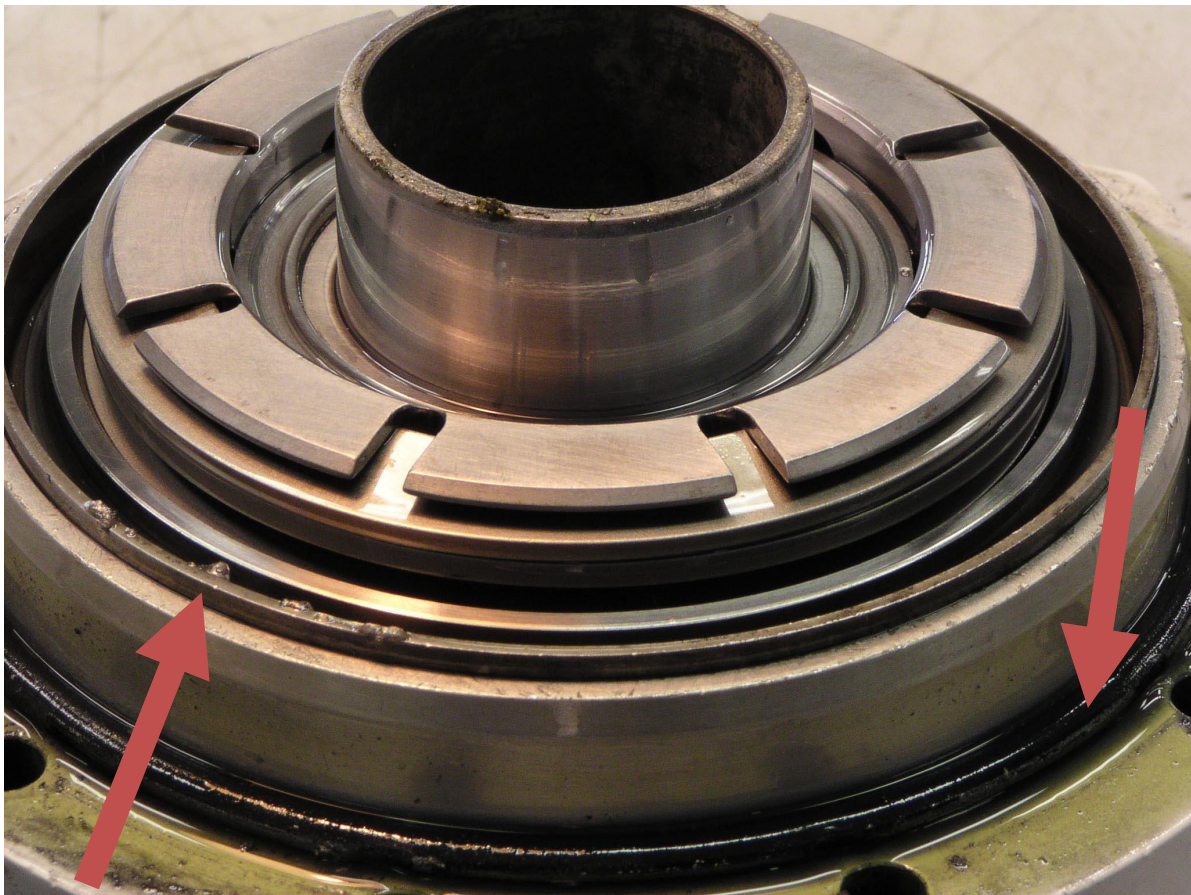
During disassembly of the shimmy damper it was determined that the attachment bolts were torqued with values between 130-170 in.lb (14,7-19,2 Nm) (116-126 in.lb (13,1-14,23 Nm) was required). The O-ring between damper housing and cap was not installed in the groove inside the cap, but was clamped between housing and cap.

Damper casing with jelly-like substance and incorrectly mounted O-ring; Photo:

The shimmy damper was emptied and disassembled. Thereby, residue of the jelly-like substance and dirt particles were found on all parts. In the area of the piston a metal chip the size of 2 mm was found.

The results of the flow tests, where the determined failures were gradually eliminated, showed that the incorrectly mounted O-ring and the contamination and/or the metal chip had an essential influence on the performance of the damper. The contamination and the metal chip caused an increase in flow rate of 0.8 Gallon Per Minute (GPM); whereas the incorrectly mounted O-ring led to an increase of 0.16 GPM.

The examination of the damper showed that the incorrectly mounted O-ring in connection with the jelly-like substance and the metal chip within the damper housing caused the failure of the damping and then the fracture of the torque link.

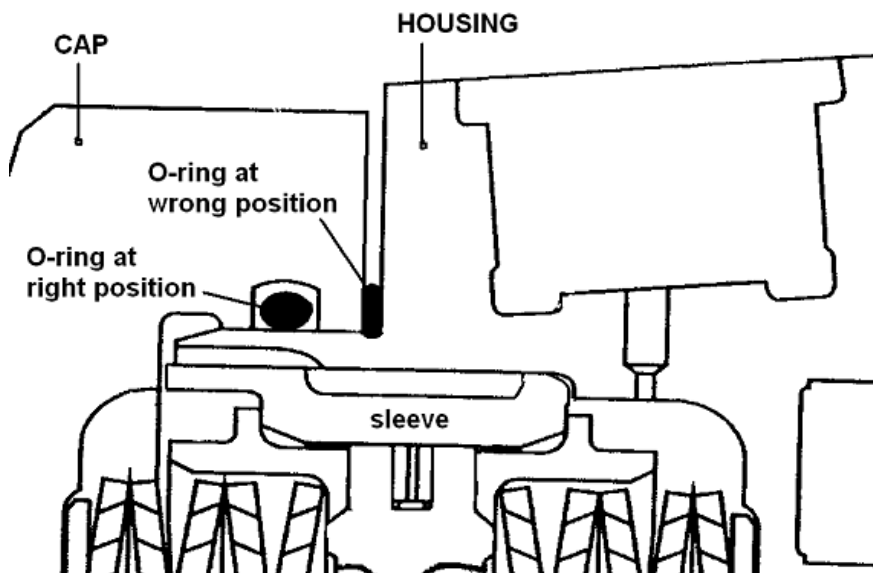
O-ring as found during investigation Drawing

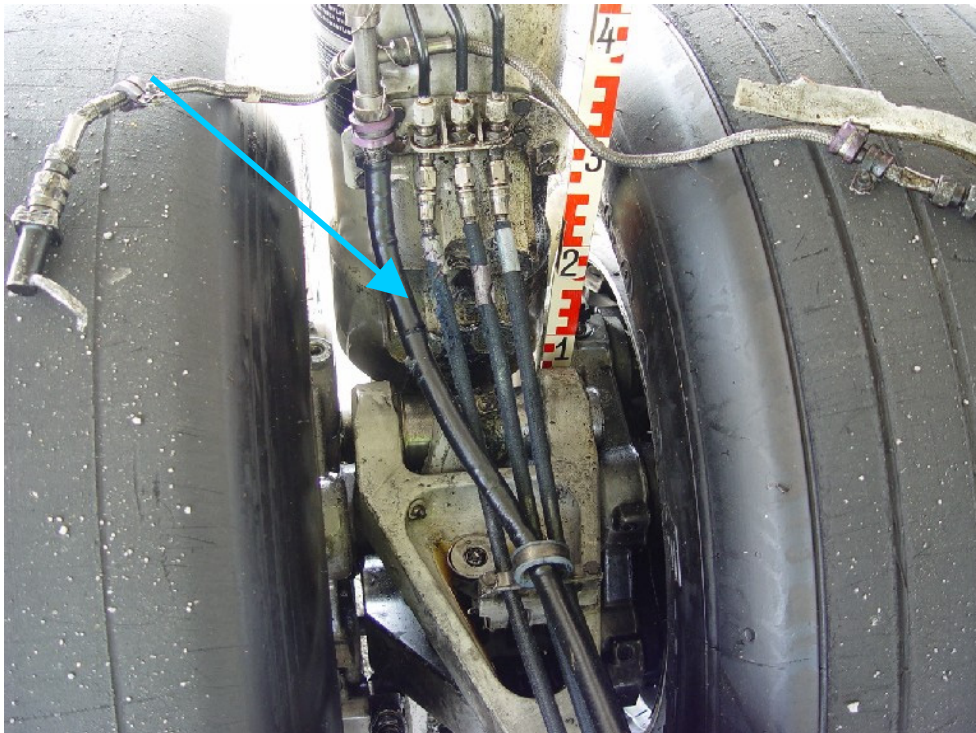
Appendix 1: Photos of the upper torque link lug and the shimmy damper of the left main landing gear

It was determined that the left main landing gear upper torque link lug was broken (refer to Appendix). Parts of the lug were found between the bolt and the upper torque link. The air - ground switches were torn off their mountings. The hydraulic oil reservoir of the shimmy damper was 3 mm away the refill marking. The entire area of the shimmy damper was wet with hydraulic fluid.

The fracture of the upper torque link lug was a forced rupture.
