Investigation Report

Identification

Type of Occurrence:	Serious incident
Date:	3 July 2006
Location:	Saarbrücken Airport
Aircraft:	Airplane
Manufacturer / Model:	Embraer / EMB 145
Injuries to Persons:	None
Damage:	Minor damage to aircraft
Other Damage:	None
Information Source:	Investigation by BFU
State File Number:	BFU EX005-06

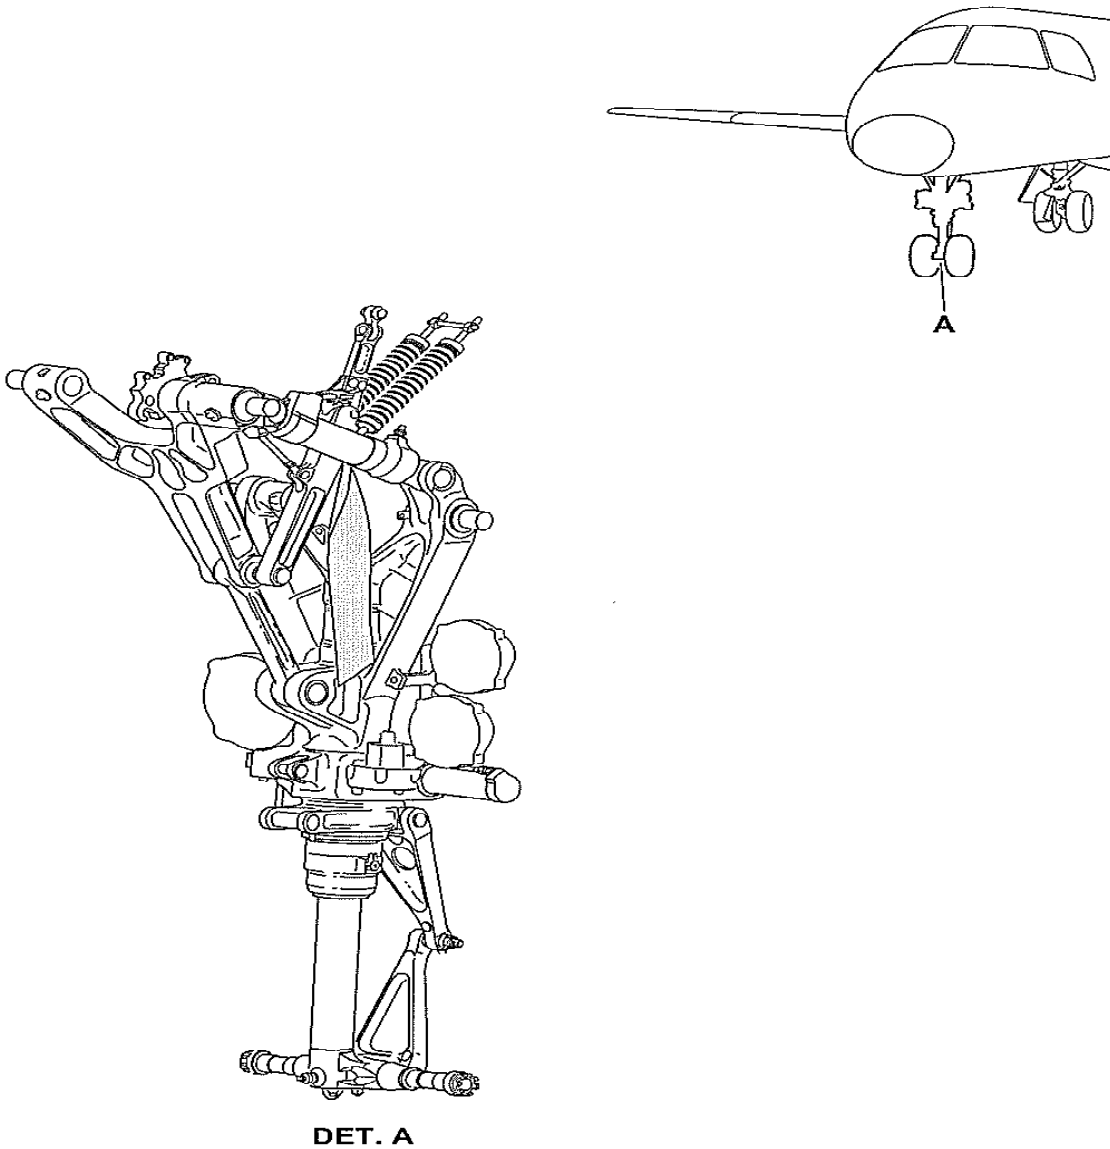
The nose landing gear of the Embraer EMB 145 (Appendices Image 1) was equipped with a through axle which was fitted in the centre of the landing gear leg. The two nose wheels were mounted with tapered roller bearings to the two axle legs to the left and right of the landing gear leg. Crown nuts held the mounting and therefore the wheels in place (Appendices Image 2). The fastening torque of the crown nuts determined the bearing clearance. Bolts prevented the crown nuts from spinning off the axle.

Image 1: Nose landing gear Embraer EMB 145

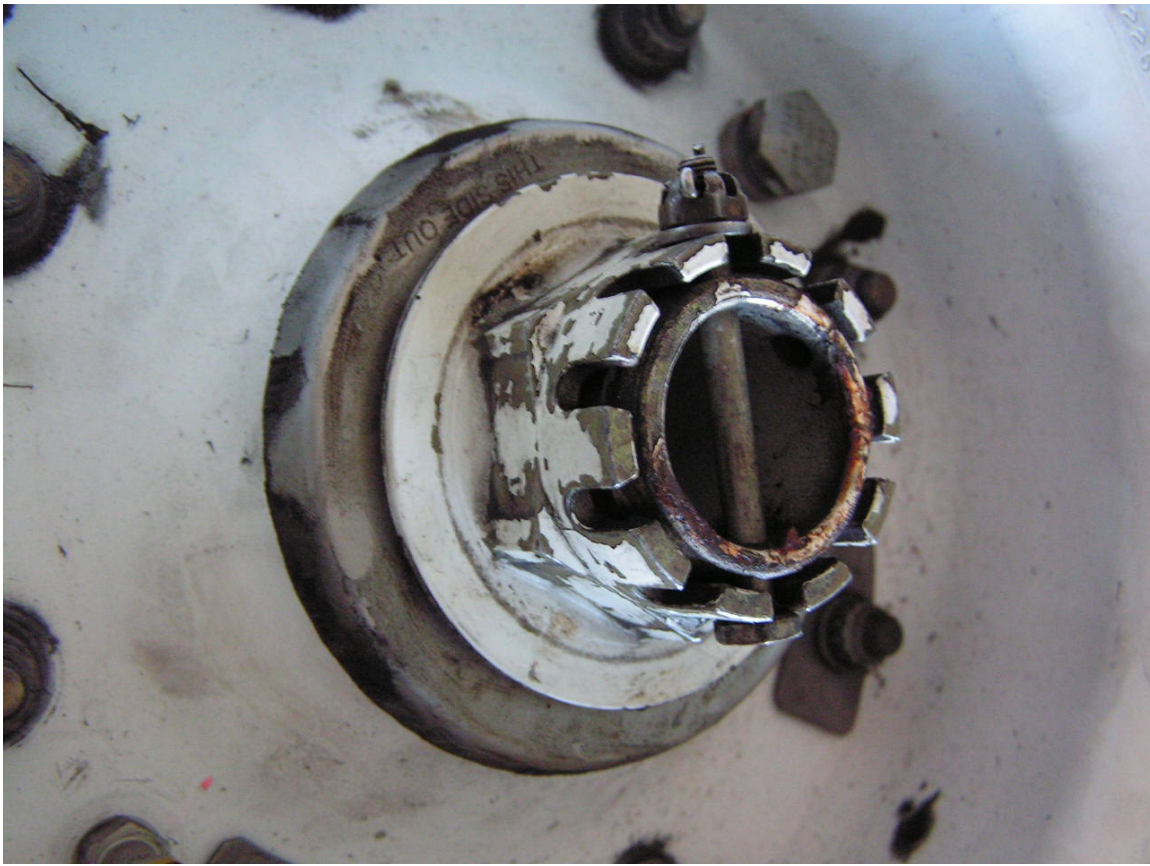
Image 2: Axle with crown nut and safety bolt

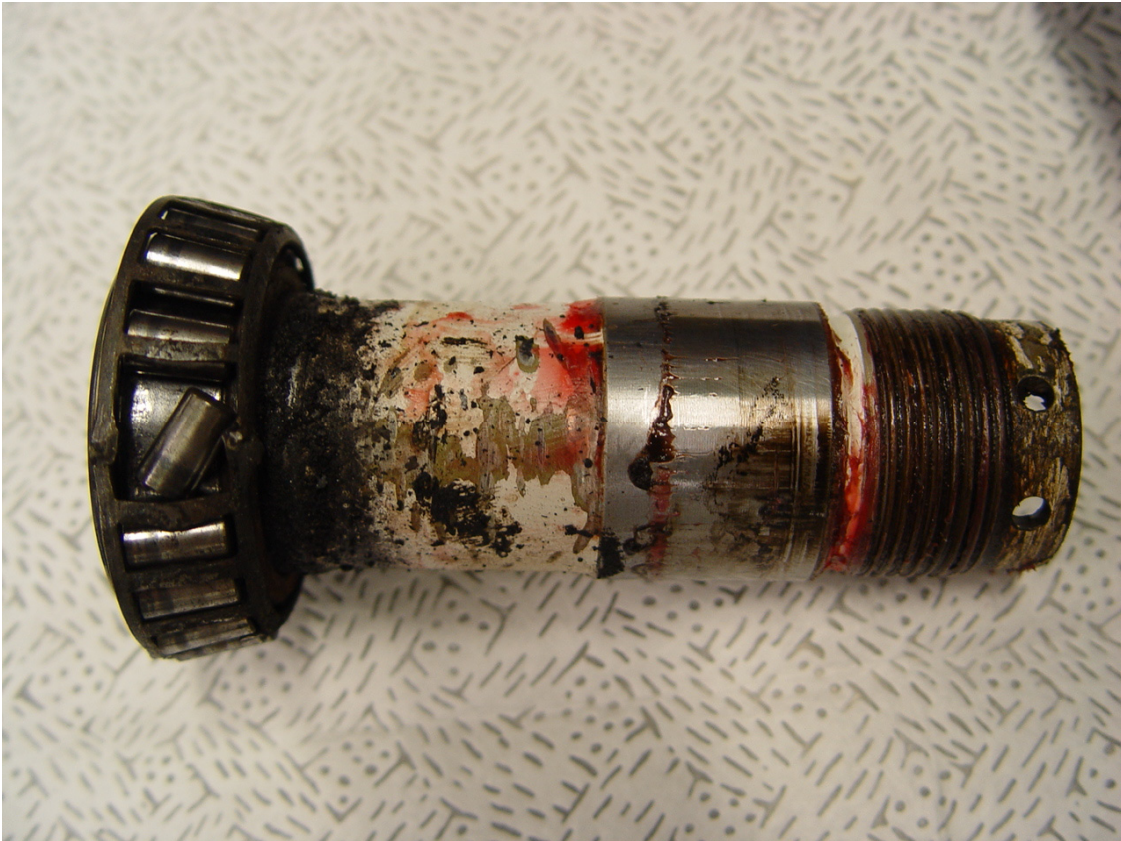
The left axle leg fractured in the area of the inner wheel mounting. The mounting directly adjacent to the fracture was destroyed, and showed distinct staining due to overheating (Appendices Image 3).

Image 3: Axle stump with destroyed tapered roller bearing

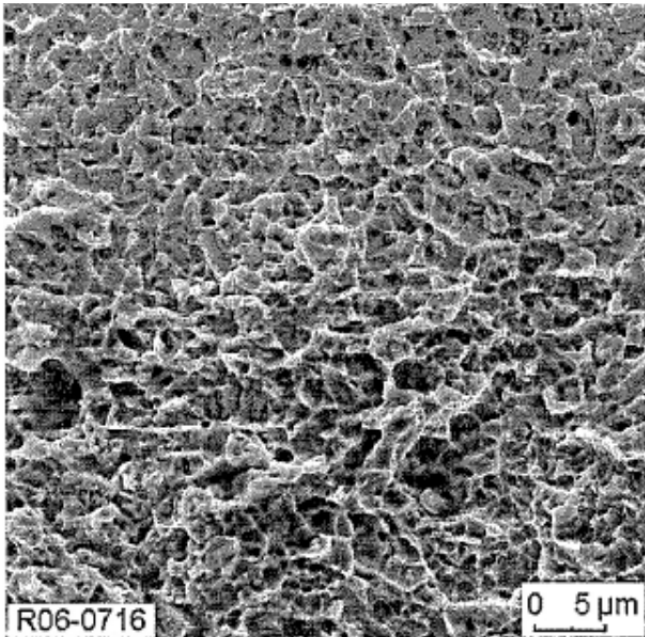
The fracture pieces were examined at the Technische Universität Braunschweig, Institut für Werkstoffe (IfW). The macroscopic appearance of the fracture surface did not allow a definite identification of the type of fracture. Therefore the fracture surface was examined using a scanning electron microscope. The micro-ductile comb structure typical for forced ruptures was found (Appendices Image 4). To verify the result a reference fracture was induced on the larger of the fracture pieces which subsequently showed the same micro topography. In summary it was determined that the wheel axle was not pre-damaged by a fatigue crack. No indications were found pointing to a corrosive attack. The entire fracture surface showed exclusively signs of forced rupture.

Image 4: Scanning electron microscopic image, micro-ductile comb structure
