Investigation Report

1X001-0/07
November 2008

Type of incident:	Accident
Date:	21 September 2007
Place:	Munich
Aircraft:	Transport aircraft
Manufacturer / type:	Bombardier Inc. / DHC 8-400
Injuries to persons:	No injured persons
Damage to property:	Aircraft seriously damaged
Other damage:	Airport installations
Source of information:	Investigation by BFU

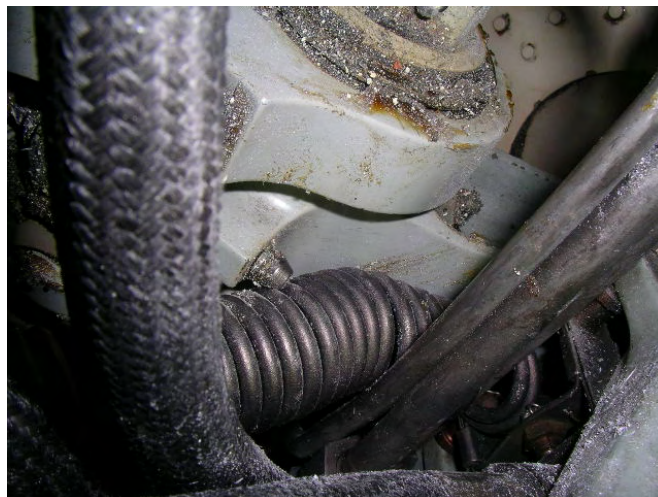
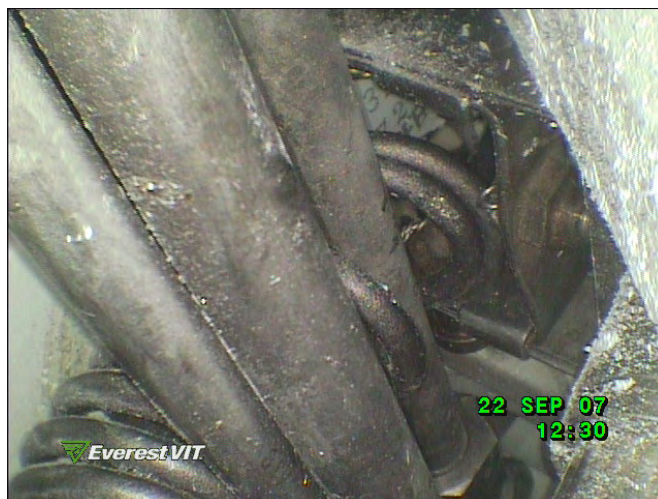
A coil spring was found jammed between the nose landing gear steering control hydraulic lines situated on the lower part of the NLG drag strut (Appendix 1). The spring was broken on one end. After removing the spring from the landing gear, the nose landing gear could be extended and retracted without any problems.

Jammed spring

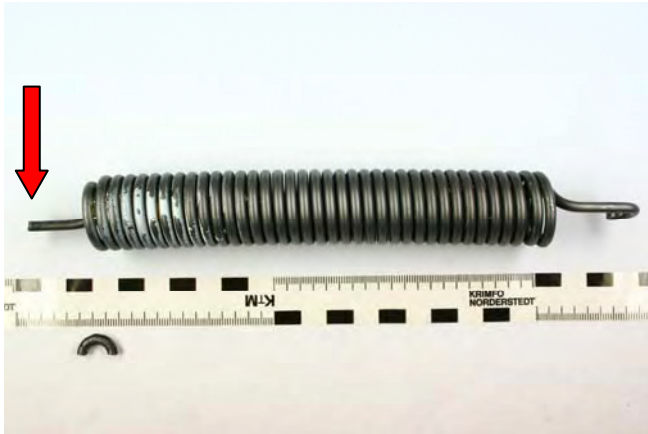
Broken coil spring

The spring (spring PN: 47844-101) was a part of the actuation mechanism of the nose landing gear doors. It is loaded with the NLG doors in the closed position (Appendix 2) and is bent at both ends approximately 185° to facilitate its attachment to the NLG door and to the NLG door actuation mechanism, respectively. It was broken at one of the two hook ends. During the first visual investigation of the fracture surfaces, signs of a fatigue fracture were determined.

1. *The scanning electronic microscope confirmed a fatigue fracture without any doubts.*
2. *The fatigue crack started on the inside of the hook end.*
3. *Within this already critical zone, the hook surface had been damaged additionally by fretting corrosion.*

4. *Due to the wear of the outer layer of the wire, the spring lost its protecting residual compressive stress, brought into it by shot peening in the surface area.*

5. *Due to the length of the crack and the striation width, a minimum of 3,000 crack-driving cycles must be assumed.*
6. *The damage results from the spring actuation during take-off and landing, not from the vibrations during flight.*

7. *The opposing hook, not broken so far, also showed noticeable traces of fretting corrosion. A crack having developed there, too, confirmed the principal conspicuity of the design.*

8. *The only way to avoid fretting corrosion is the constructive separation of the two fretting elements.*

Since the accident, the coil spring vendor and the aircraft manufacturer have introduced a modification to improve the Nose Landing Gear door linkage assembly. Modification 4-113552 introduces an improved NLG Door Spring Assembly attachment incorporating a retainer cap and insert to retain the spring in the event of breakage of a coil at either end.

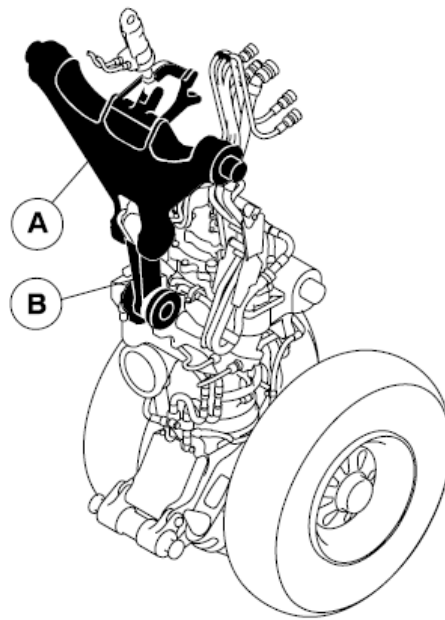
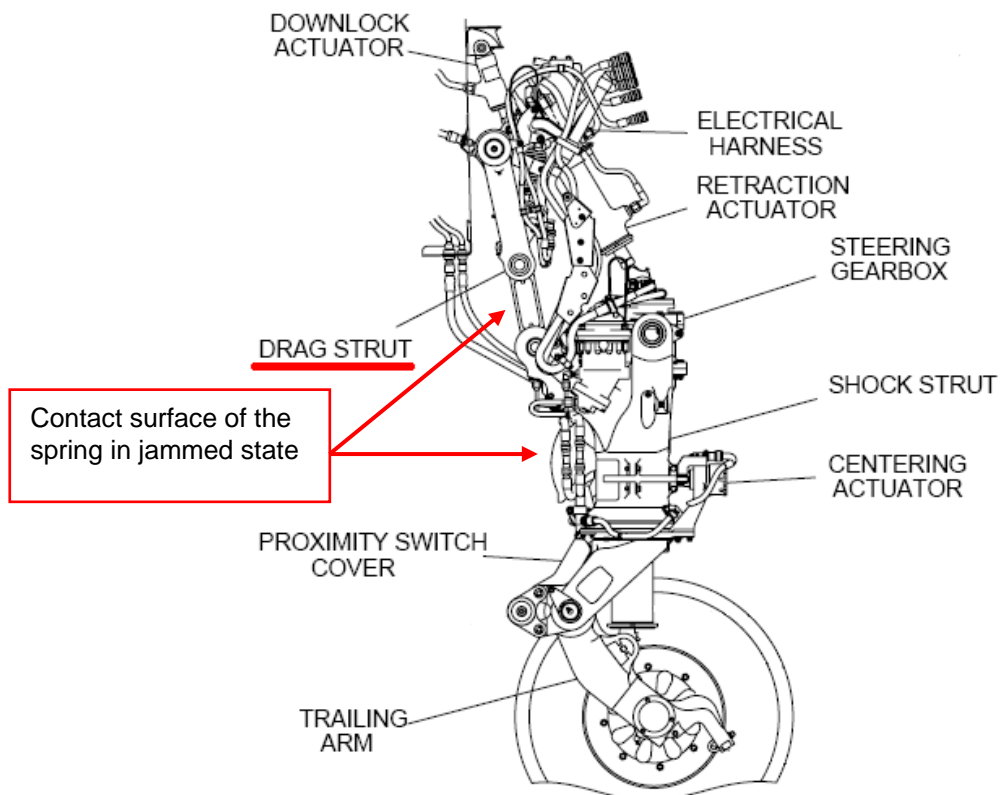
Appendix 1

Figure of the nose landing gear

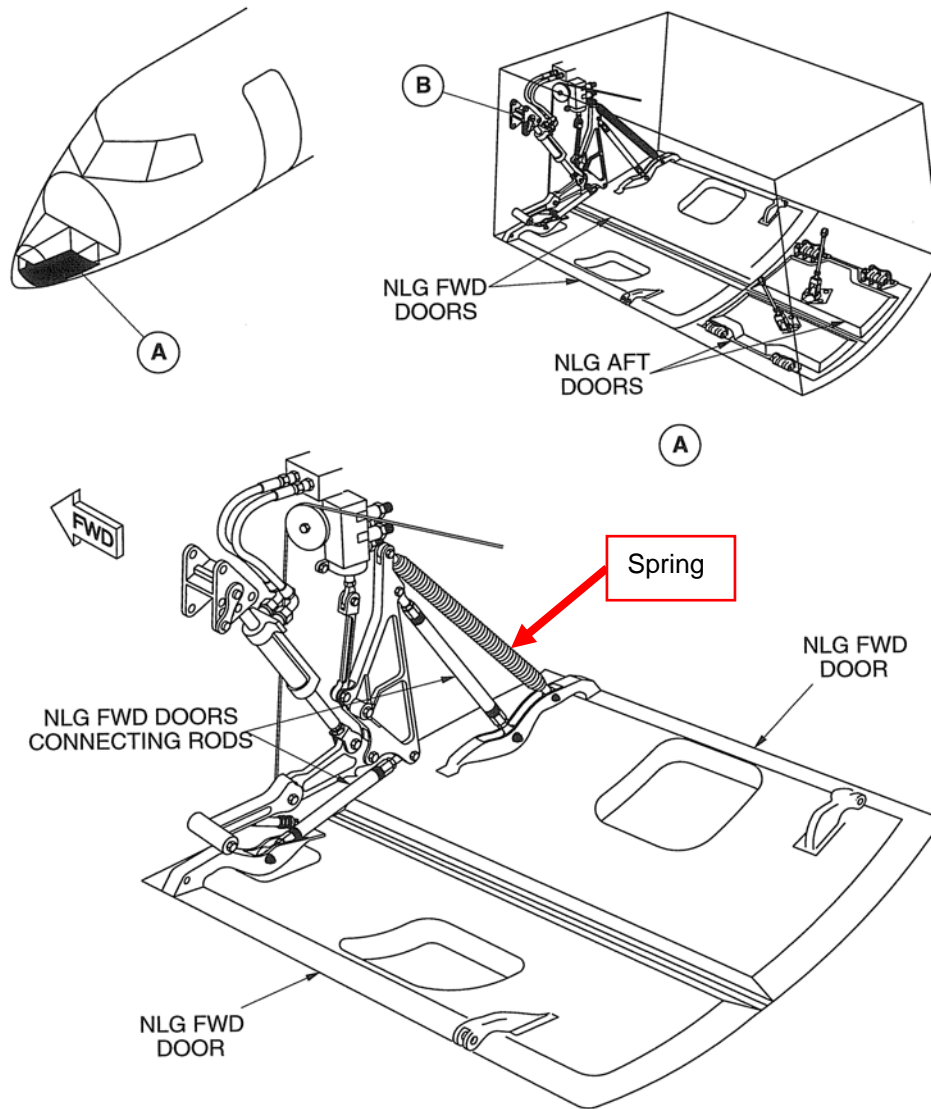
Appendix 2:

Position of the spring in the nose landing gear chamber
