# Investigation Report

3X182-0/07  
March 2009

Type of incident:	Accident
Date:	14 November 2007
Place:	Hanover
Aircraft:	Helicopter
Manufacturer / type:	MD Helicopters, Inc. / MD 900
Injuries to persons:	three slightly injured persons
Damage to property:	Aircraft seriously damaged
Other damage:	None
Source of information:	Investigation by BFU

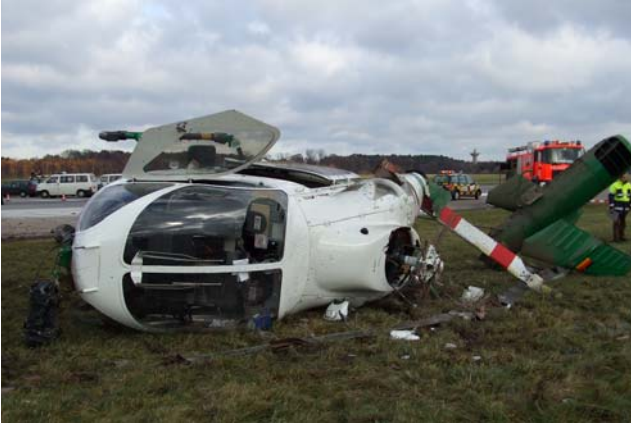
The helicopter lay 858 m past the threshold of runway 09L, between the taxiways Juliet and Kilo, 13.7 m to the right (in southerly direction) of the runway, on its left side.

The tail boom was severed at the level of the registration mark. The only remaining connection between tail boom and fuselage were two electric power cables. All five main rotor blades were severed at the rotor head. The linkages of the blade to the swash plate were torn off. The left skid of the landing gear was broken. The right windscreen presented a big hole.

Accident side

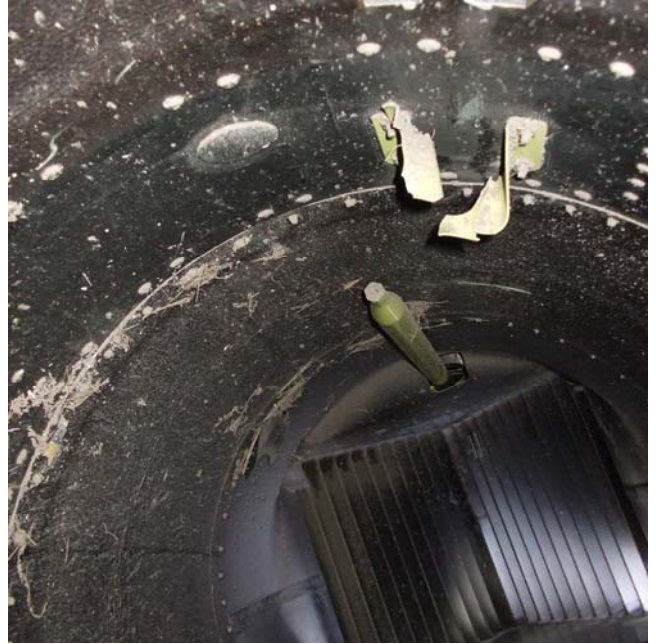
- The connection was interrupted at the connection point between the push-pull cable and the push rod. A remaining piece of the threaded rod of the push-pull cable was found in the threaded bush of the control rod.

- This remaining piece of the threaded rod had a groove in longitudinal direction. A locking plate engages in this groove in order to prevent the rotation of the threaded rod with respect to the pushing sleeve and the push rod. The locking plate and the pushing sleeve were missing and could not be found at the accident site, even though metal detectors were used.

Image of the damage at the accident helicopter, view from the front to the rear towards the control rod for thruster adjustment

- *The point of fracture is located – as expected – directly at the exit of the threaded stud from the threaded bush of the control rod*
- *The macroscopic appearance of fracture clearly points to a vibration fracture (also designated endurance or fatigue fracture)*
- *These findings were confirmed without any doubt with the scanning electronic microscope*
- *The forced final fracture is limited to a very small border surface*
- *A small final fracture surface principally indicates a low (oscillating) stress level*
- *Vice versa, the start of a local fatigue fracture requires a high local stress concentration, for example due to a sharp notch, possibly in conjunction with a peak load*

The fracture in the mechanism of the thruster occurred in a threaded stud at the transition from a push-pull cable to a control rod. The determined fracture type – oscillation (fatigue) fracture – was caused by a high local stress concentration. The crack had started in the area of a milled recess. Depending on the position of the milled recess in relation to the oscillation direction, a different stress level already results from the installation position.

The stress concentration in the threaded rod and thus the risk of a fracture could be essentially reduced if it was possible to avoid the milled recess in the section. The pushing sleeve secures the connection of the push rod to the threaded rod and fixes these parts to each other. A tightening torque and a locking wire ensure that this connection cannot loosen. It should be checked whether an additional rotary protection for the threaded rod is absolutely necessary.

MD Helicopters Inc. released the Service Bulletin 900-0108 on 12. August 2008 which lead to the emergency AD 2008-17-51 of the FAA, issued 14. August 2008. These publications require an inspection of the control system of the rotatable thruster and a change of the lock device.

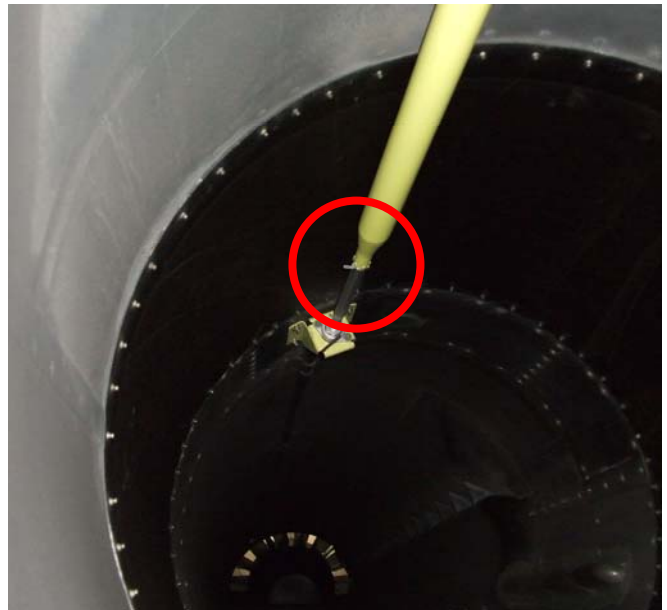
Connection between bowden cable and push rod in a helicopter of same type, view from the rear to the front
