# Investigation Report

5X002-0/07  
May 2010

Type of Occurrence:	Serious Incident
Date:	24. January 2007
Location:	En route
Aircraft:	Civil Air Transport
Manufacturer / Model:	Airbus Industrie / A 320
Injuries to Persons:	None
Damage:	Aircraft not damaged
Other Damage:	None
Source of Information:	Investigation by BFU

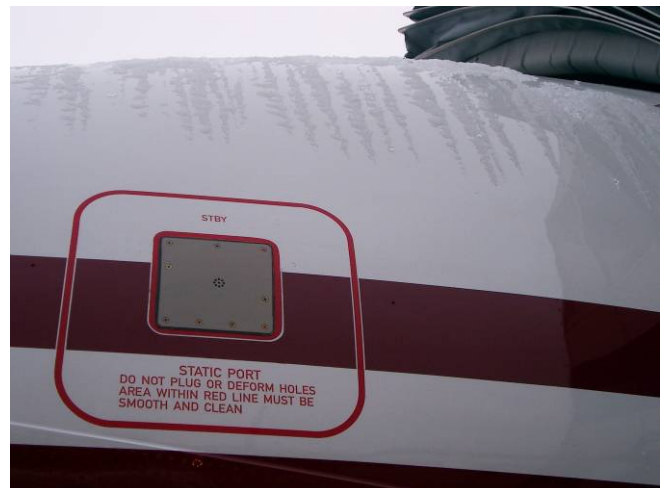
The wings and tailplane had been de-iced prior to the flight. There had been no intention to de-ice the fuselage, for which reason there was residual snow and ice on top of the fuselage nose. It is therefore quite possible that water melted from snow or ice into the apertures for the Pitot Probes and Static Ports.

The BFU draws the inference, that this was the time at which the crew heard the loud bang, probably caused by detachment of a sheet of ice from the fuselage nose.

After the landing in Frankfurt, ice was still visible on the aircraft nose over the Static Ports and Pitot Probes.

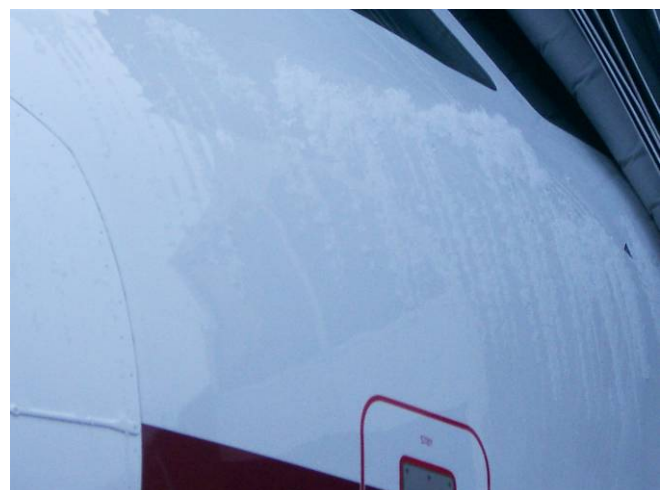
Snow and residual ice on the aircraft nose below the cockpit windscreen after the landing in Frankfurt.

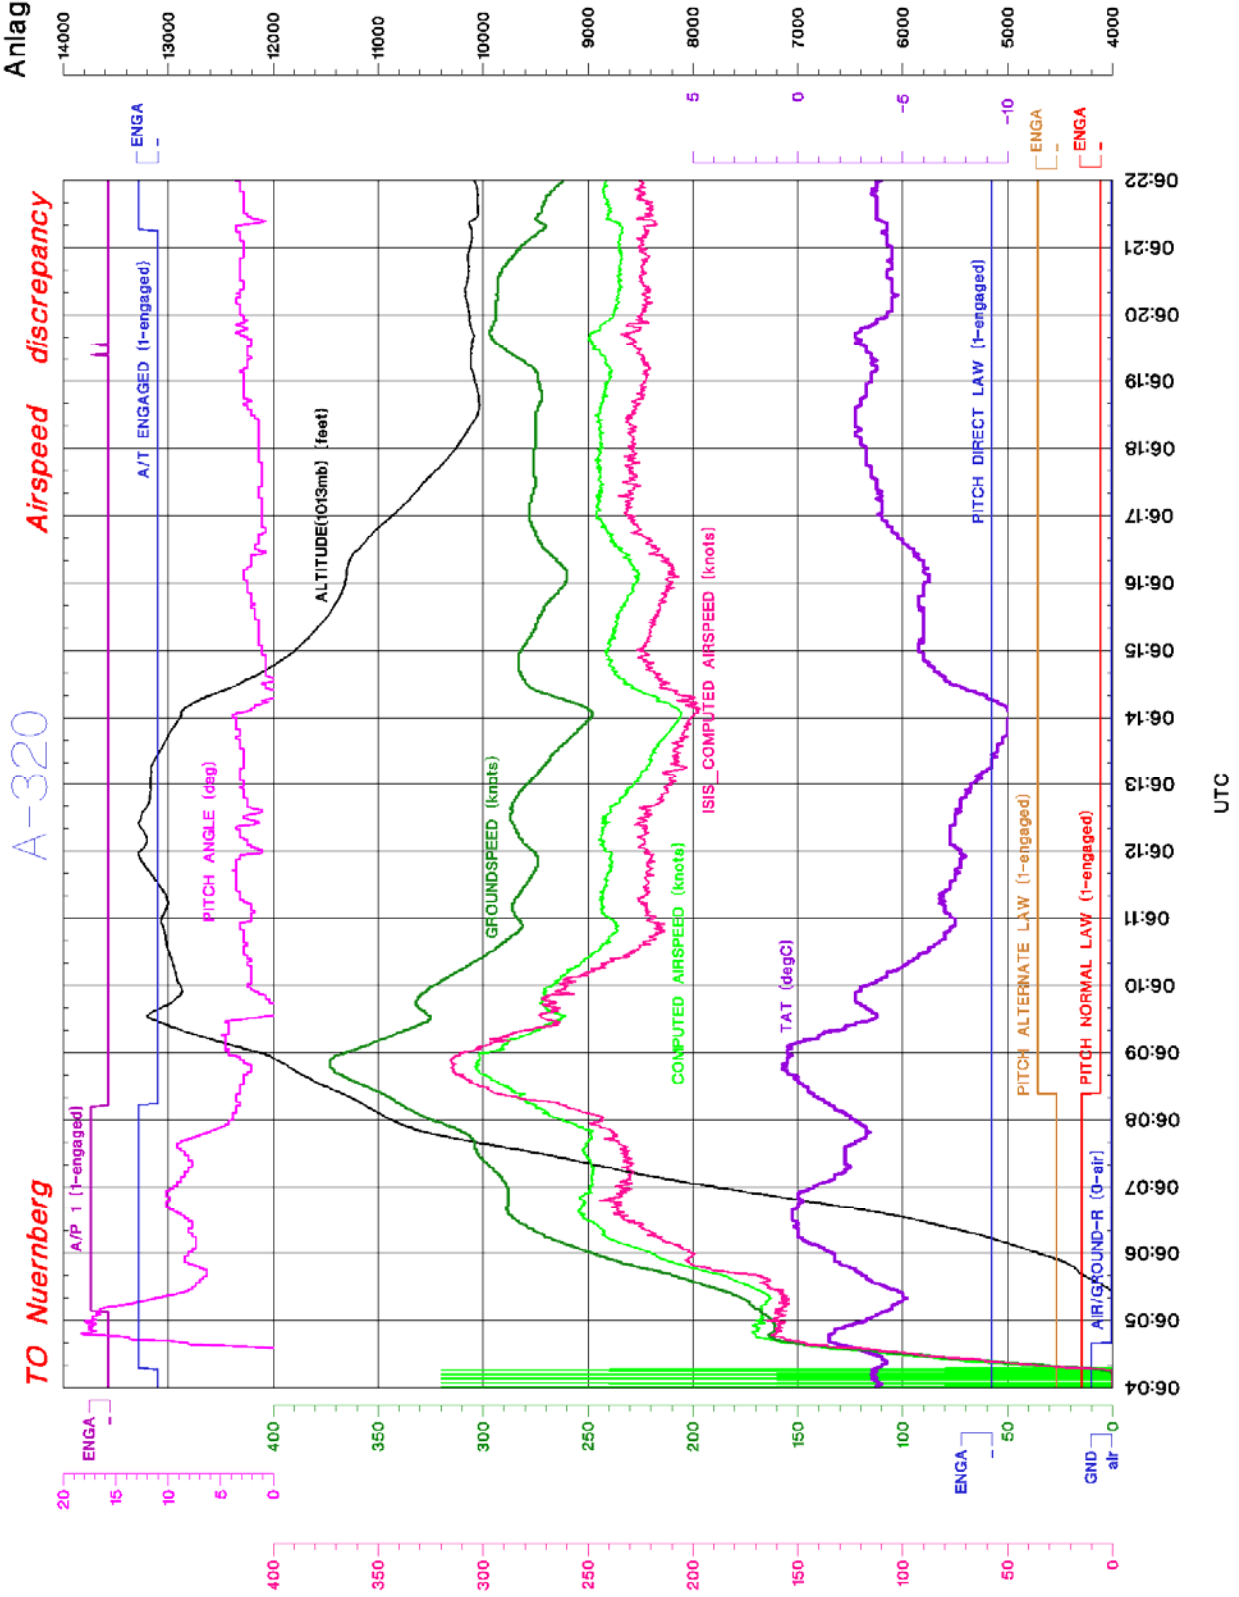
Anlage 1

Appendix 1 shows the speed differences in the period 06:08 UTC to 06:10 UTC. The value displayed by the Standby Airspeed Indicator (ISIS, red line) exceeded that of the COMPUTED AIRSPEED (CAS, green line).
