Investigation Report

Type of Occurrence:	Serious incident
Date:	14 May 2008
Location:	Zweibrücken
Aircraft:	1. Transport aircraft 2. Military transport aircraft
Manufacturer / Model:	1. Airbus Industry / A319-112 2. Transporter Allianz / C-160 Transall
Injuries to Persons:	None
Damage:	Aircraft not damaged
Other Damage:	None
Information Source:	Investigation by BFU
State File Number:	BFU 5X006-08

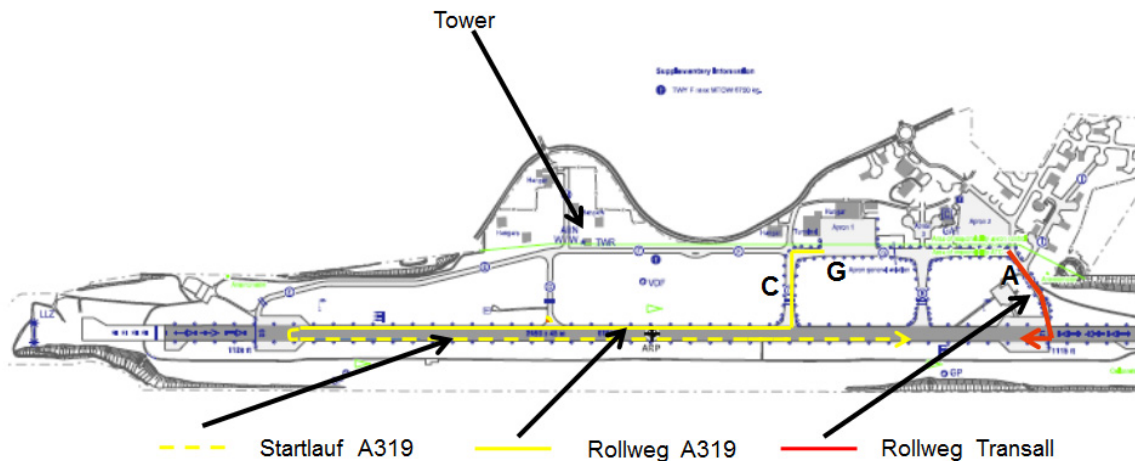
Reconstruction of the taxi path

The runway incursion occurred because a C-160 Transall did not stop at the holding point 21 but lined up on runway 21 due to misinterpreting the taxi clearance.

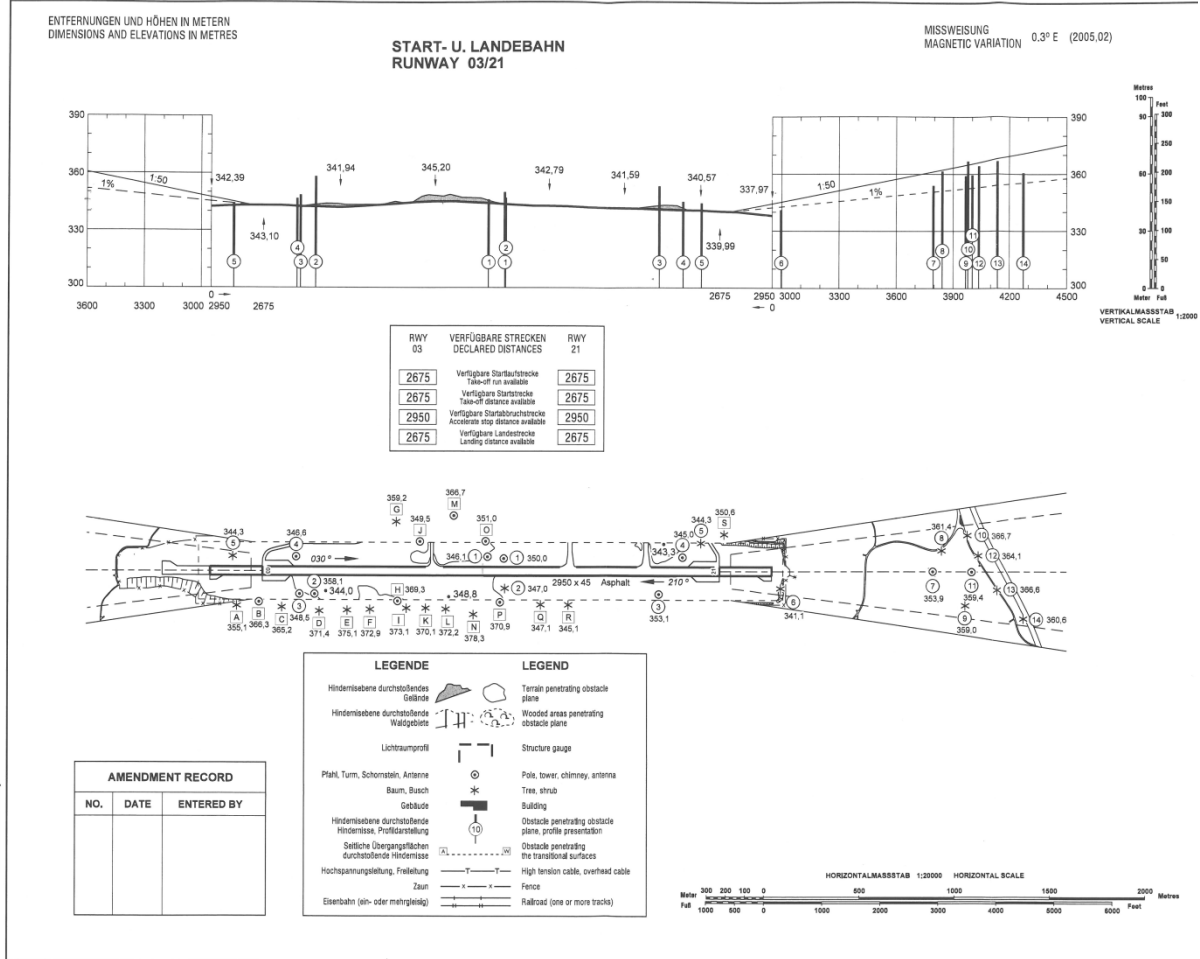
Aerodrome obstacle chart including runway elevations of runway 03/21

The elevation profile of the runway was of importance. Because the middle runway section was about 10 ft higher than threshold 03 and about 20 ft higher than threshold 21 the crews of the airplanes could only see each other to a limited extent. Neither crew had an unobstructed view to check whether the runway was free.

The wrong line-up could not be detected by the crews of the airplanes involved. Due to the elevation profile of the runway, the opposite airplane could not be seen or only to a limited extent.

The BFU is of the opinion that due to the runway's geographical position and the resulting elevation profile, operation on opposing runways should in general be avoided at this airfield. The safety problem was caused by the fact that airplanes standing at opposing runway ends cannot see each other or only to a limited extent depending on their size.
