Investigation Report

Type of Occurrence:	Accident
Date:	16 November 2008
Location:	Near Nordhorn
Aircraft:	Helicopter
Manufacturer / Model:	Rotorway / Exec 162 F
Injuries to Persons:	Pilot fatally injured
Damage:	Aircraft destroyed
Other Damage:	Crop damage
Source of Information:	Investigation by BFU
State File Number:	BFU CX012-0/08

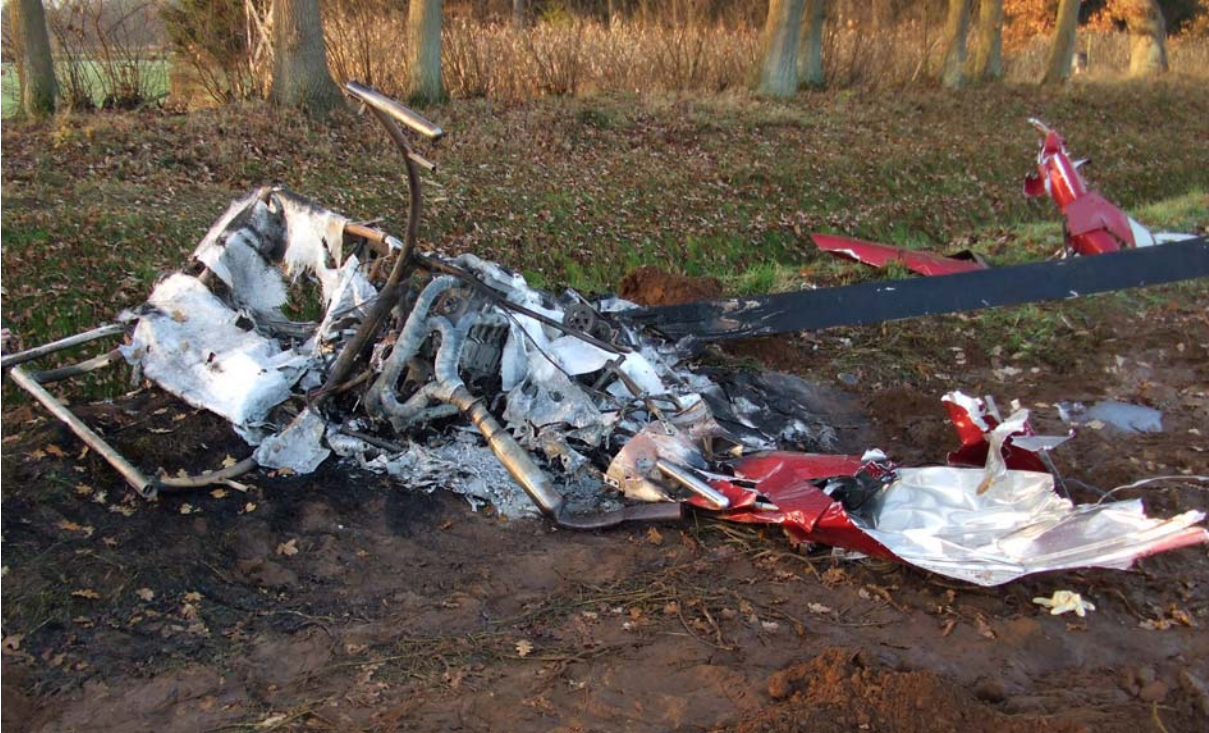
The main wreck was found resting on its right hand side. The main rotor was transverse to and underneath the main wreck. One rotor blade was found with reddish paint residues towards the tip along the leading edge. The other rotor blade had lost a piece of skin about 10 x 10 cm from the upper surface. The rotor head had separated from the rotor mast, the central pivoting bolt bearing shells were broken. The left skid had been torn off together with the front section of the landing gear crossbar and was found in front of the main wreck in a ditch. The tip and heel were missing from the right skid. The skid tip with the trim weight for solo flight was found buried upright about 1 m deep in the ground about 25 m west of the main wreck. All the fuselage plastic fairings and most of the instruments had burned out. The engine had been torn from its frame and the induction manifold and the fuel control unit had melted. Drive belts in the vicinity of the engine had burned away. The control system was broken at a number of places between the cyclic stick, collective stick and swashplate. The push-pull cable to the tail rotor adjustment was connected in the vicinity of the cockpit, but separated in the vicinity of the tail rotor. The tail boom had separated close to the horizontal stabilizer. Two pairs tail rotor drive belt pulleys, two drive belts, an intact drive belt and a broken drive belt were found in the tail boom.

General view of the burned out helicopter

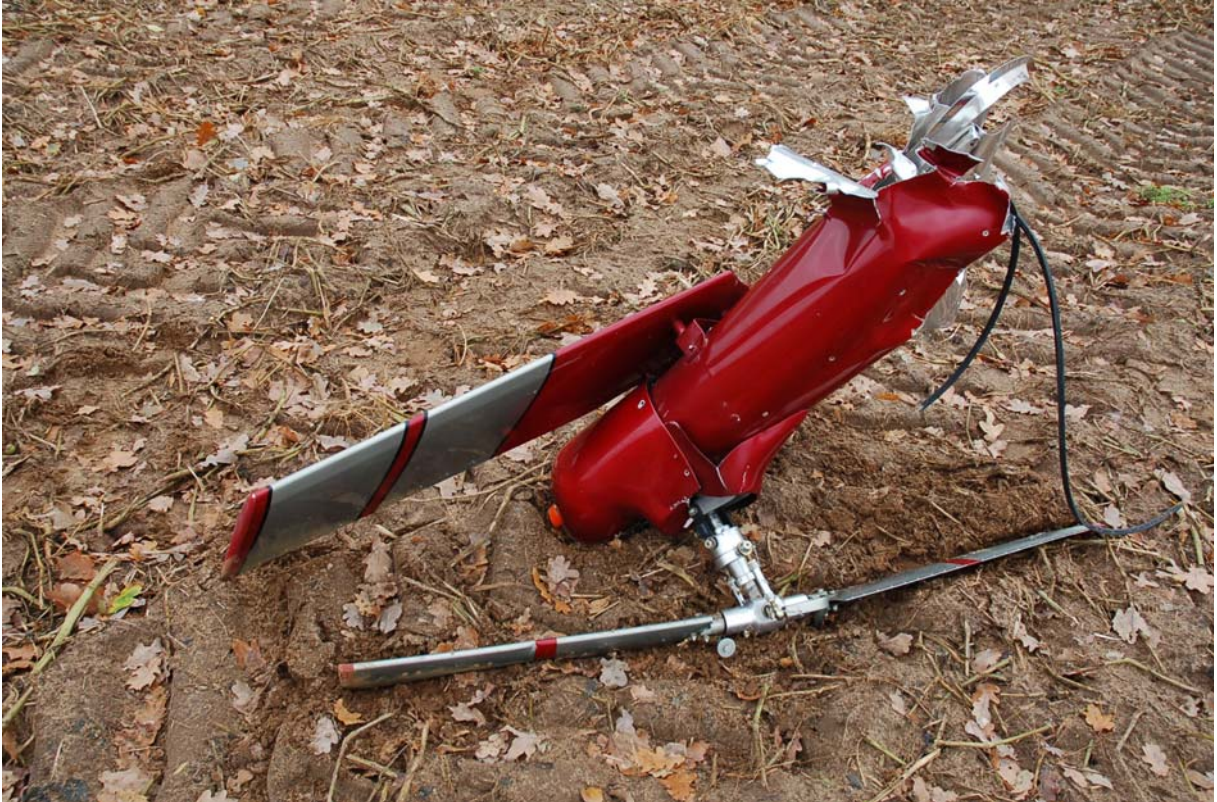
Wreckage from the tail boom, horizontal fin with winglets, cabin glazing and both doors were found on the field. The missing orange-coloured skin from one of the rotor blades was found about 190 m from the main wreck, while the separated tail boom and tail rotor were found about 74 m from the main wreck. Orange paint residues were found at the tail boom separation point, also at the break point on the tail rotor drive belt.

Separated tail boom with tail rotor and drive belt

Likewise, in this instance the main rotor impacted with the tail boom and separated it from the forward section during flight. This is demonstrated by the fact that the tail boom was found away from the main wreck, that coloured paint residues were found on the tail boom, the tail rotor drive belt, and on one rotor blade. Given the distribution of the wreckage and the trim weight buried deeply in the ground, the impact between rotor blade and tail boom must have taken place at cruise altitude.

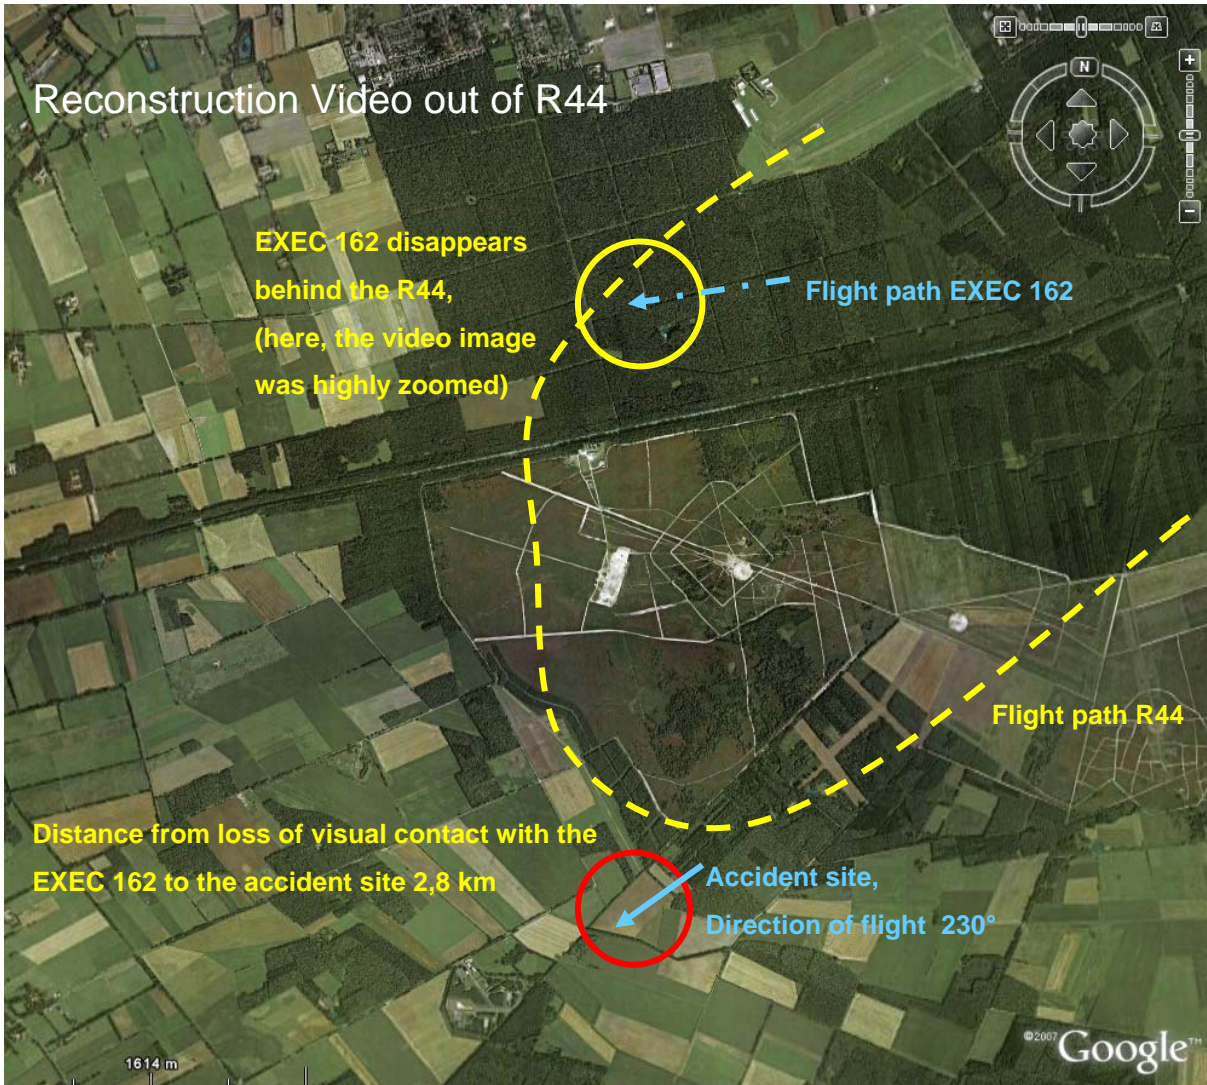
The film images taken from the preceding R44 helicopter confirm the flying instructor's statement. The Exec 162F was to the left, behind and below the R44. The Exec 162F climbed from this position and disappeared from the field of view above and behind the R44. Given the background to these images, it was possible to reconstruct the position of the helicopter and its manoeuvre at this point.

Flight track, reconstructed from video film
