Investigation Report

Type of Occurrence:	Accident
Date:	10 April 2009
Location:	Schmoldow Special Airfield
Aircraft:	Airplane
Manufacturer / Model:	PZL-104 „Wilga 35"
Injuries to Persons:	Both pilots fatally injured
Damage:	Aircraft destroyed
Other Damage:	None
Information Source:	Investigation by BFU
State File Number:	BFU 3X020-09

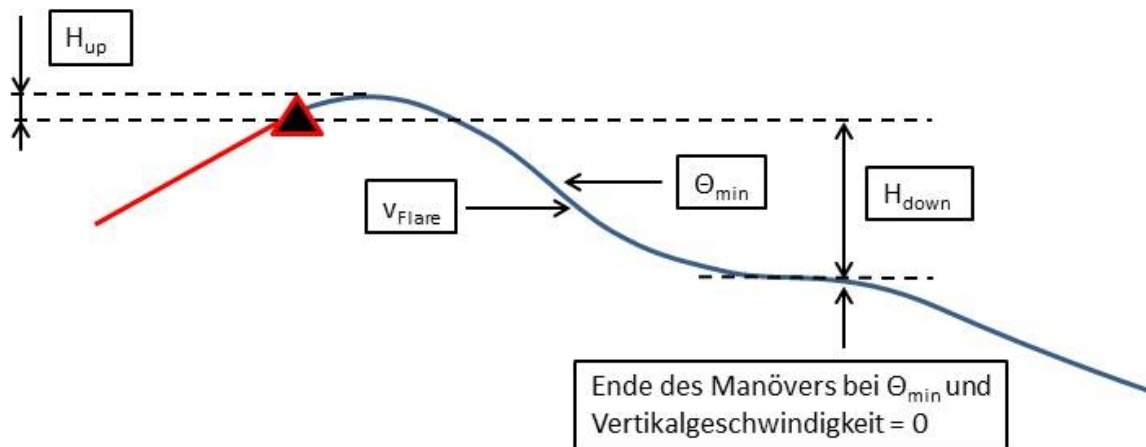
Measured values

Appendix 3 shows the graph of one such flight. Analysis of the results showed that the loss of altitude H_{down} mainly depends on the speed reached right before the flare. A stronger input in the first phase does not necessarily result in higher speeds but often leads to smaller pitch angles (steeper nose down) (lesser Θ_{min})⁴ at roughly the same height and speed.

The analysis showed that the mean loss of altitude was 40 m between the initiation of the simulated engine failure and the simulated landing. Depending on the pitch angle the loss of altitude changed significantly. Under favourable conditions the loss was 24 m and under the most unfavourable 115 m.

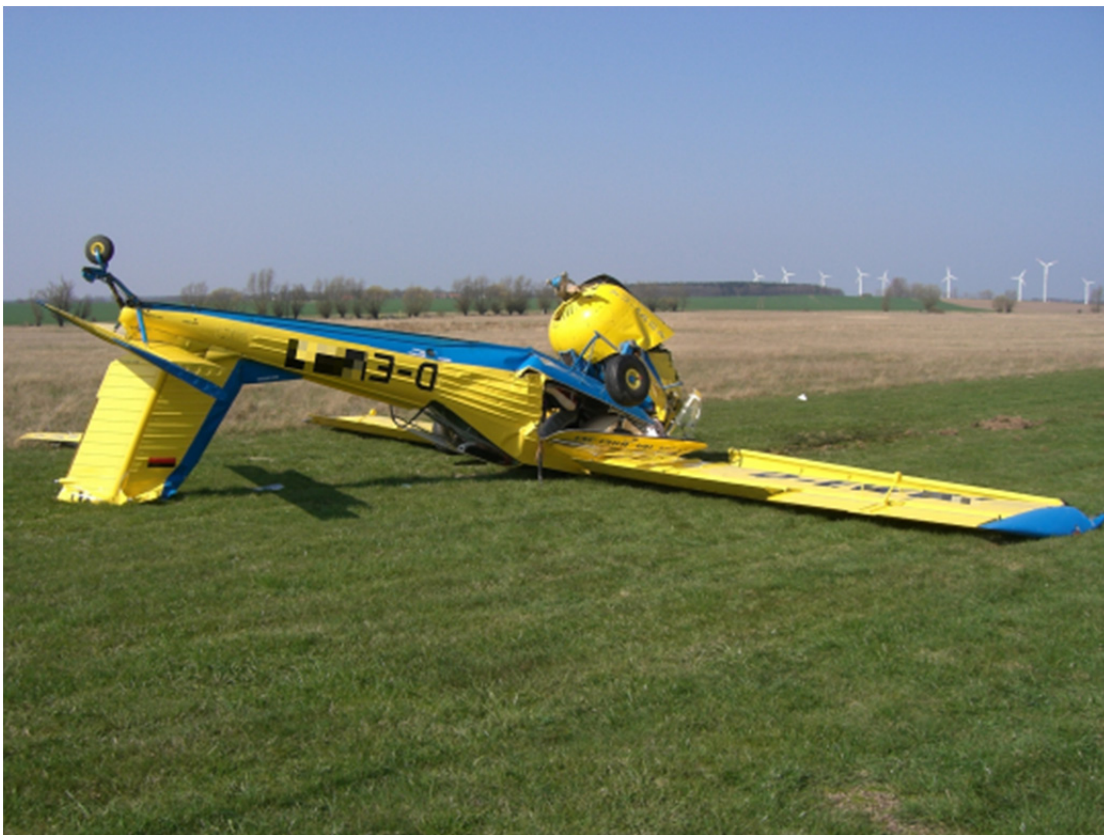
The accident site was approximately 4.5 km beyond the threshold of runway 15. The airplane was found in an inverted position. The airplane fuselage pointed in the direction of about 330°. Two parallel traces in the ground were found in flight

The fuselage had fractured between the engine compartment and the cabin. The engine including the firewall had been bent backward and was lying on the fuselage pointing toward the tail. The propeller spinner and the two main landing gear struts showed traces of earth. The main landing gear had been bent backward. The left strut was about parallel to the longitudinal axis. The right strut almost reached the underside of the flap. The cabin had been compressed by about a third. During the recovery work the engine, the firewall, and the main landing gear were put back in their original positions.

Image 1: Wreckage

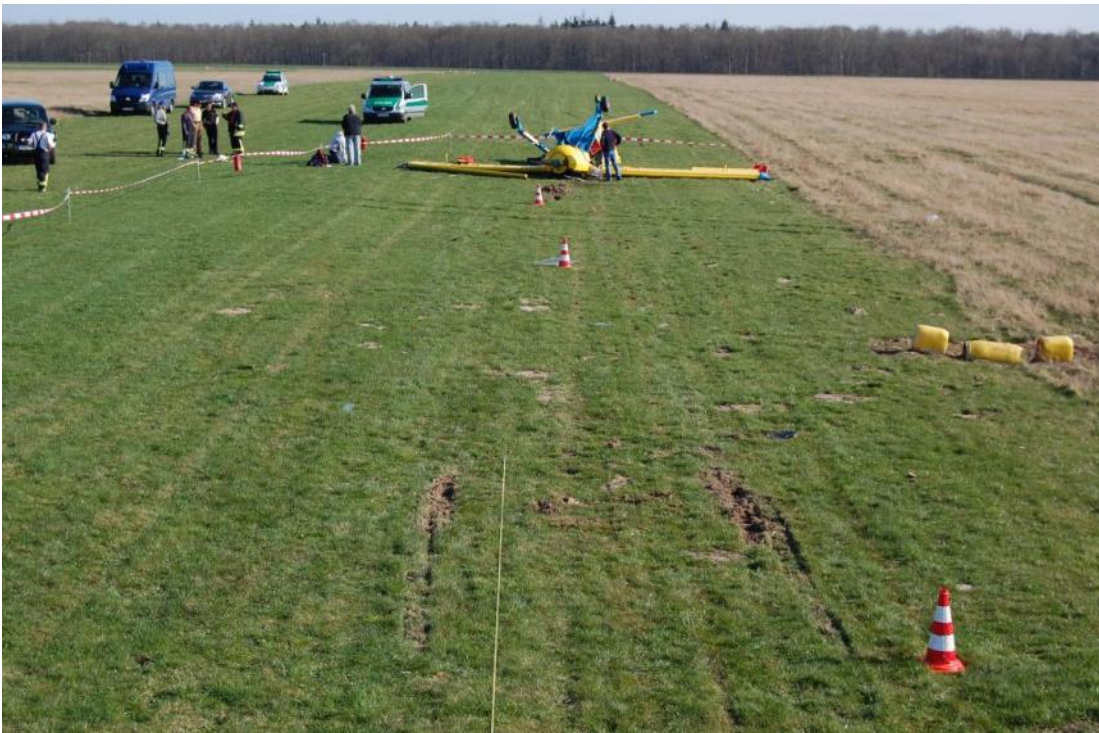
Image 2: Wreckage viewed from the approach direction

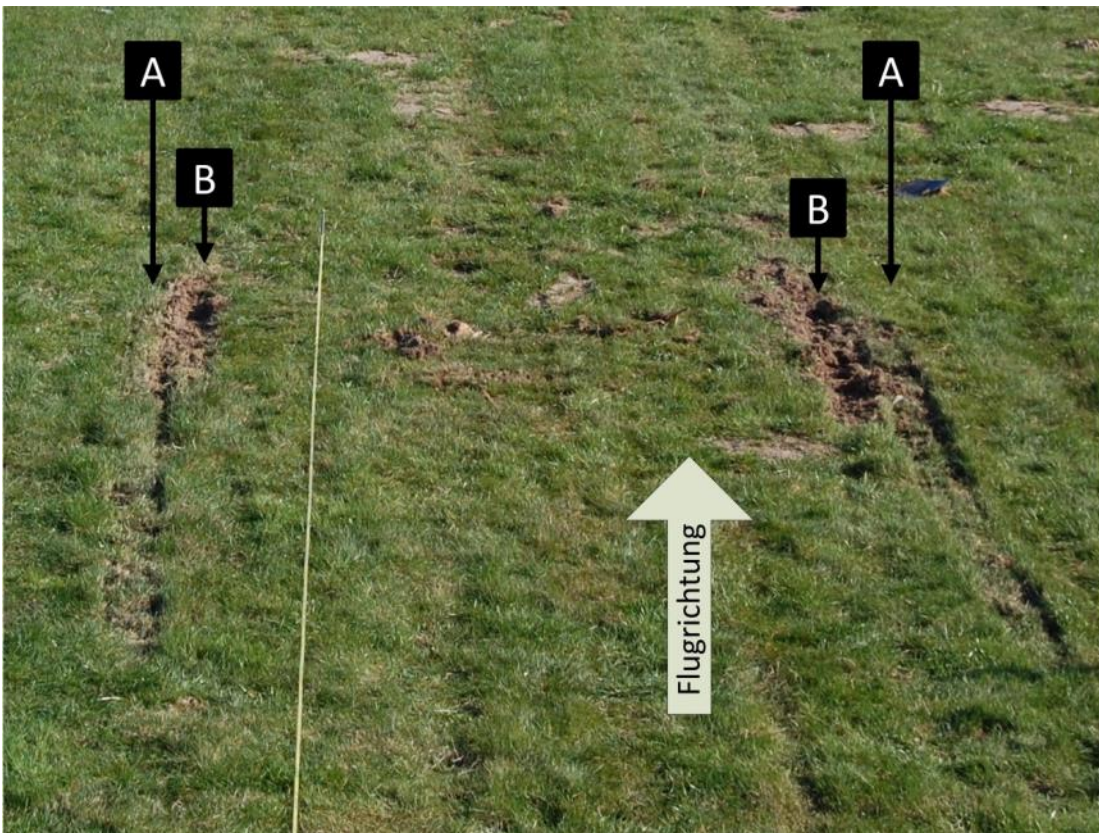
direction 46.20 m from the wreckage (Appendix 1, Image 3, Trace A). These traces were approximately 4 m long. The lateral distance roughly equalled the width of the main landing gear. Two additional parallel traces were found in a distance of 43.20 m to 41.70 m (Appendix 1, Image 3, Trace B). These had torn open the sod and each was located about 30 cm within the two other traces described above. In two areas propeller traces were found in the sod.

information as to the pitch angle during impact. The first parallel traces (Appendix 1, Image 3, No A) correlate with the wheels of the main landing gear. In the extension of the point of impact no propeller traces were found. Therefore, in this phase the pitch angle of the airplane was approximately 8° . The traces located further inward and which are closer together, correlate with the landing gear struts (Appendix 1, Image 3, No B). This shows that the landing gear was heavily pushed inside the earth. From the initial propeller traces (distance 43.2 m to the main wreckage) it can be deduced that the airplane had a pitch angle of 25° (Appendix 2, Image 2). Since no other traces were found on the ground in the direction of the wreckage on a length of 18 m, it can be concluded that the airplane had lifted off again for a short time. In a distance of 19.6 m to the wreckage, the traces on the ground indicate another impact of the airplane. The deep trace in the ground in the immediate vicinity of the wreckage was caused by the propeller spinner which bore into the ground and then the airplane flipped over. It can be concluded that beginning with the initial ground contact until the spinner bore into the ground, the airplane had a negative pitch angle (nose down) which could not be recovered by active counter-steering.

Image 3: Impact traces

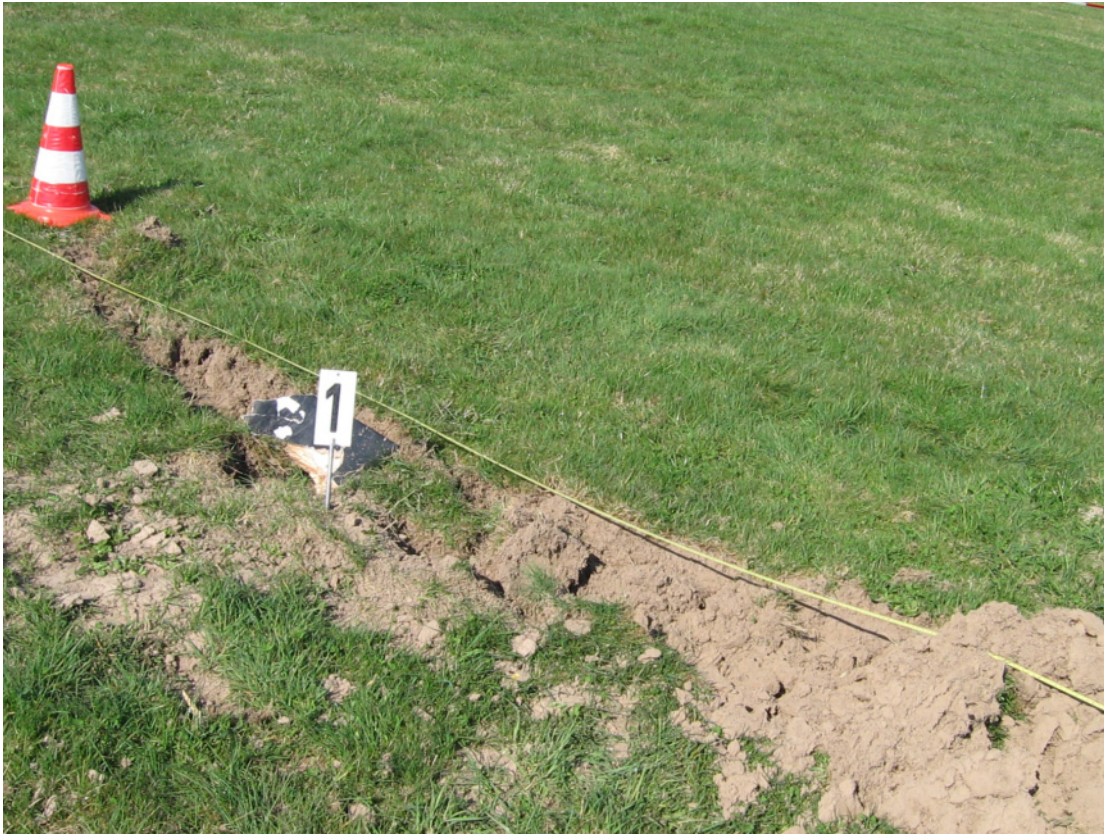
The trace with a distance of 18 m was 10 cm deep and therefore more distinct than the others. The trace with a distance of 7 m was inside a larger heap of earth which was in the middle of the assumed moving direction (Appendix 1, Image 4).

Image 4: Propeller traces and a heap of earth 7 m from the wreckage

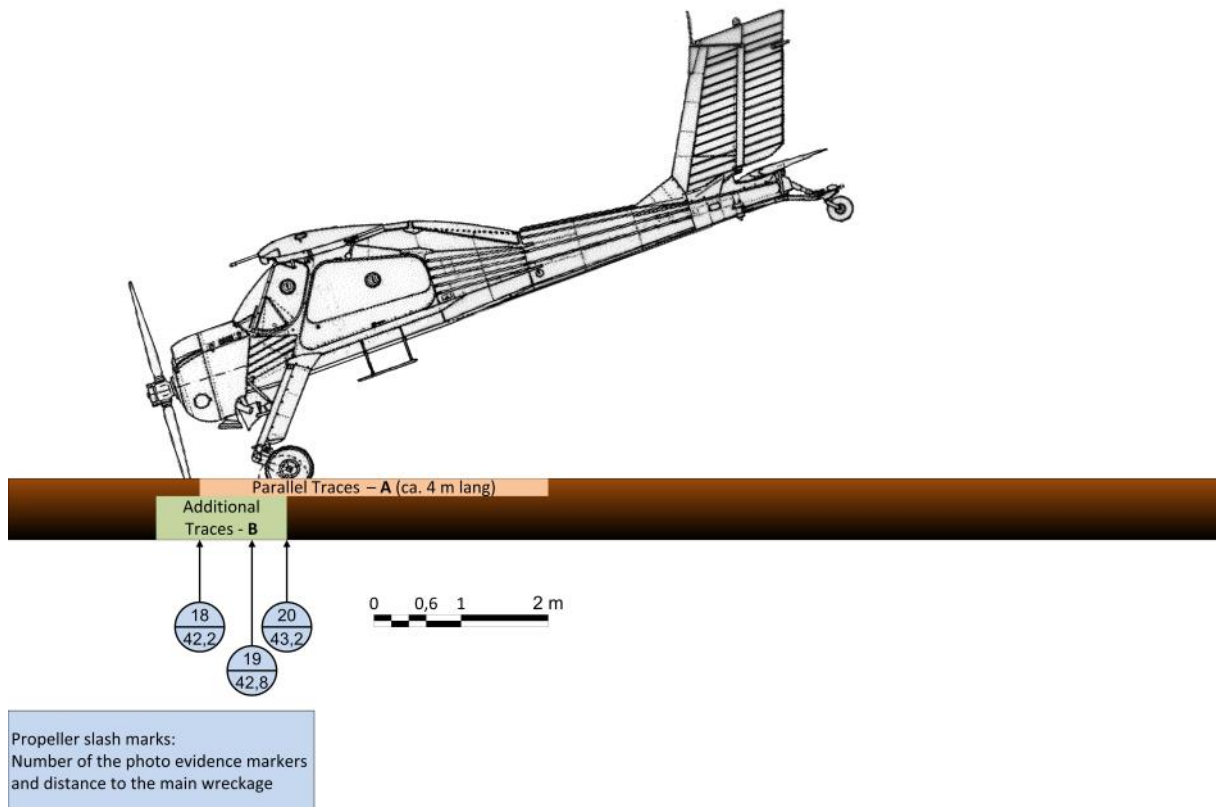
From the described course of the flight it can be deduced that the airplane was not flared completely. The relatively high energy during impact, which caused the main landing gear to sink into the ground up to the landing gear wing, indicates a high sink rate. The distances between the individual propeller traces show that the horizontal velocity was not very high. Even if a propeller RPM of $1,300 \text{ min}^{-1}$ is assumed, the speed is only about 62 km/h.

Image 7: Drawing of the pitch angle / impact sequence

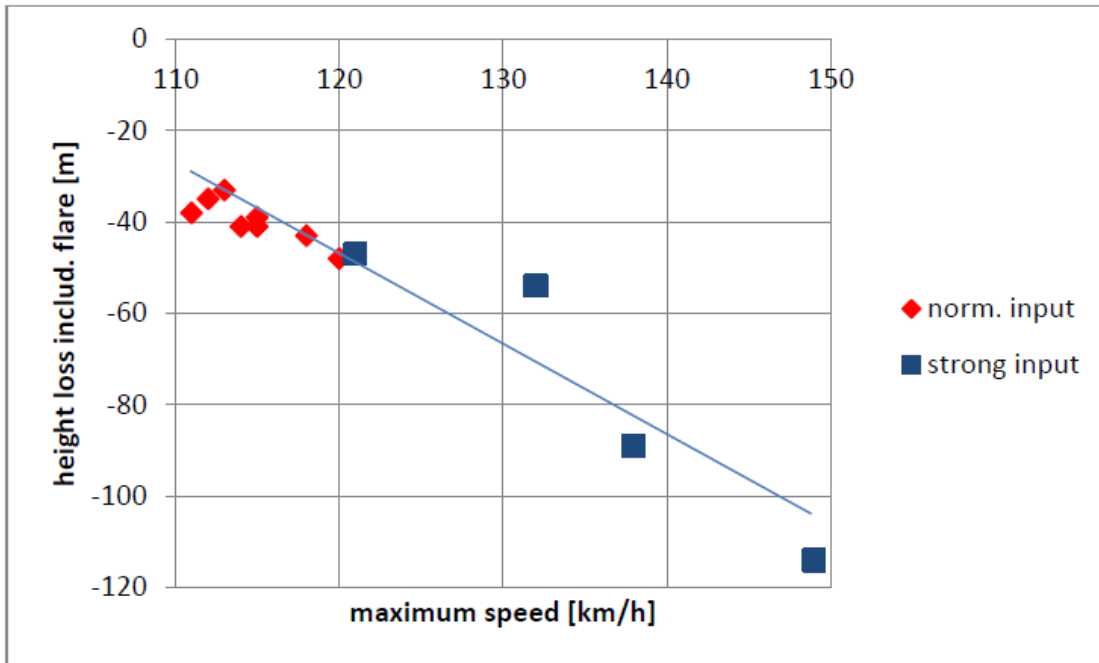
Only in a few tests, stronger stick forward motion resulted in higher maximum speed in combination with increased loss of altitude. In two tests this could be largely compensated by stronger flare (n_z about 2 g). Compared to normal control input the loss of altitude was about 10 m higher.

Figure 12: Height loss over maximum speed

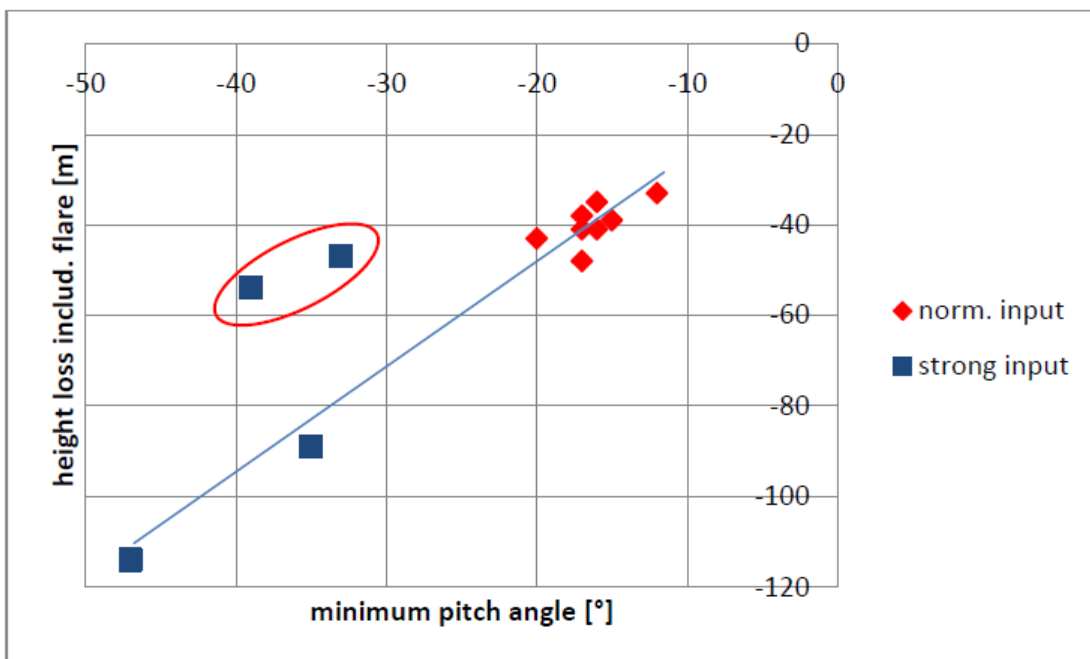
During the flare phase, larger pitch angles (lesser Θ_{min}) resulted in prolonged flare phases with corresponding higher loss of altitude. More time was required to recover the airplane from the larger pitch angle. In addition, larger pitch angles resulted in higher sink rates which led to additional loss of altitude.

Figure 11: Height loss over minimum pitch angle
