# Investigation Report

Type of Occurrence:	Accident
Date:	19 June 2009
Location:	Mannheim
Aircraft:	Helicopter
Manufacturer / Model:	Eurocopter France / EC 120B
Injuries to Persons:	Three persons slightly injured
Damage:	Aircraft substantially damaged
Other Damage:	Crop damage
Source of Information:	Investigation by BFU
State File Number:	BFU 3X078-09

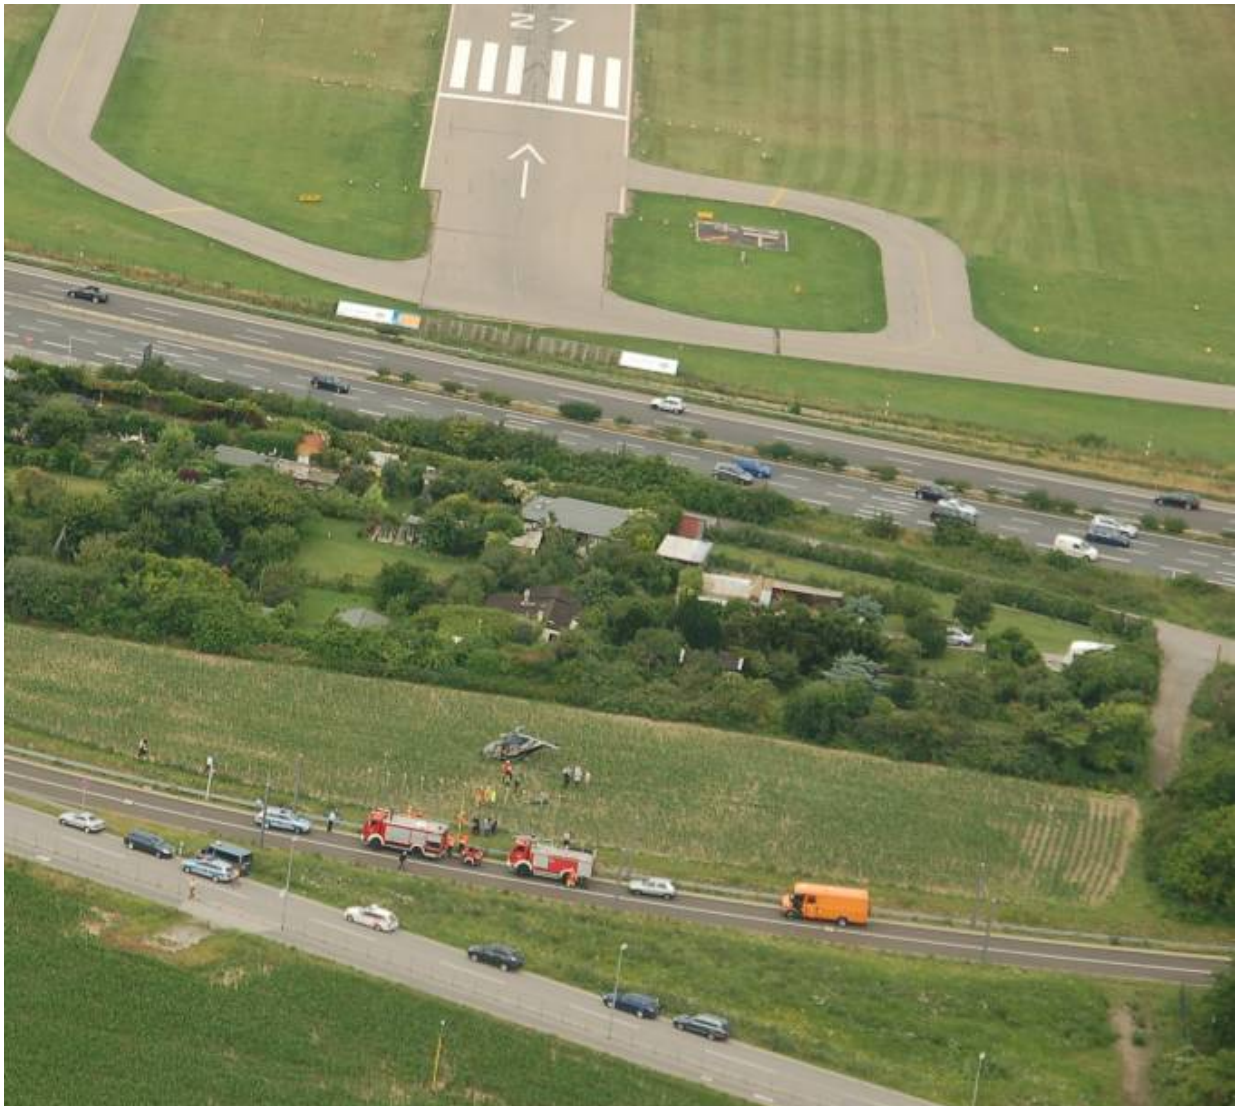
The accident site was 250 m east of Mannheim-City Special Airfield's asphalt Runway 27 in a field of maize at about 309 ft AMSL. The helicopter fuselage rested on its belly oriented at 170°. The skids had broken off from the aft cross-tube and were directed upwards. The cross-tubes were twisted rearwards. The tail boom had sepa-

Air-to-ground view, accident site / airfield

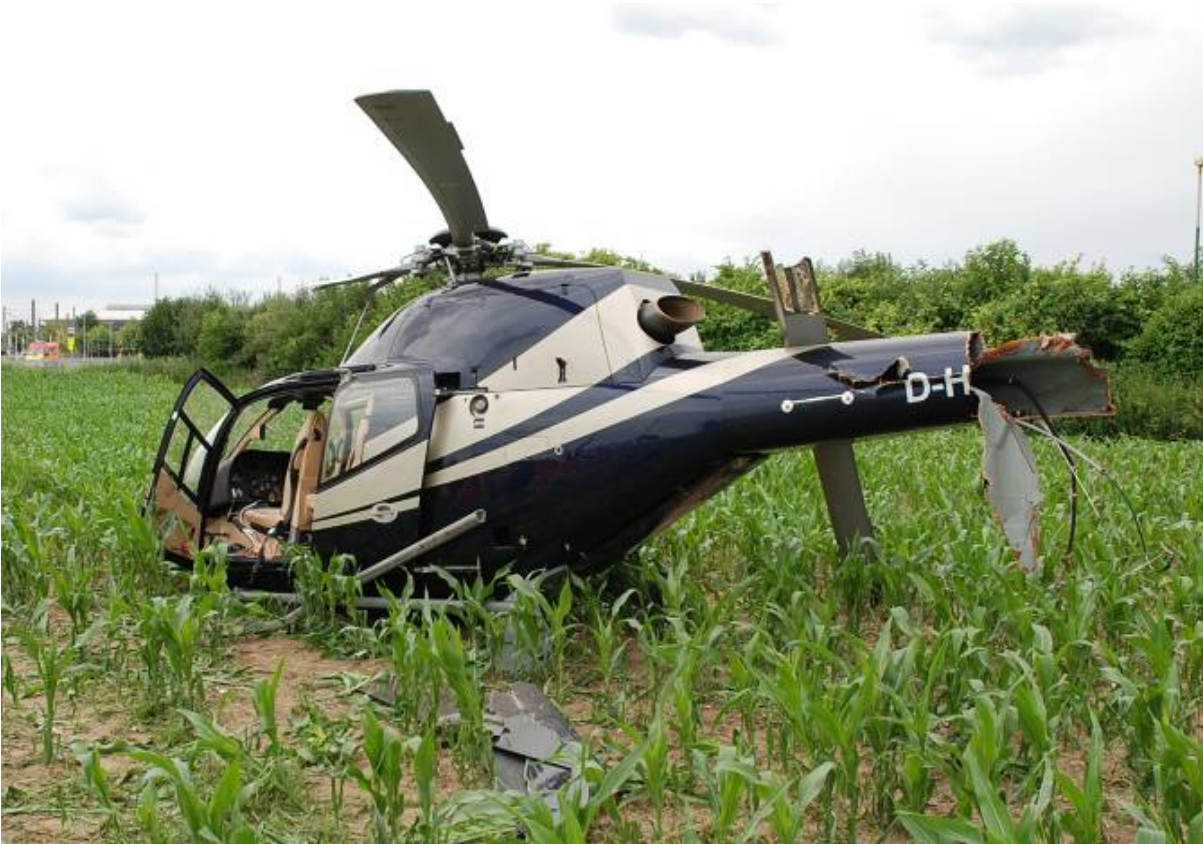
rated just in front of the vertical fenestron fin. The three main rotor blades were all damaged to varying degrees. One rotor blade had torn off and lay directly alongside the wreck. Parts of the tail boom and the fenestron drive shaft were found 44 m east of the wreck. The twist-grip power control on the collective lever was found in the 'FLIGHT' position.

General view, main wreck

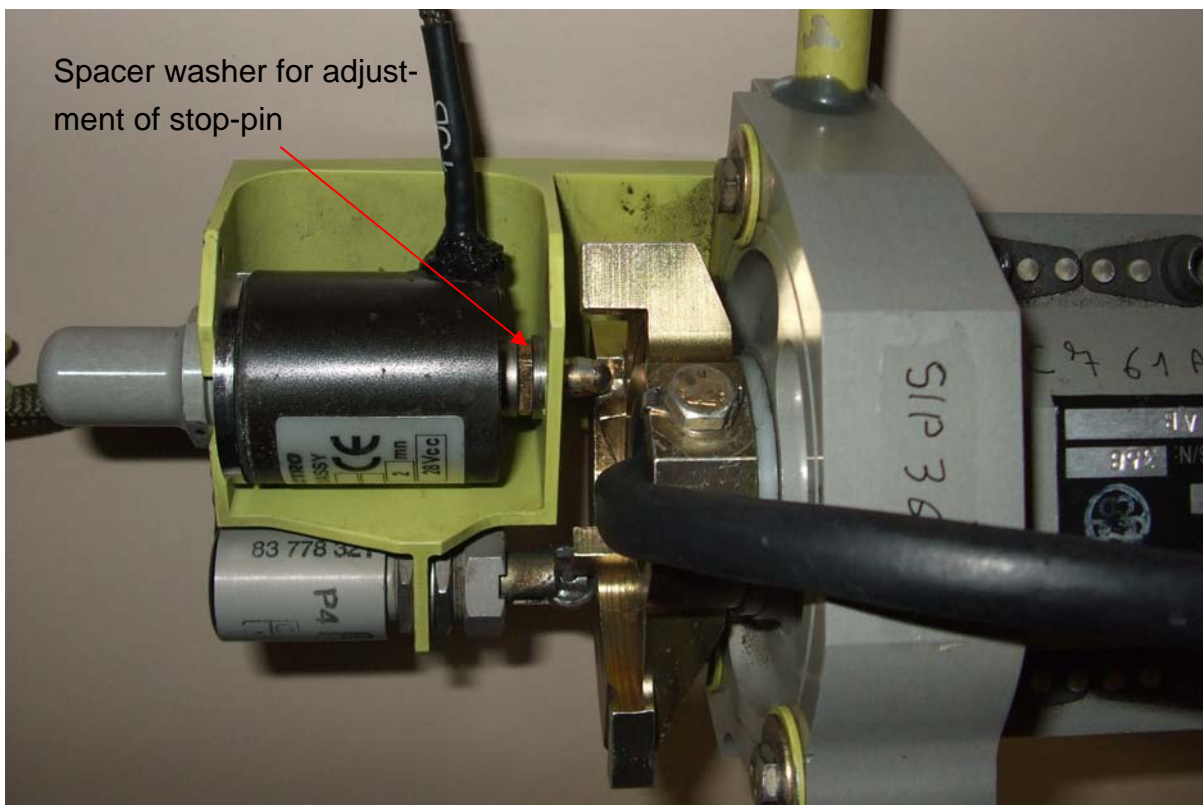
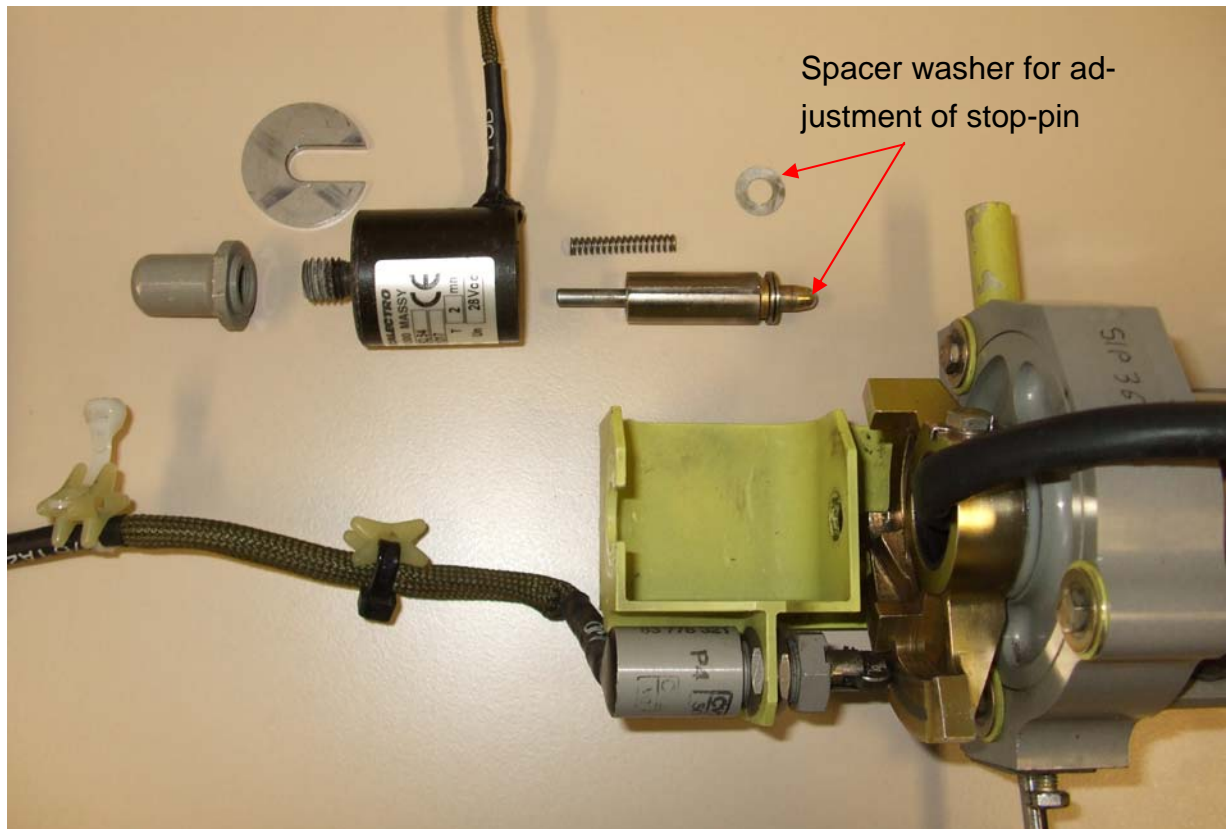
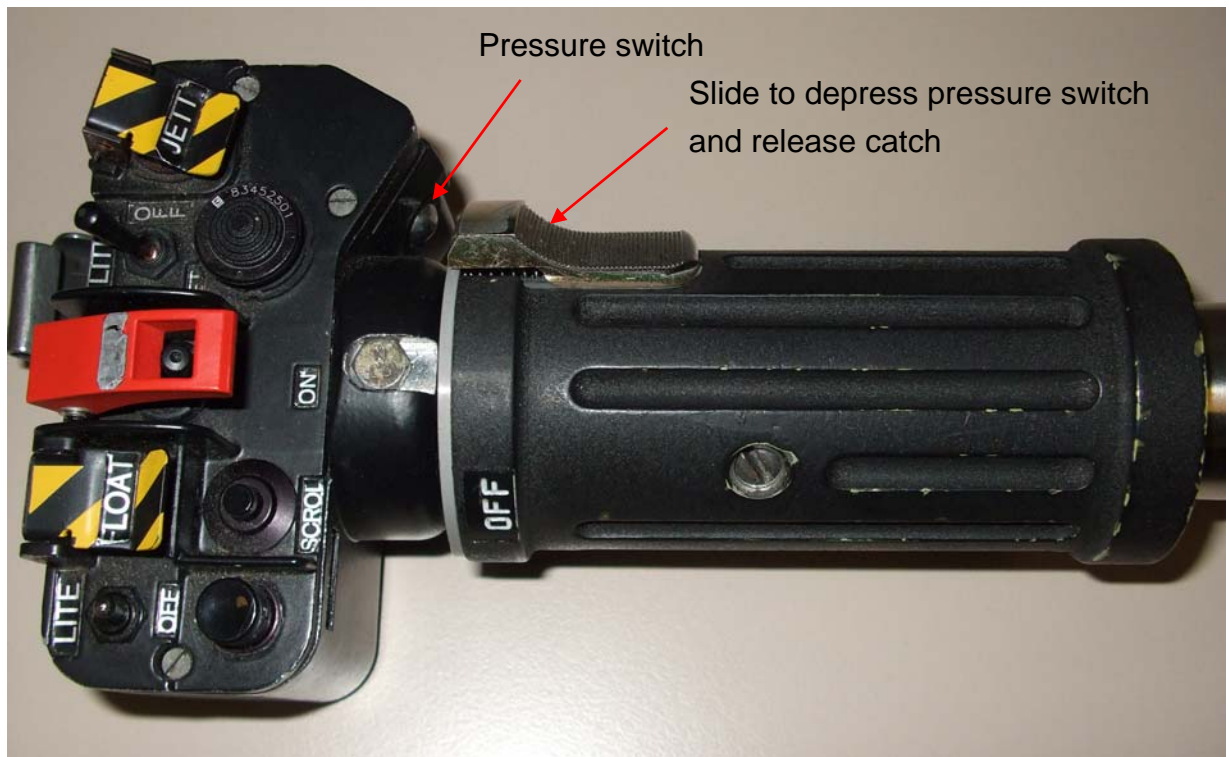
Inspection of the twist grip power control on the pitch determined that it was possible to rotate it from 'FLIGHT' to 'IDLE' using normal strength, but without releasing the electric catch, the twist grip could be moved by force from the 'IDLE' position to 'OFF'. Eurocopter France conducted tests to determine the strength needed and the results showed that it was 10-times higher than to rotate the twist grip from 'FLIGHT' to 'IDLE'.

On the helicopter in question, contrary to the manufacturer's instructions, when not in receipt of electric current it was possible to turn the power twist grip from 'FLIGHT' to 'IDLE' and 'OFF' without releasing the catch. The investigation could not discover any technical reason. The stop-pin mechanism and setting were correct. Several comparable pitch levers showed no differences and operated in accordance with the manufacturer's requirements.

Detailed views of the twist grip electric catch

Due to this accident Eurocopter France intends to revise the specifications for the stop-pin adjustment. The change will be introduced as a Service Bulletin. Eurocopter France also intends to change the training procedure in the Flight Manual.

Until a Service Bulletin and a Flight Manual change can be published, Eurocopter France issued the "Information Notice" No.2261-I-76 for all operators of the helicopter EC 120B. It describes the possible problem with the twist grip and the visual and acoustic indications for pilots in case of an engine failure (see appendix).
