Investigation Report

Type of Occurrence:	Accident
Date:	8 May 2009
Location:	Frankfurt/Main
Aircraft:	Airplane
Manufacturer / Model:	The Boeing Company / B 747-400 F
Injuries to Persons:	None
Damage:	Aircraft severely damaged
Other Damage:	None
State File Number:	BFU AX001-09

During the approach to Frankfurt/Main parts of the left wing inboard fore flap separated and damaged the pressurised fuselage.

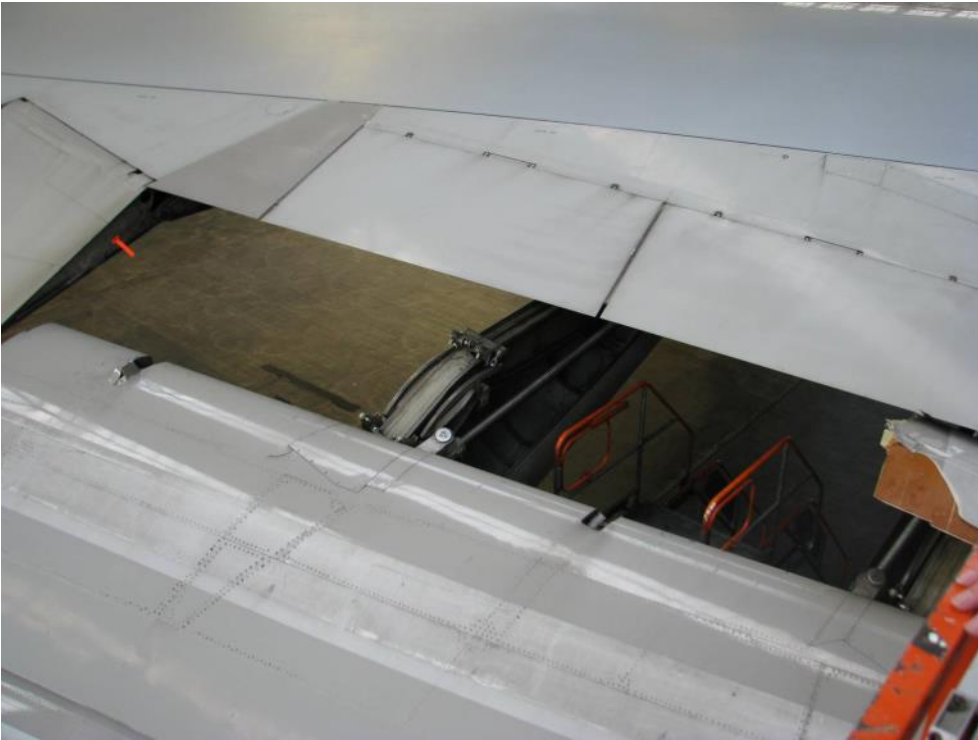
On the airplane part of the left wing inboard fore flap (approximately 4.5 x 1 m) was missing. The fracture had occurred approximately half a metre left of the inner flap attach fitting (Appendices Image 1). The remaining flap part was twisted around the attach fitting point and jammed between fitting and fuselage (Image 2). Two fore-flap tracks between the front and middle flap had fractured or been torn out.

Image 1: Area of the left wing, where the flap part is missing.

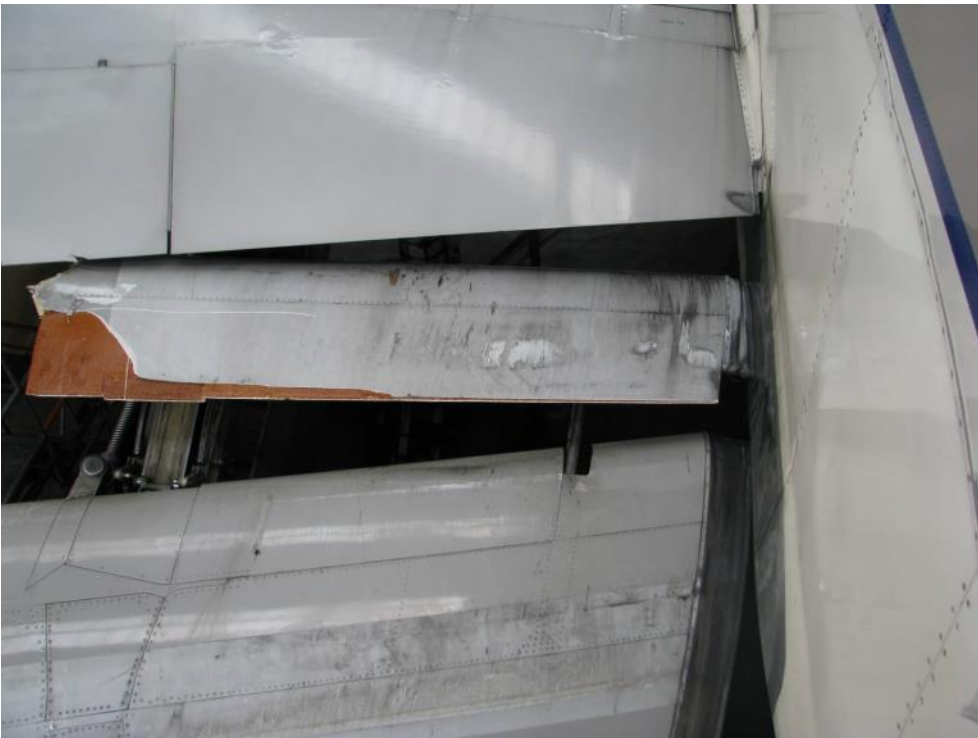
Image 2: Jammed part of the remaining flap

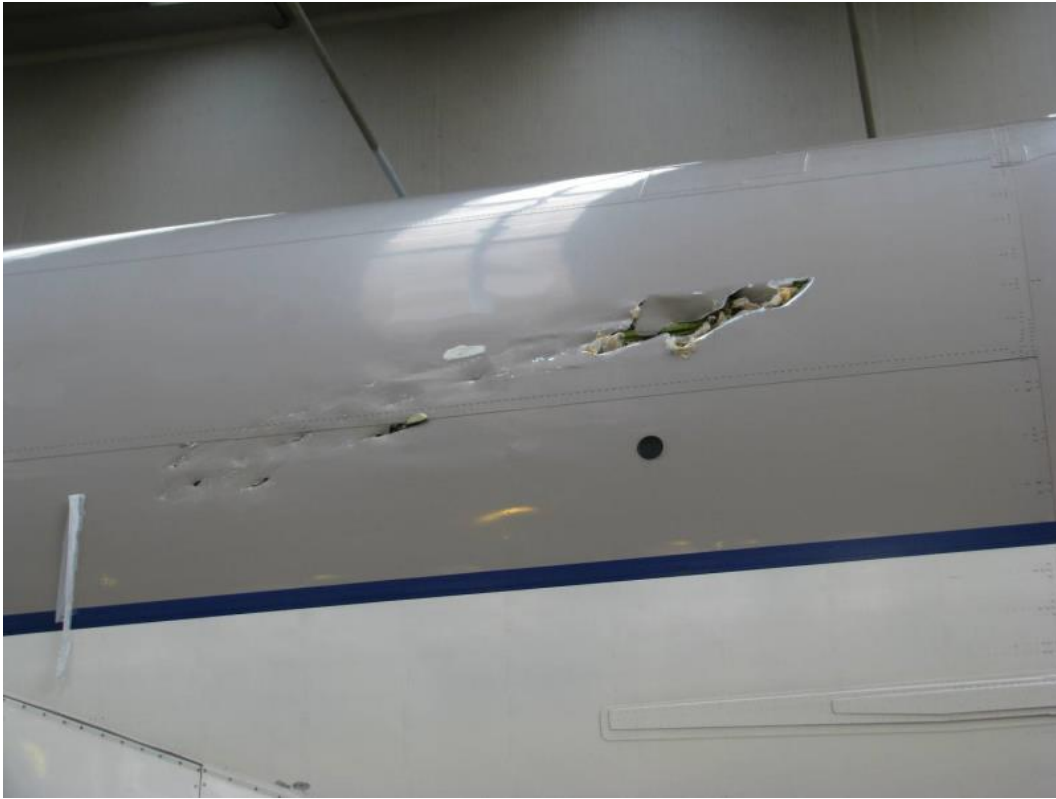
The airplane's left outer fuselage skin was dented and punctured on a length of 3.5 m in the area between the fairing run-out and the aft cargo door. The frames and ribs in this area showed severe damages; the skin of the pressurised fuselage was punctured (Images 3 and 4).

Image 3: Damage on the fuselage

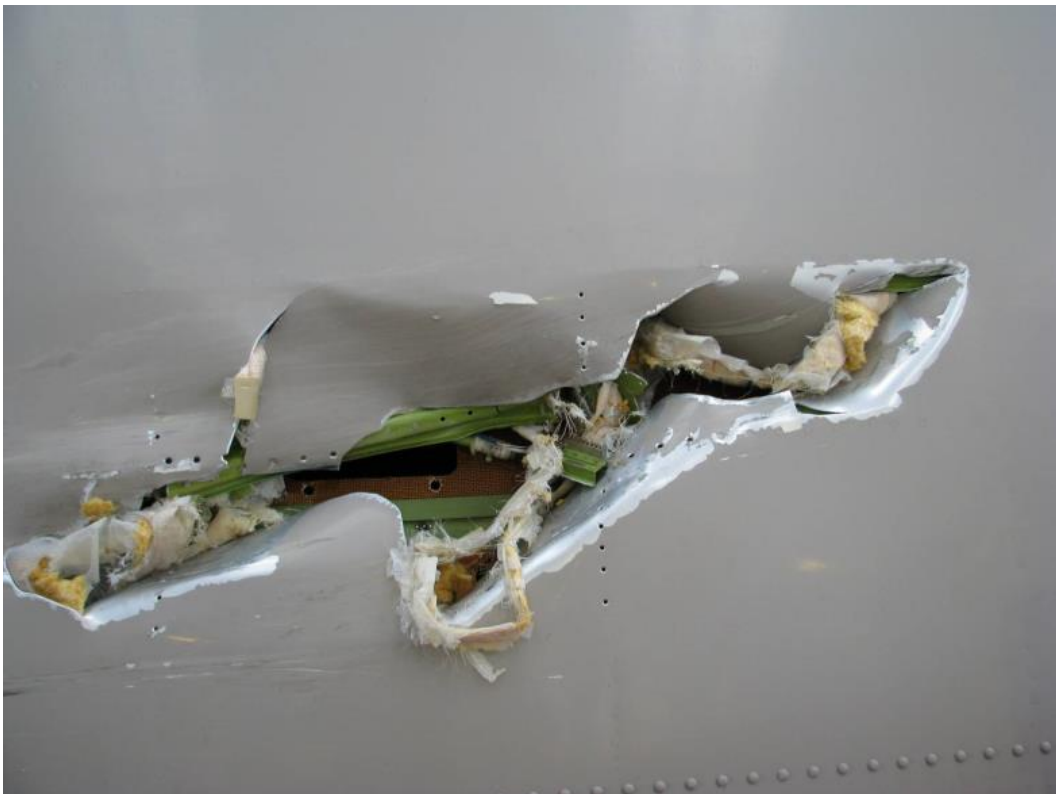
Image 4: Damage on the fuselage

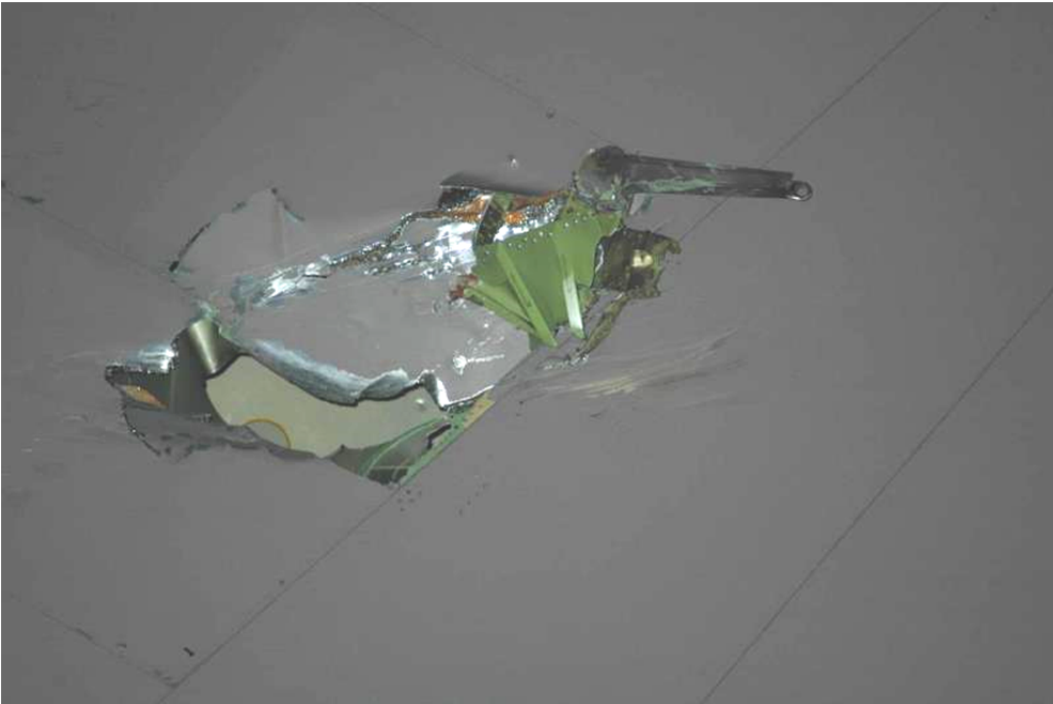
Another puncture site was found on the left side of the vertical tail (Image 5).

Image 5: Damage on the vertical tail

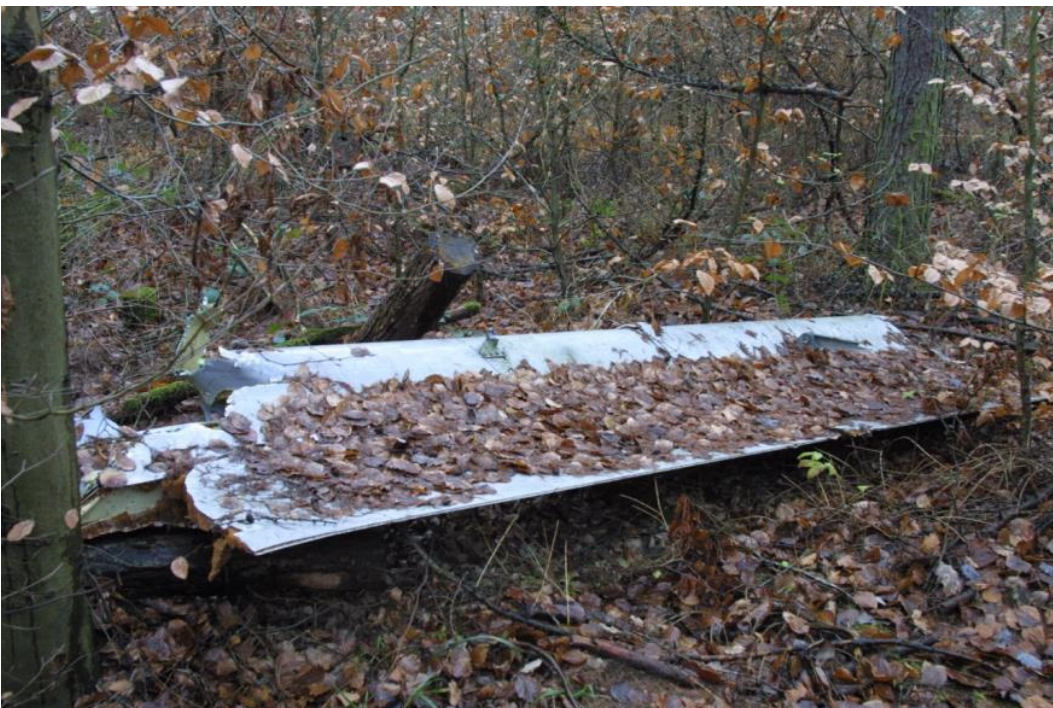
On 12 December 2009 the police helicopter squadron Hessen found the fractured flap part in the Frankfurt Stadtwald (forest) east of the approach area of runway 25L (Image 6). The flap part was transported to the BFU for further investigation. The fractured outer attach fitting of the left wing inboard fore flap was removed (Images 7 to 9). The attach fitting had the Part Number "Assy 65B39025-2" (Image 10).

Image 6: Located flap part

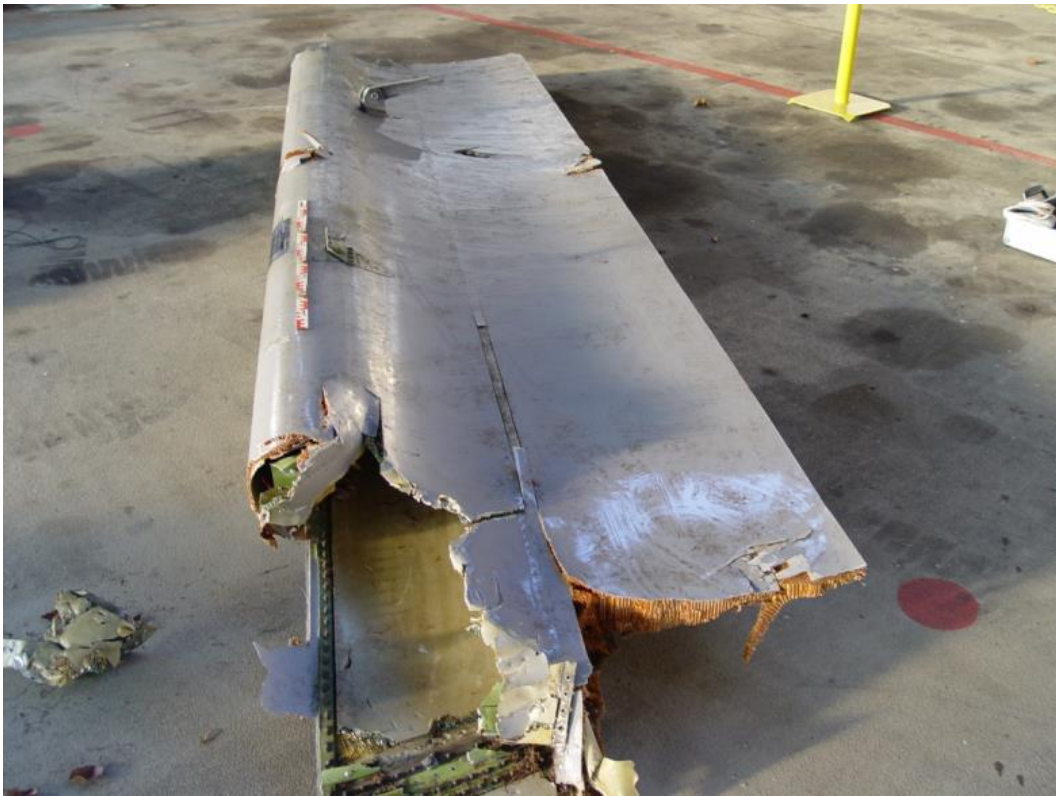
Image 7: Located flap part

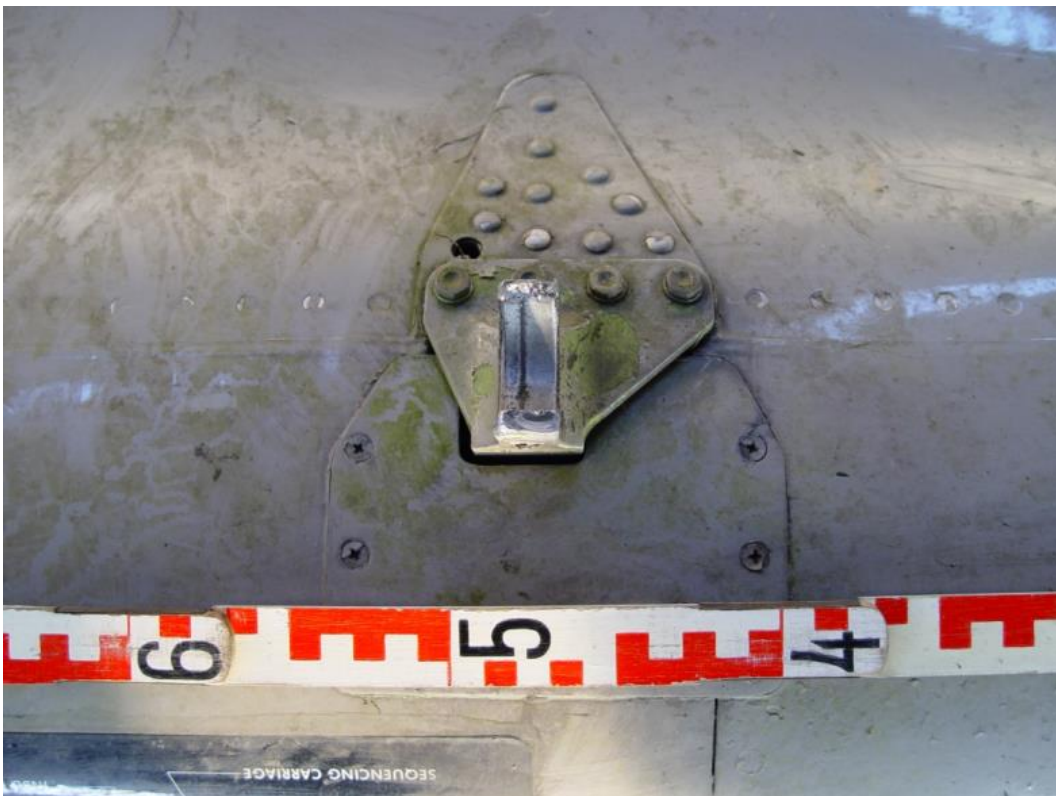
The flap attach fitting was destroyed by an extended fatigue fracture. It is highly likely that it started with a corrosion depression.

Image 8: Fractured flap attach fitting (bearing seat)

The aircraft manufacturer, as type certificate holder of aircraft type Boeing B 747-400, should enhance the corrosion resistance of the flap attach fitting, especially in the bearing seat area.

The aircraft operator should check the flap attach fittings used in their Boeing B 747-400 aircraft pursuant to the manufacturer's revised Service Bulletin (SB) 747-27-2366R3 and Service Letter 747-SL-57-085-C and, if appropriate, replace them.

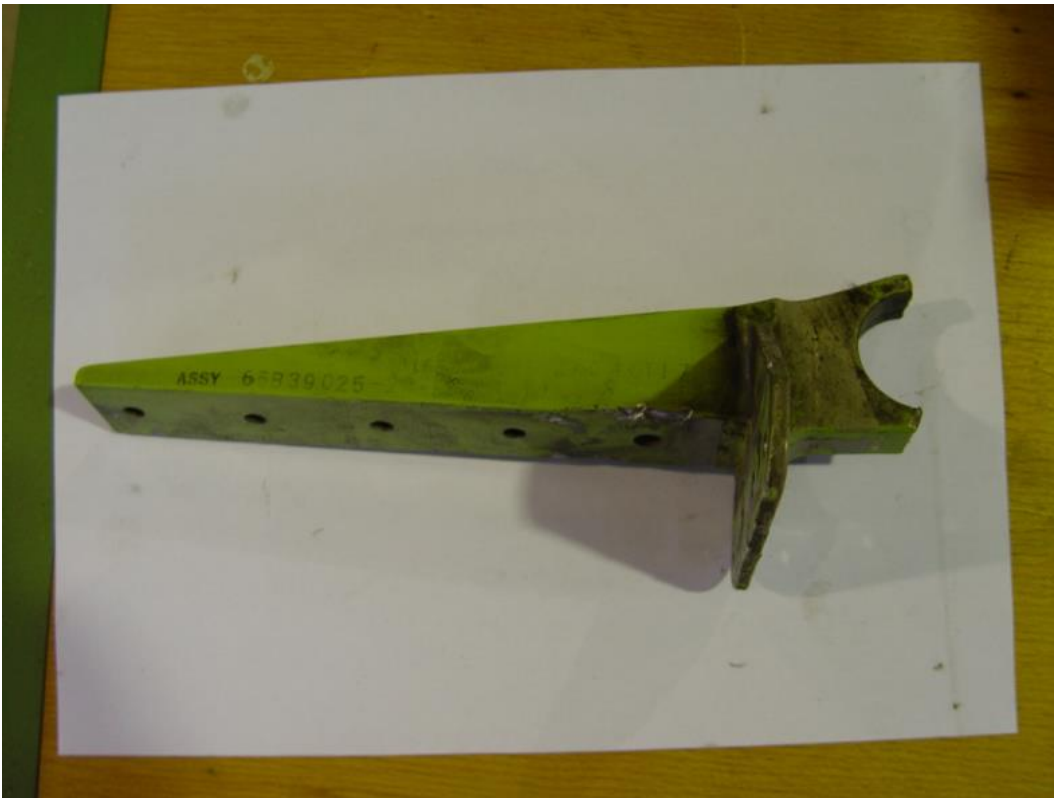
Image 9: Removed flap attach fitting

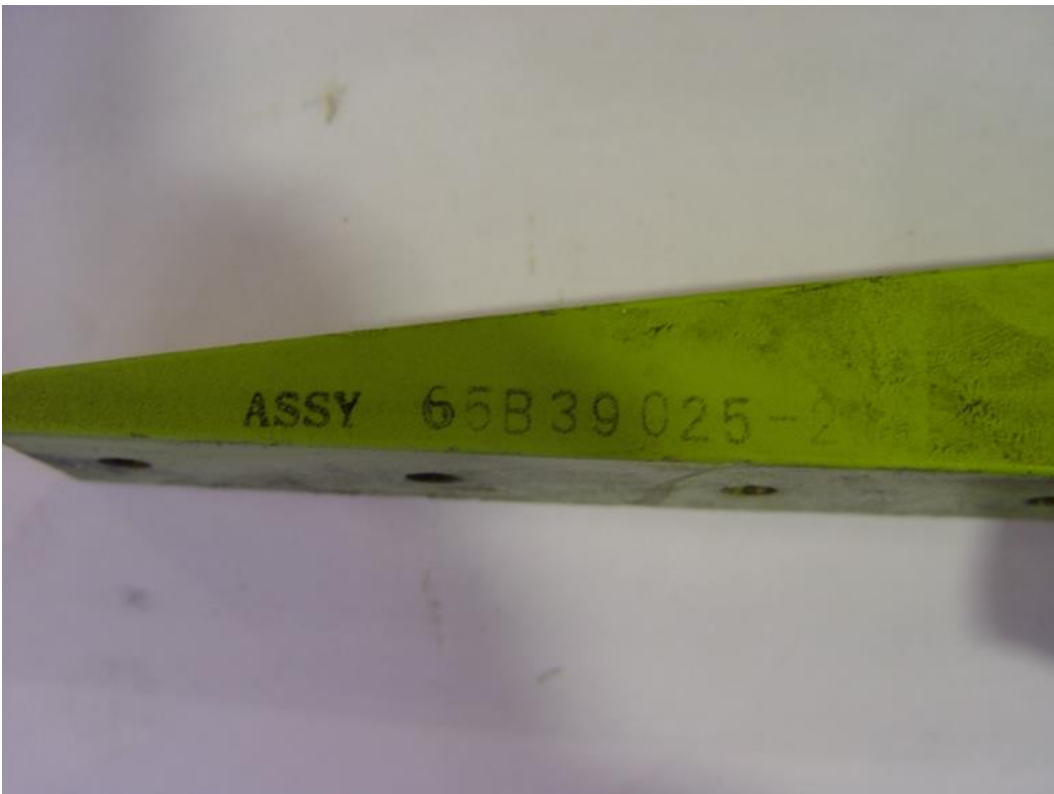
According to the manufacturer the flap attach fittings with the Part Number 65B39025-2 corresponded with the original design but are no longer in use. The attach fittings currently in use have the Part Number 65B39025-31/20.

Image 10: Part number of the fractured flap attach fitting

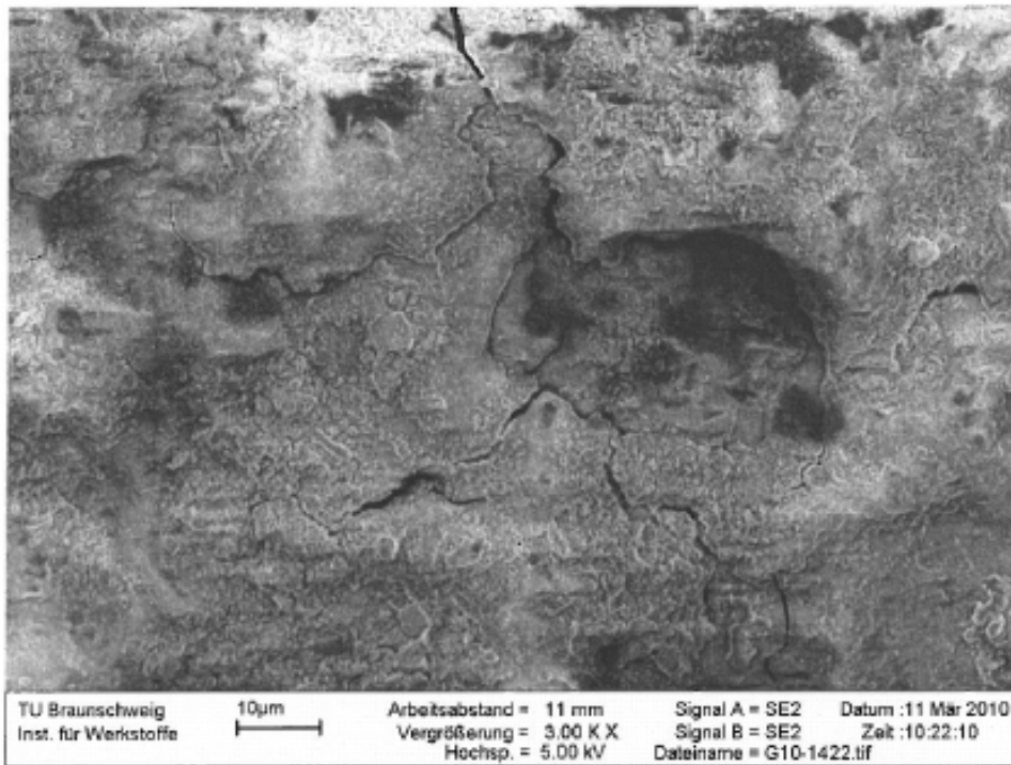
The scanning electron microscope (REM) Jeol JSM-6480 confirmed the macroscopic result in full. Image 11 in the Appendix shows a plaque of oxidation coating in the starting area of the main crack. In the metallic blank area the linear striations were clearly visible (Images 12 and 13). Image 14 shows the transition to the forced residual fracture. Image 15 depicts the dimples of this microscopic ductile forced fracture area.

Image 11: Aluminium fretting oxidation plaques in the black starting area of the fatigue crack Source: ifw

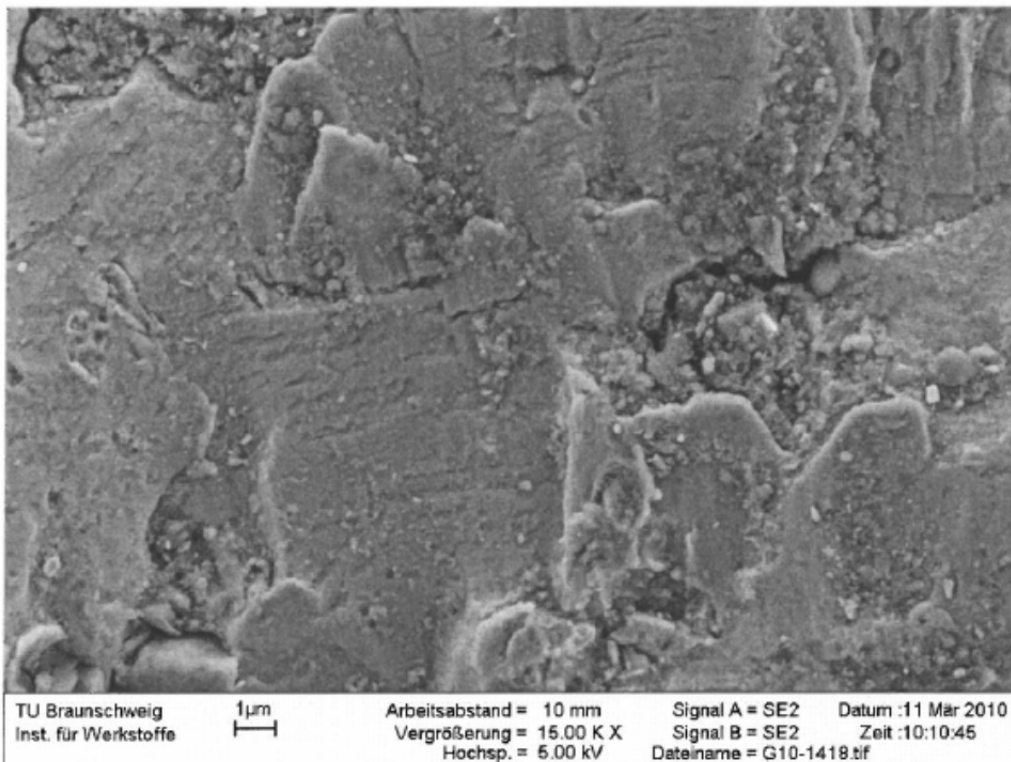
Image 12: Flattened striations in the metallic blank crack section

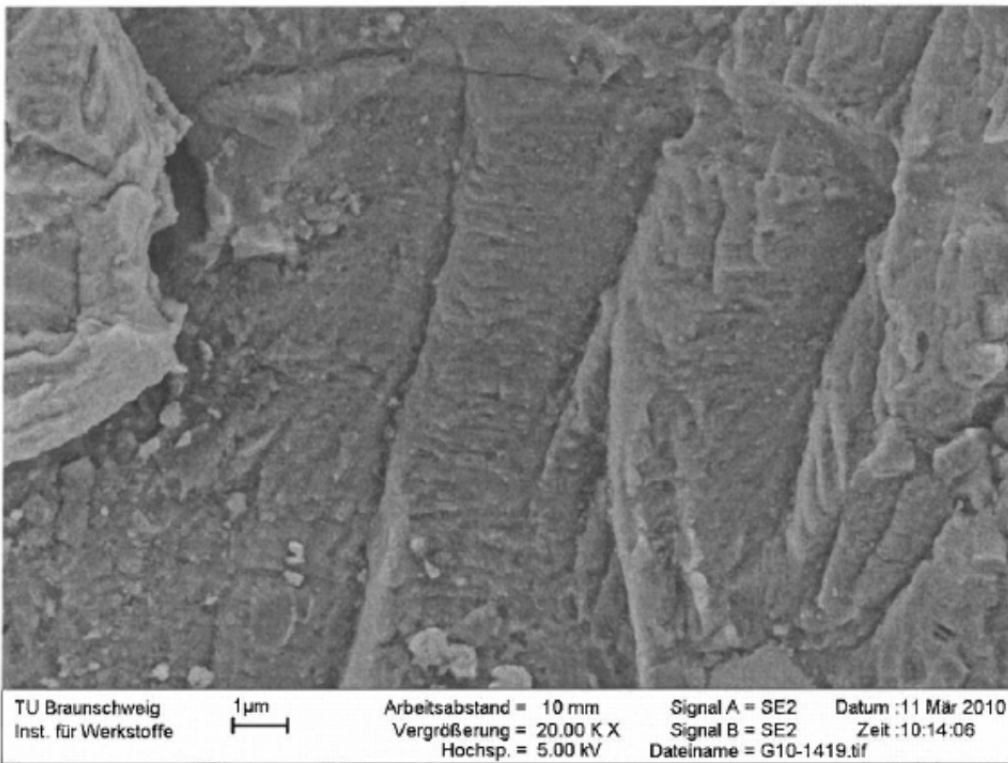
Image 13: Flattened striations in the metallic blank crack section

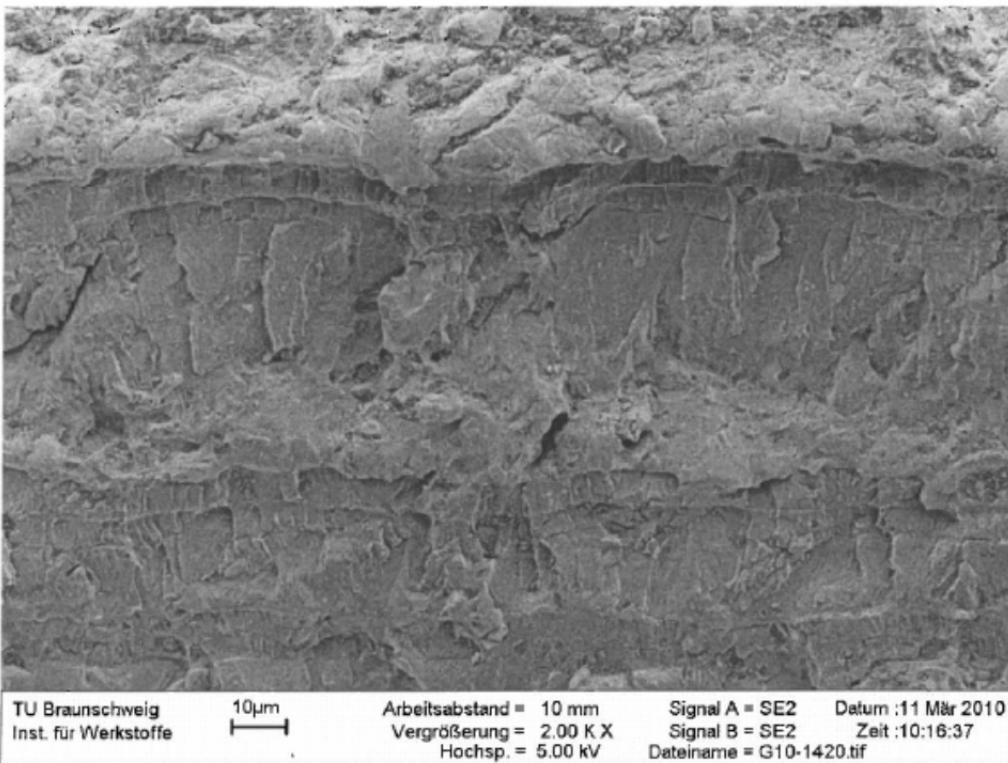
Image 14: Transition area between fatigue fracture and residual fracture

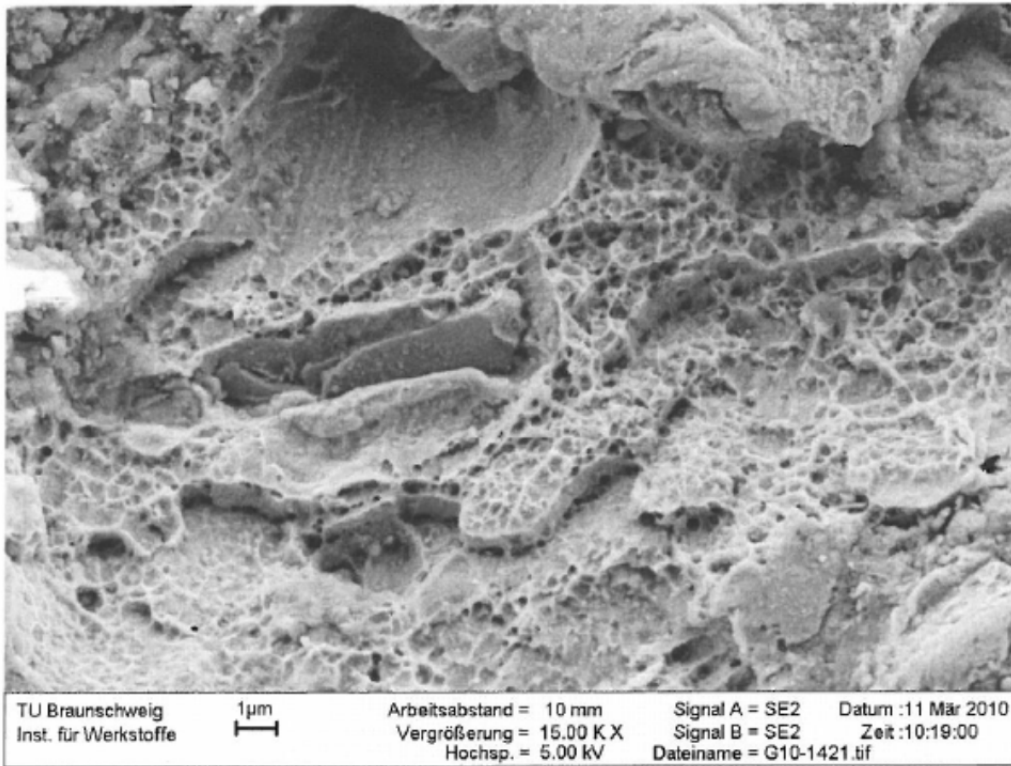
Image 15: Characteristic dimple structure in the area of the forced rupture

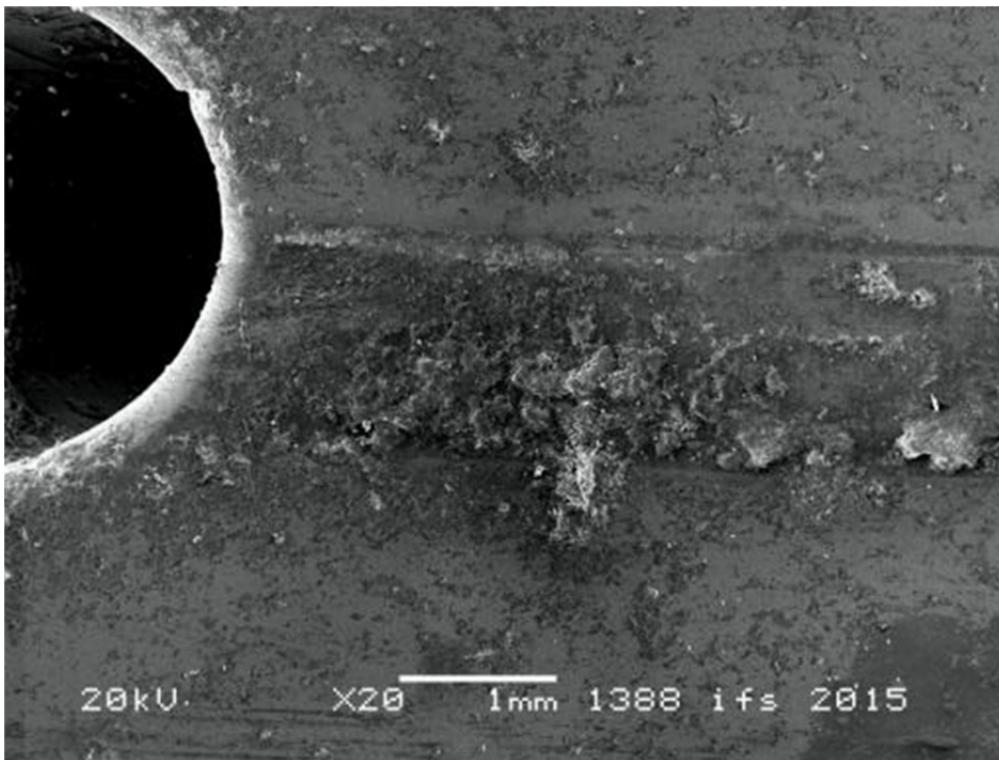
Due to the experiences with another occurrence, where the flap attach fitting of the same aircraft type had fractured at the same place, the inner surface, where the crack originated, was analysed again. The examination with the REM revealed that the inside of the bearing seat showed distinct corrosion areas in form of holes and depressions. These were located mostly in the "track" and often in the transition region on the edge to the "track". "Track" means the area where the bronze bearing located in the bearing seat had its lubrication groove (Images 16 and 17). This "track area" showed almost no corrosion.

The laboratory results showed that the surface condition of the bearing seat, in which the lubrication groove of the bronze bearing was located, was different from the remaining area. The "track area" was slightly elevated and clearly less sensitive to corrosion. The major part of the surface showed depression and hole corrosion. Such an area provided the kerf where a fatigue crack could start.

Image 16: Overview, left lubrication supply, middle hole corrosion, above "track area"

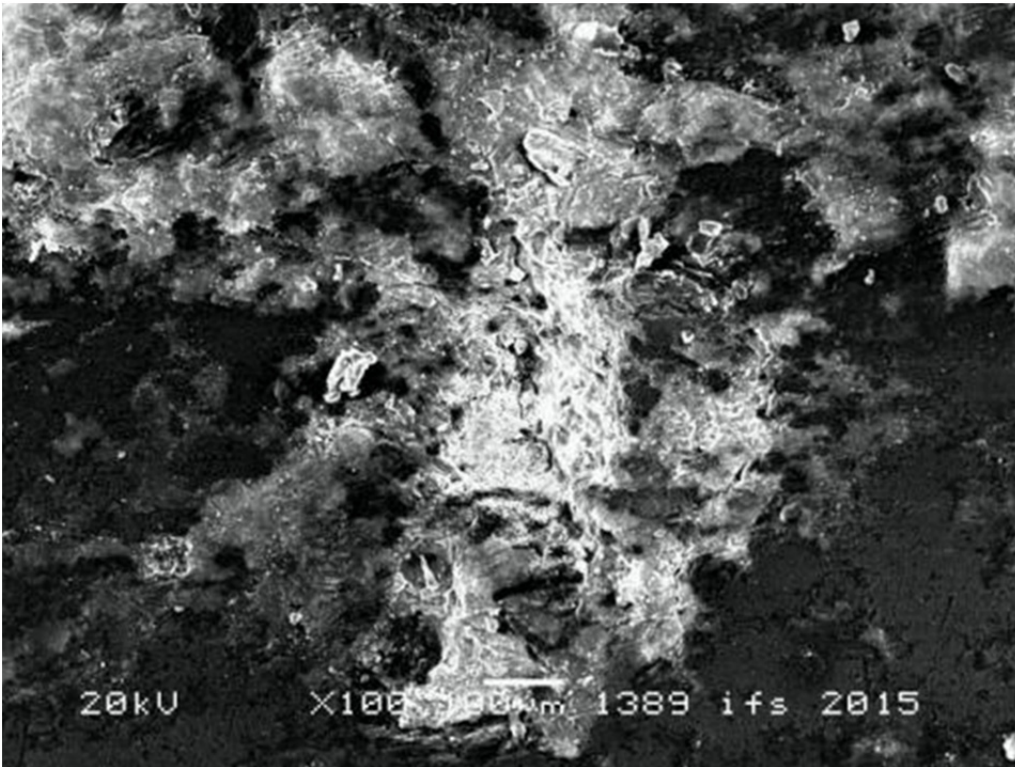
Image 17: Detail enlargement hole corrosion (hole filled with corrosion products)

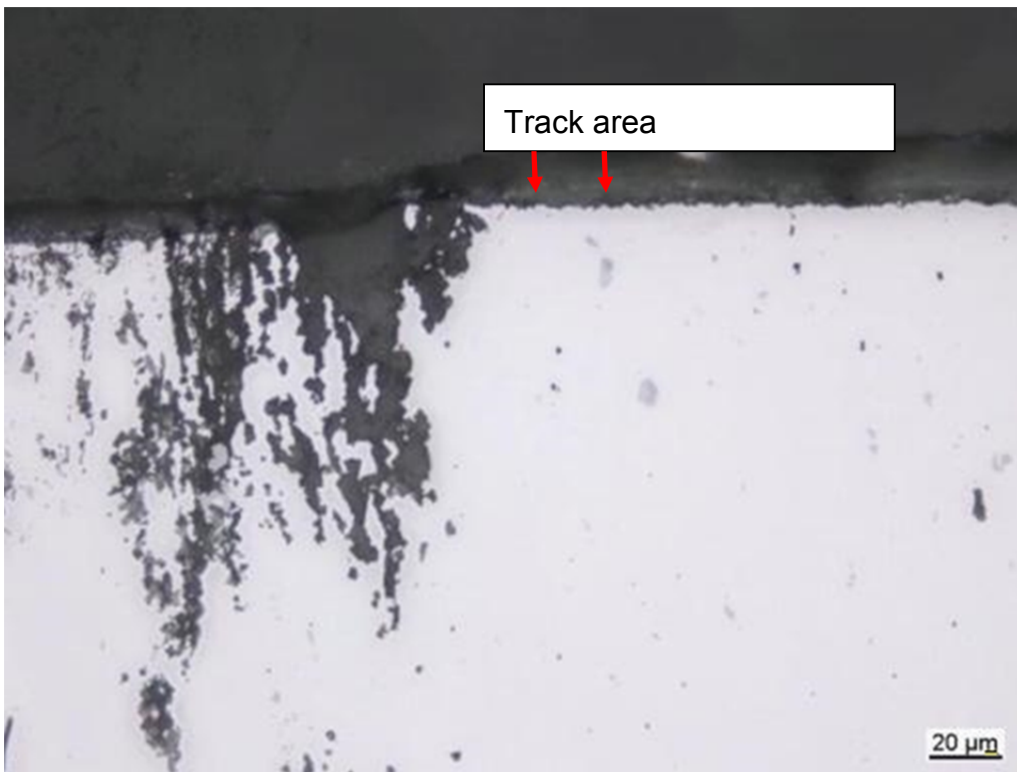
The metallographic cross specimen showed heavy corrosion on the entire surface of the bearing seat. The base metal seemed to dissolve. The surfaces left and right of the “track” were much more affected than the “track area” itself. Heavy corrosion could be seen in the transition region and at the edge to the “track”. This result correlated with the REM examination. The difference in wall thickness between the “track area” and the rest of the inner surface had attracted attention. The inner surface’s wall was thinner than the one of the “track area” (Image 18). The reason was different mechanical abrasion in these areas.

Image 18: Cross specimen with "track area" left to the strong corrosion
