# Investigation Report

Type of Occurrence:	Serious incident
Date:	28 August 2009
Location:	Münster-Osnabrück Airport
Aircraft:	Cargo airplane
Manufacturer / Model:	Antonov / AN-12 BK
Injuries to Persons:	None
Damage:	Minor damage to aircraft
Other Damage:	None
Information Source:	Investigation by BFU
State File Number:	BFU EX007-09

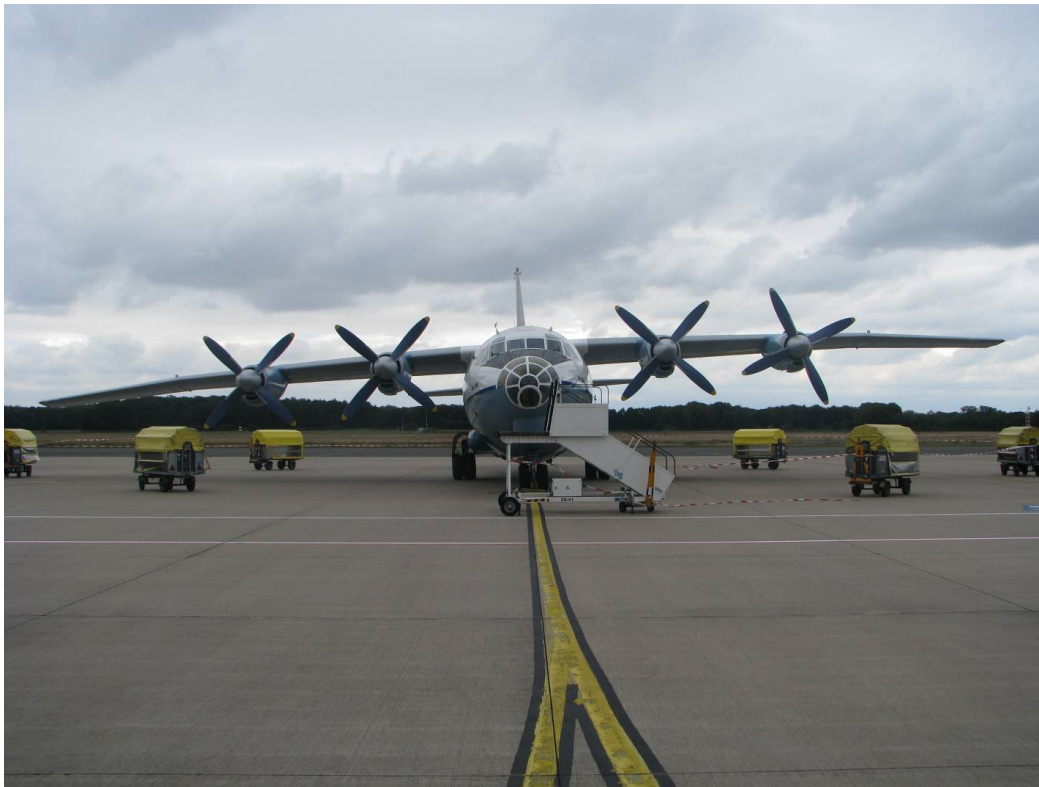
Appendix 1: Aircraft

The aircraft had been parked at the northern edge of Apron East. It tilted to the right (Appendix 1). The right main landing gear had collapsed (Appendix 2); for comparison purposes, the intact left main landing gear is depicted in Appendix 3. The right main landing gear bogie beam was broken in flight direction right behind the pivot pin lug for the landing gear leg and the tow rod was bent (Appendix 4). The right landing gear had descended through the torque link onto the tyres. Parts of the broken landing gear bogie beam (Appendix 5) were taken to the BFU in Braunschweig for further investigation.

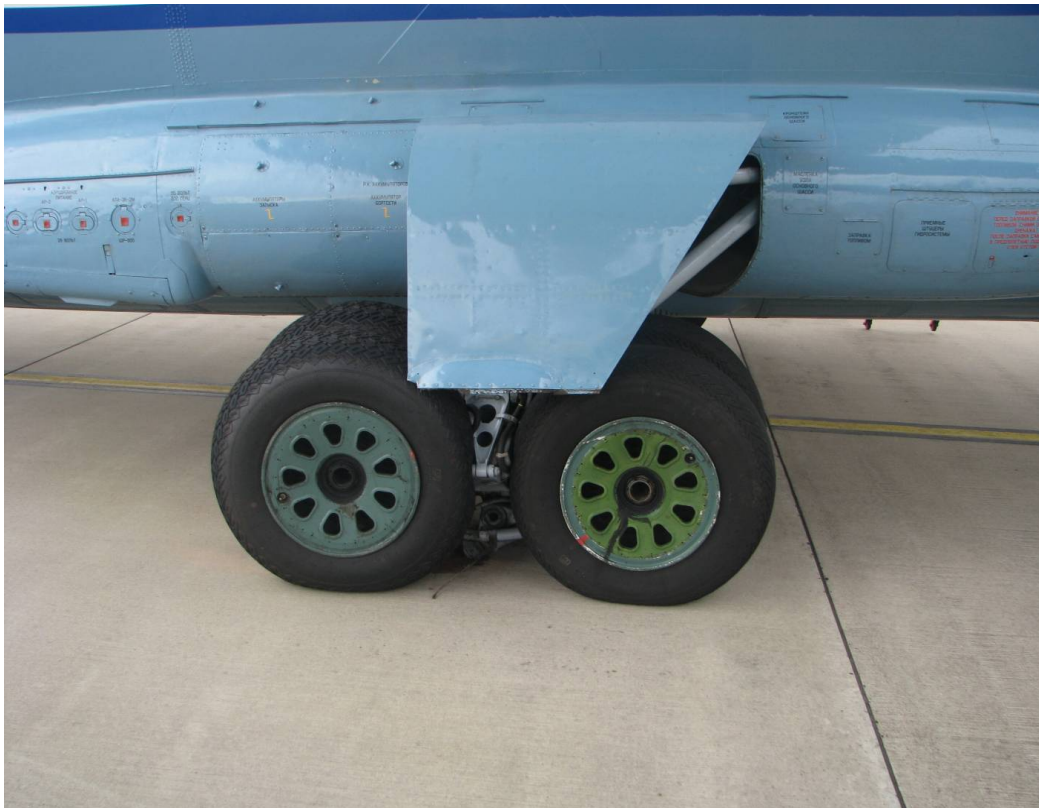
Appendix 2: Damaged right main landing gear

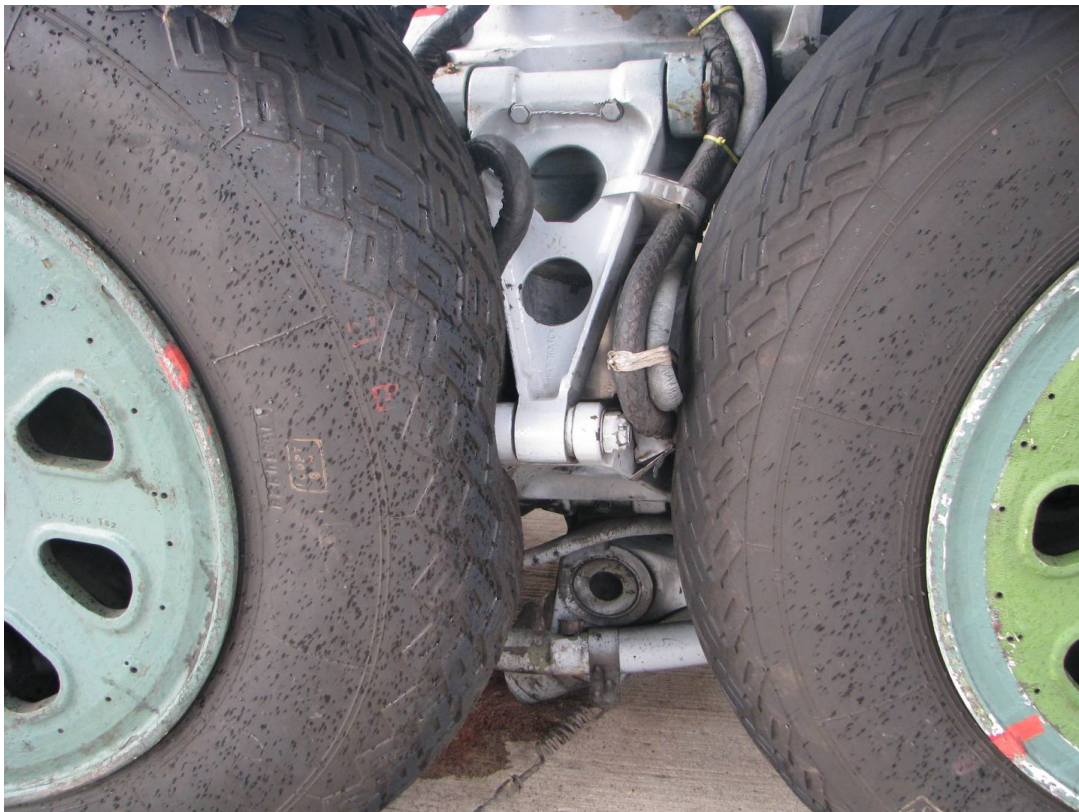
Appendix 4: Broken landing gear bogie beam and bent tow rod

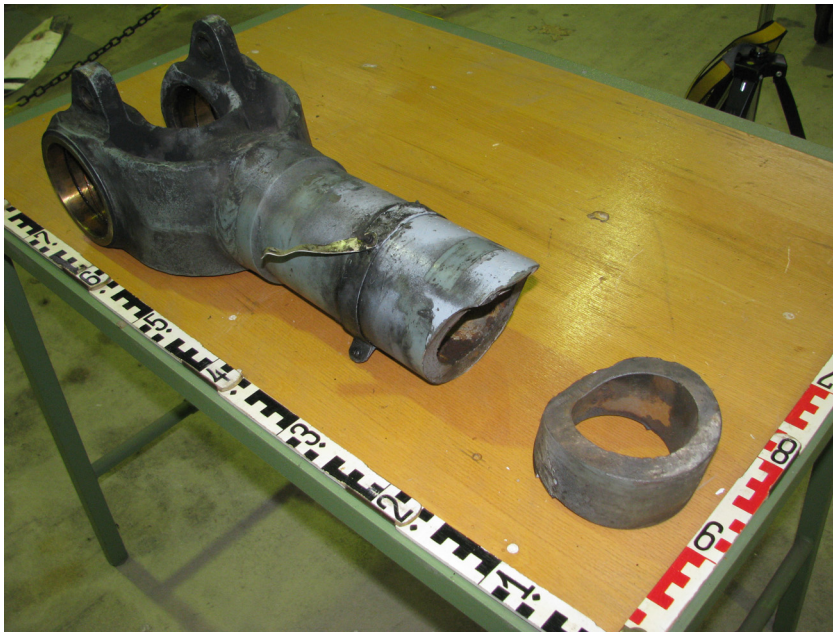
Appendix 5: Parts of the fractured landing gear bogie beam

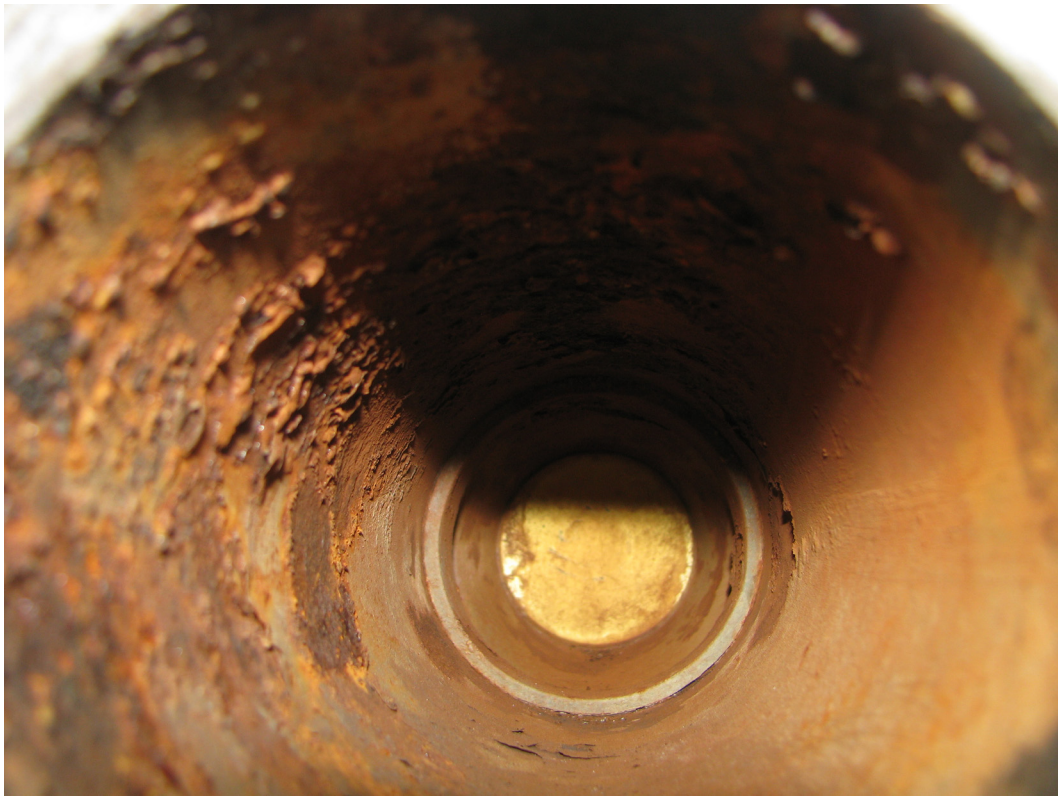
The entire inside wall of the bogie beam was heavily corroded (Appendix 7); especially in the six o'clock position (Appendix 8). The individual fracture pieces were consequently significantly damaged by the collapse of the aircraft and covered by oil absorbents. However, at the beginning of the fracture an extensive corrosion pit was

The landing gear bogie beam is designed so that all support pipes are mounted to it from the outside. The pipe itself is sealed off from outside influences by caps. However, moisture or liquid found its way inside the support pipe. The Chlorine peaks in the energy dispersive allocation chart indicate splash water possibly mixed with de-icing salt. Significant corrosion protection could not be determined on the

inside wall of the pipe. This also confirms the significant corrosion on the inside of the pipe especially in the 6 o'clock position.

Appendix 7: Corroded inside wall

The State Aviation Administration of Ukraine should ensure that on all Antonov AN 12 main landing gears the inside of the landing gear bogie beams are inspected for traces of corrosions and the caps on the ends are inspected for liquid tightness.

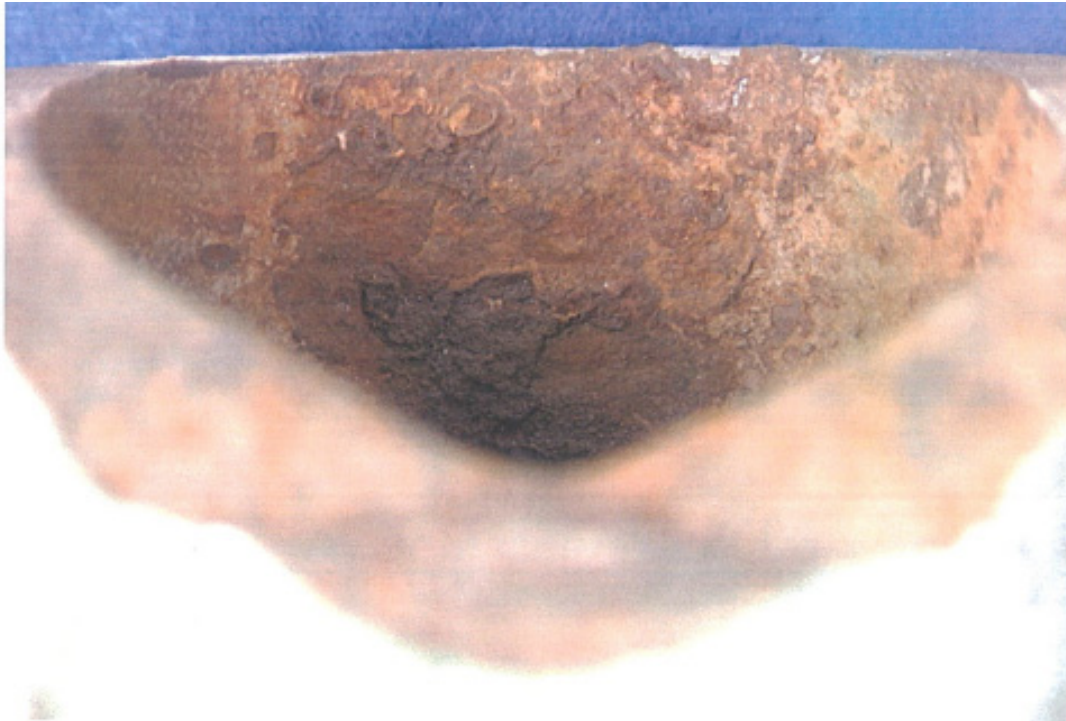
Appendix 8: Corrosion in the 6 o'clock position (top view)

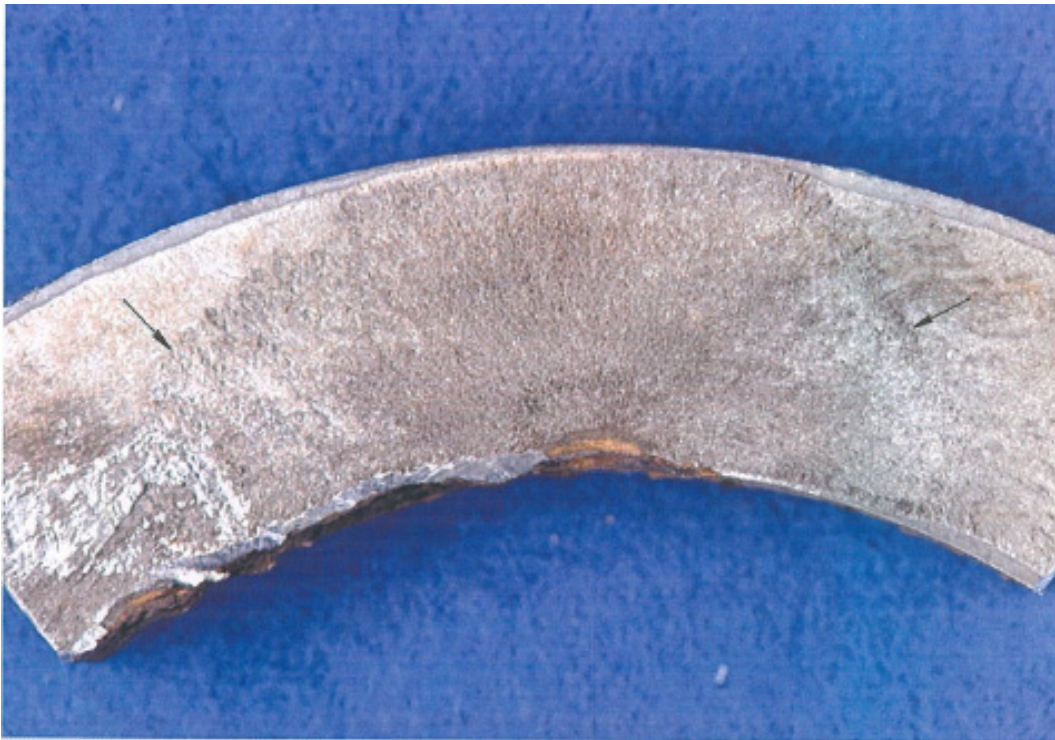
visible. For further investigation the aft part of the landing gear bogie beam was chosen because its fracture surfaces were better preserved. After the fracture surface had been cleaned a thumbnail shaped crack could be clearly distinguished from the final rupture (Appendix 9). The corrosion pit which initiated the crack is depicted in Appendix 10.

Appendix 9: Thumbnail initial crack (arrows)

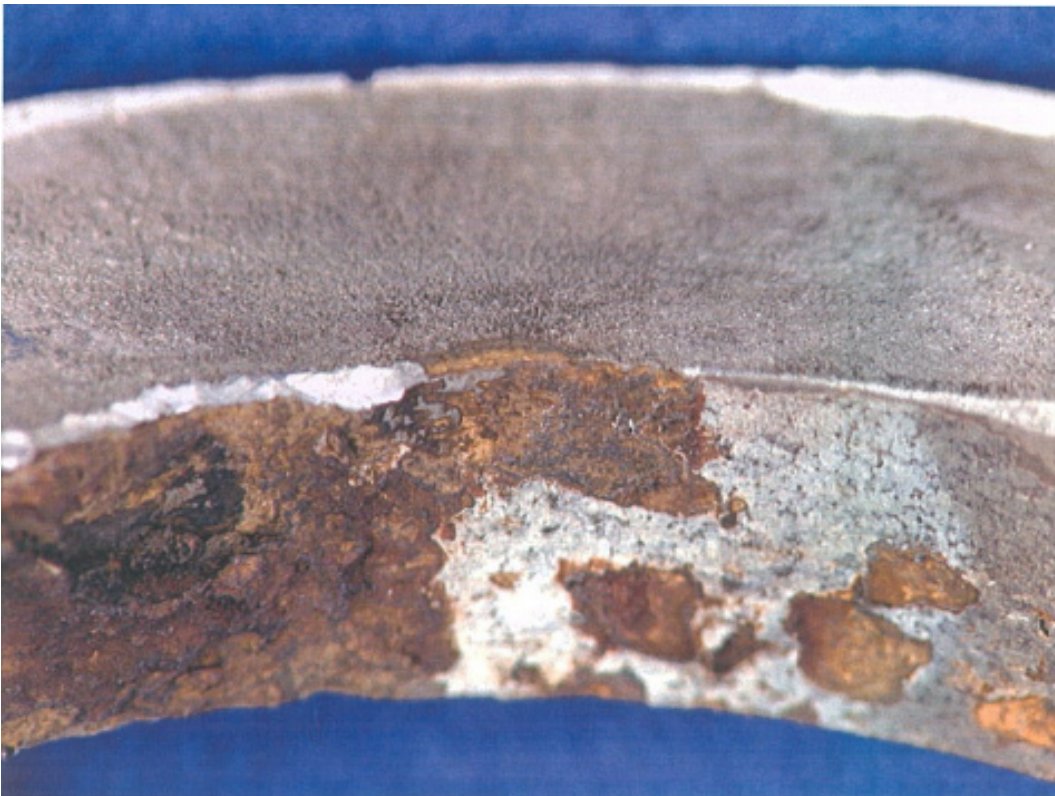
Appendix 10: Corrosion pit (tilted)

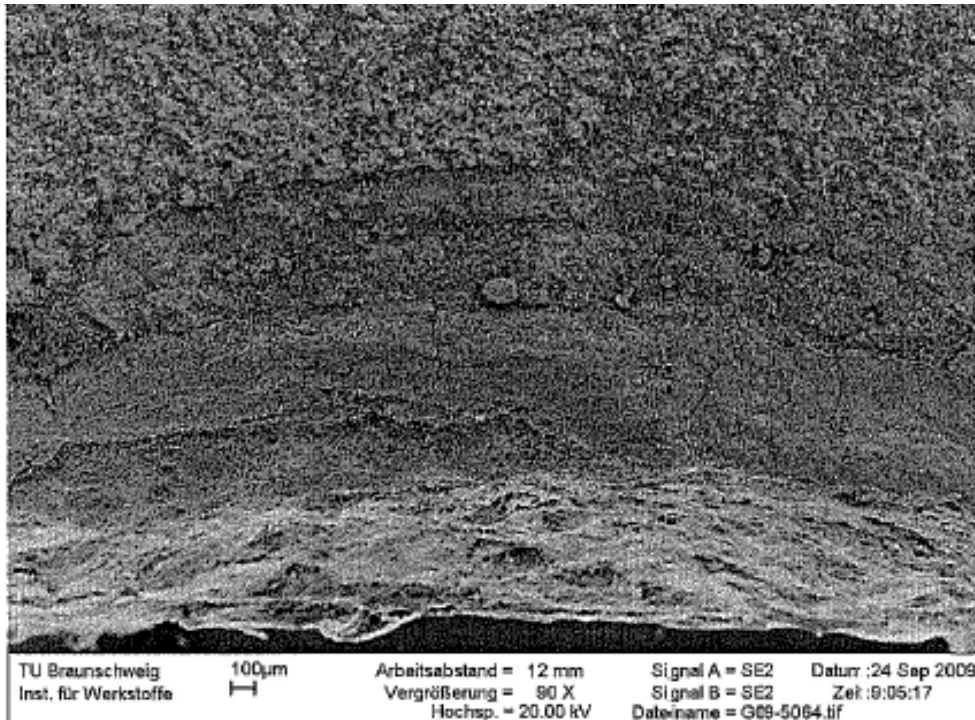
After this analysis the fracture area was sputtered with Gold and looked into the scanning electron microscope once again. It was found that the whole fracture area showed the typical topography of hydrogen induced breakup: Bare grain boundaries with ductile flashes („crow's feet“), wide open cracks between grains, scattered transgranular, strongly fragmented cleavage plains plus sporadic “pores” (seats of dissolved spherical chromium carbide) (Appendices 11 – 13). No indications were found anywhere that vibrations supported crack expansion.

Appendix 11: Corrosion pit filled with corrosion products Scanning electron microscope

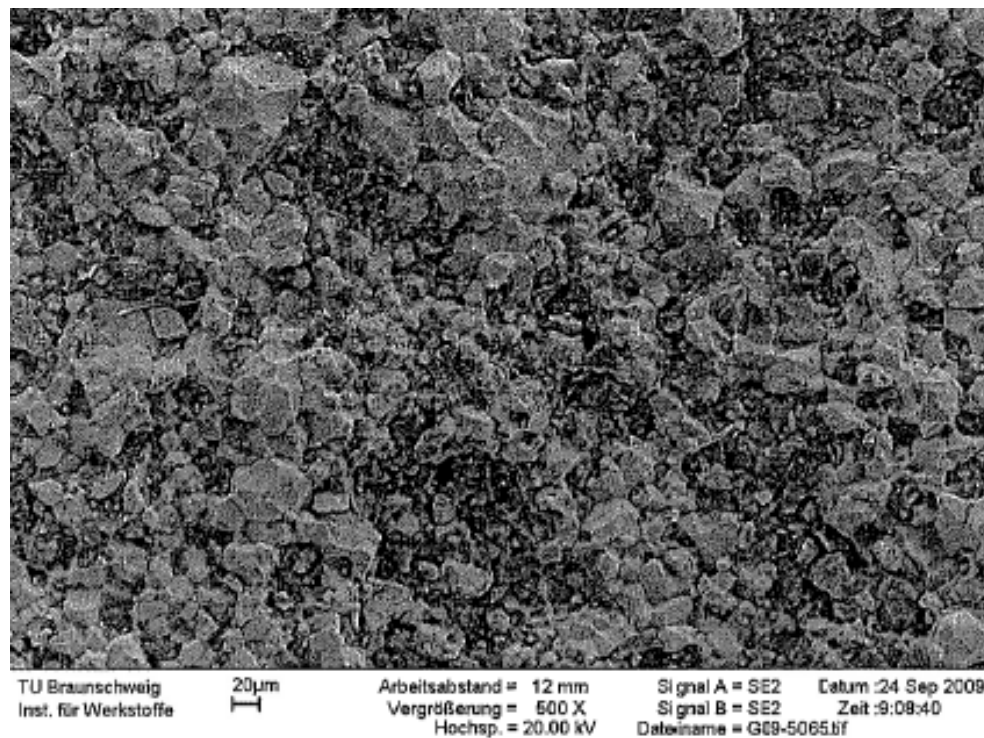
The landing gear bogie beam was, without doubt, destroyed by hydrogen induced stress corrosion cracking. Thereby, hydrogen was atomically produced directly at the "Crime Scene" by partly cathodic reaction and penetrated the steel. The underside of the bogie beam was subject to intense tensile stress, which is required for crack propagation, any time the aircraft was parked. The fracture occurred at the force transmission point; the pivot pin lug for the landing gear leg. The required time span was sufficiently given since the landing gear was mounted to the aircraft (1983). Furthermore, the steel used exceeds the minimum tensile strength required for this kind of damage. Obviously, the initial corrosion crack propagated far enough during the last parking phase on 28 August 2009 that the additional load induced at the start of engine number 3 directly above the right landing gear was sufficient to initiate a critical situation for unstable crack propagation (final rupture). The ratio of crack cross section parts and the final rupture parts is reasonable, given the limited fracture toughness of high-strength steel.

Appendix 12: Intercrystalline separation in the whole area of the fracture

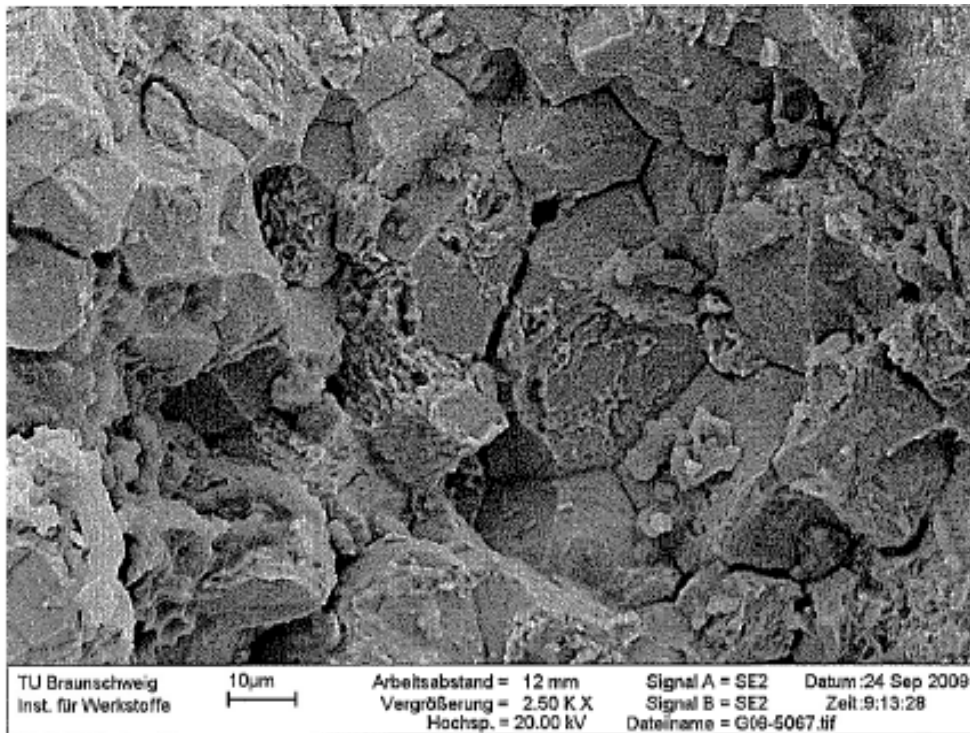
Appendix 13: Topography of the hydrogen induced crack with a higher resolution - scanning electron microscope

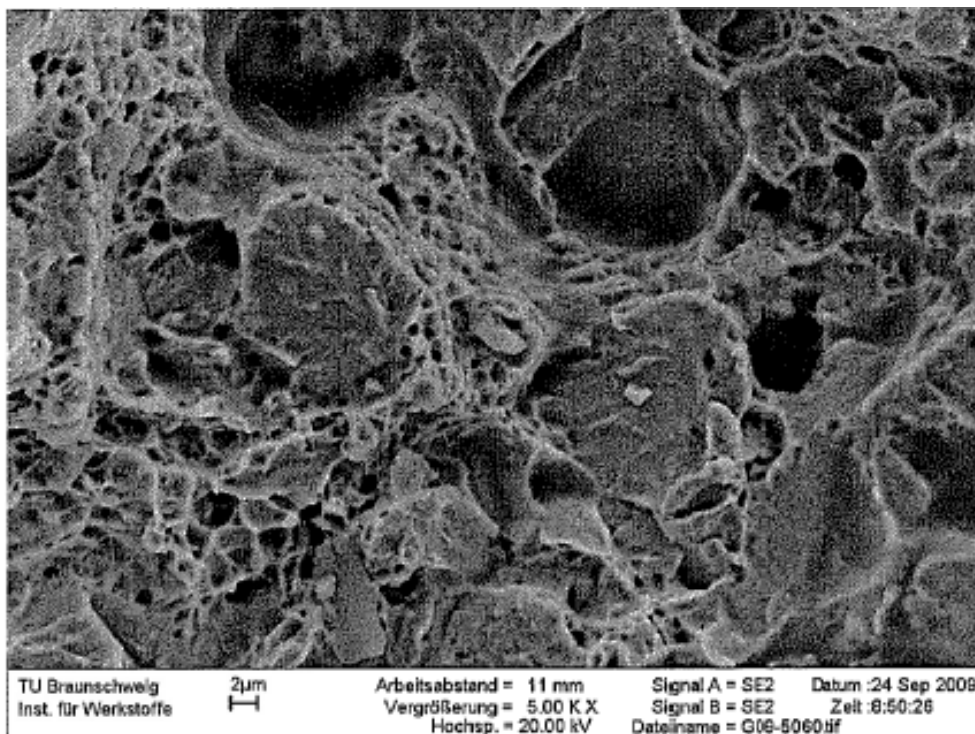
The border between initial crack and final rupture is clearly defined. There the typical mixed fracture of dimple and cleavage planes of high-strength steel was found (Appendix 14). Along a circular, approximately one millimetre wide edge zone, the final rupture has developed 45° ductile shear lips on the inner and outer side. The same applies to the outer edge at the area of the initial corrosion crack (Appendix 15). The crack had not penetrated the outer surface prior to the final rupture.

Appendix 14: Final rupture; dimple and cleavage planes - scanning electron microscope Photos (2): IfW

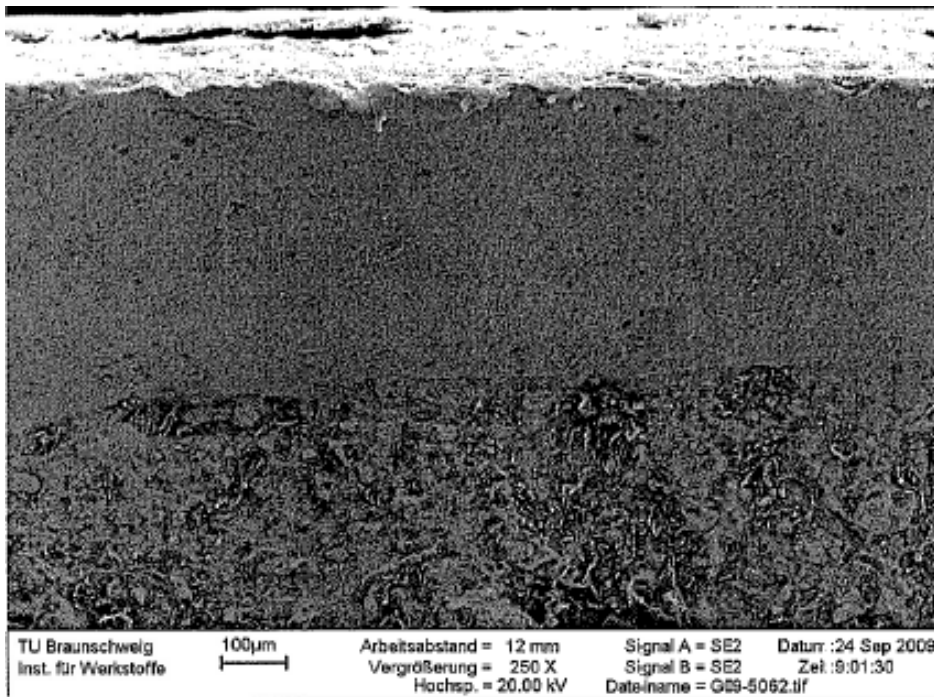
Appendix 15: Ductile shear lips on the outer wall bordering the hydrogen crack (lower part)
