Investigation Report

Type of Occurrence:	Accident
Date:	10 August 2010
Location:	Winzeln-Schramberg
Aircraft:	1. Single-engine Aircraft 2. Sailplane
Manufacturer / Model:	1. Cessna / C F152 2. Glaser / DG 300
Injuries to Persons:	None
Damage:	Both aircraft seriously damaged
Other Damage:	None
Source of Information:	Investigation by BFU
State File Number:	3X117-10

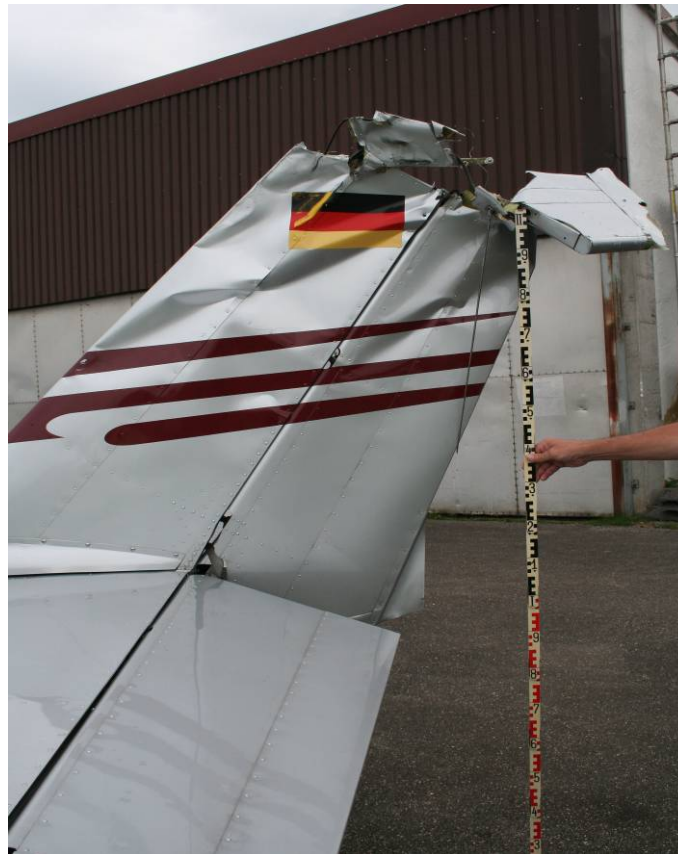
The collision between the two aircraft took place at a height of less than 50 m after they had overflown the threshold to Runway 33. The Cessna F152 fin and rudder were seriously damaged. There was further damage to the wing upper surface and cockpit glazing.

Damage to fin and rudder

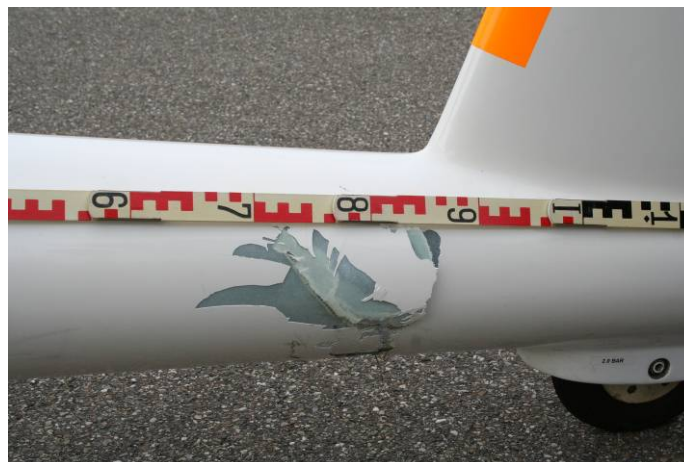
The sailplane rear fuselage was seriously damaged just in front of the tailplane. There was further damage to the fuselage lower surface and in the vicinity of the landing gear.

Damage to rear fuselage, DG 300

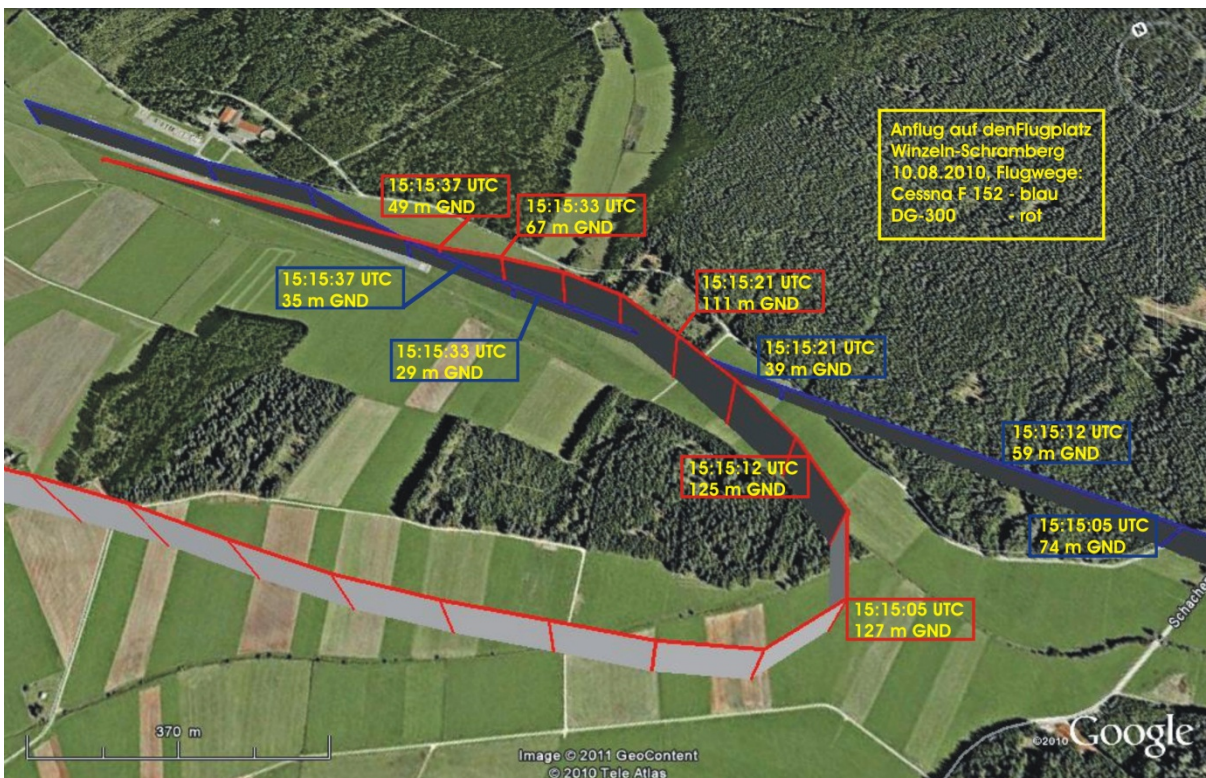
The flight path image shows that this observation would only have been possible prior to 1715:12 hrs.

Reconstruction of the flight paths

Thereafter, the Cessna disappeared from the sailplane pilot's field of view. At 1715:21 hrs, both aircraft neared each other during their approach to land at the airfield with horizontal and vertical separation of 120 m and 70 m respectively, with neither pilot able to see the other aircraft. The sailplane was above and in front of the Cessna, which was behind and below the sailplane pilot's field of view. The Cessna's high wing concealed the pilot's upward view and close proximity to the sailplane.

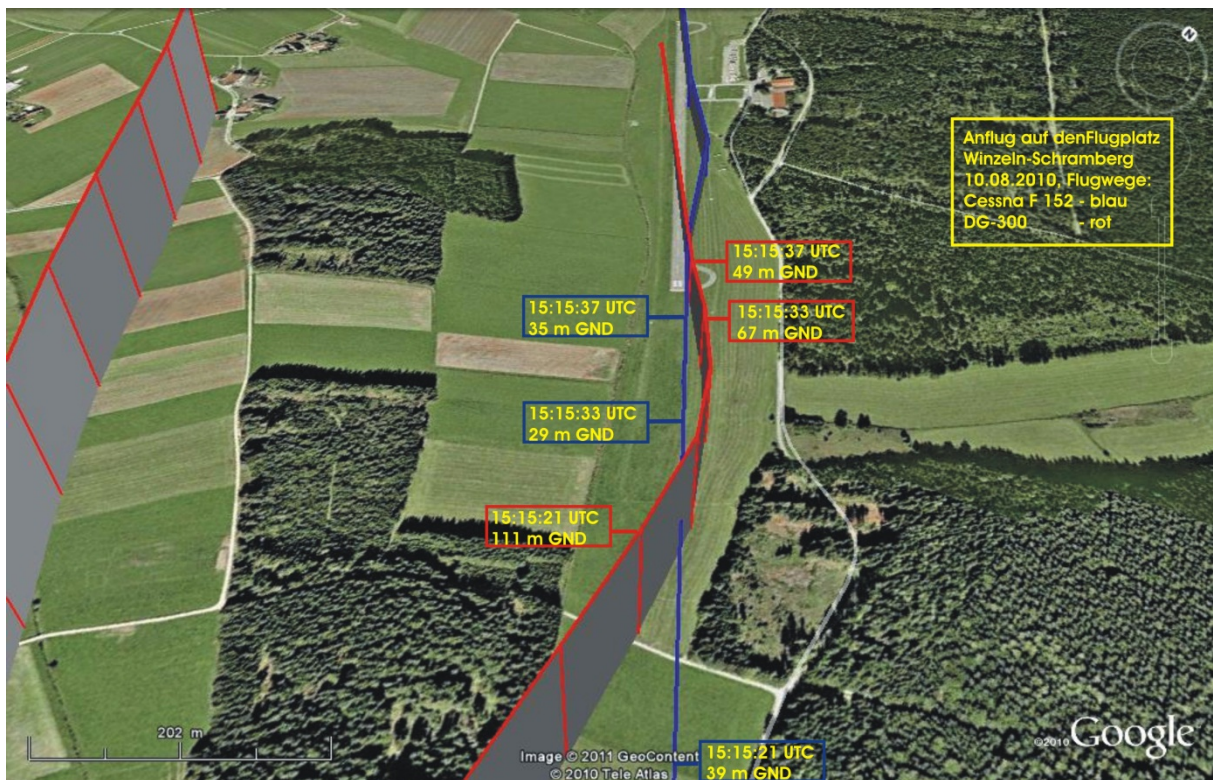
The spatial proximity of each aircraft to the other continued to decrease, and neither pilot could see the other aircraft. The sailplane then corrected heading west towards the more southerly grass runway, again crossing the extended centreline of hard Runway 33.

Reconstruction of the flight paths

Between 1715:33 hrs and 1715:37 hrs the Cessna pilot followed the air inspection officer's instruction to go-around; he terminated the approach to land and according to his own statement tried to maintain height. However, given the Cessna's higher approach speed it caught up with the sailplane from behind without the pilot realising it. Shortly after crossing the threshold to hard Runway 33 and at a height of about 40 m above ground, the two aircraft collided at about 1715:38 hrs without visual contact with each other.
