# Investigation Report

| Date: | 6 September 2010 |
| Location: | Berlin - Marzahn |
| Manufacturer / Model: | Bell Helicopter Textron / Bell 412 HP |

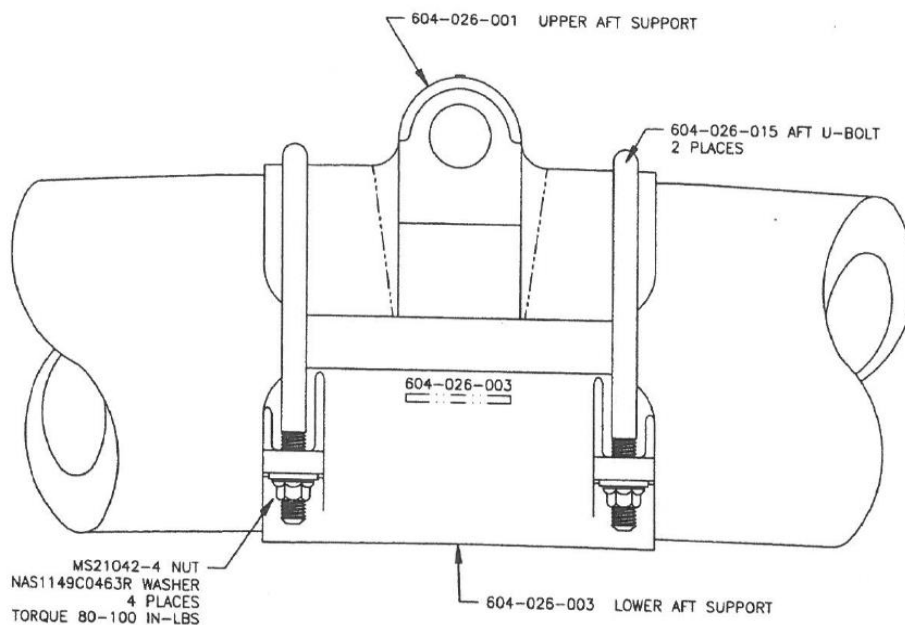
By the Bell 205 and 212, the aft and the forward cross tubes are mounted to the right and left fuselage underside. The high aft cross tube of the Bell 412 is mounted to the centre of the fuselage underside. The manufacturer stated the reason was the reduction of possible ground resonance in connection with the four-blade main rotor. The cross tube was mounted to the structure by way of two half shells. The upper and lower half shells embrace the cross tube and are clamped to it with two U-bolts. In order to avoid contact or friction, the upper half shell is glued to the cross tube; the inside of the lower half shell is lined with a separating agent / insulating agent. The upper half shell has an extension with a drilled hole where a bolt connects the cross tube with the helicopter fuselage (Drawing 1).

Drawing 1: Aft half shells at the skids

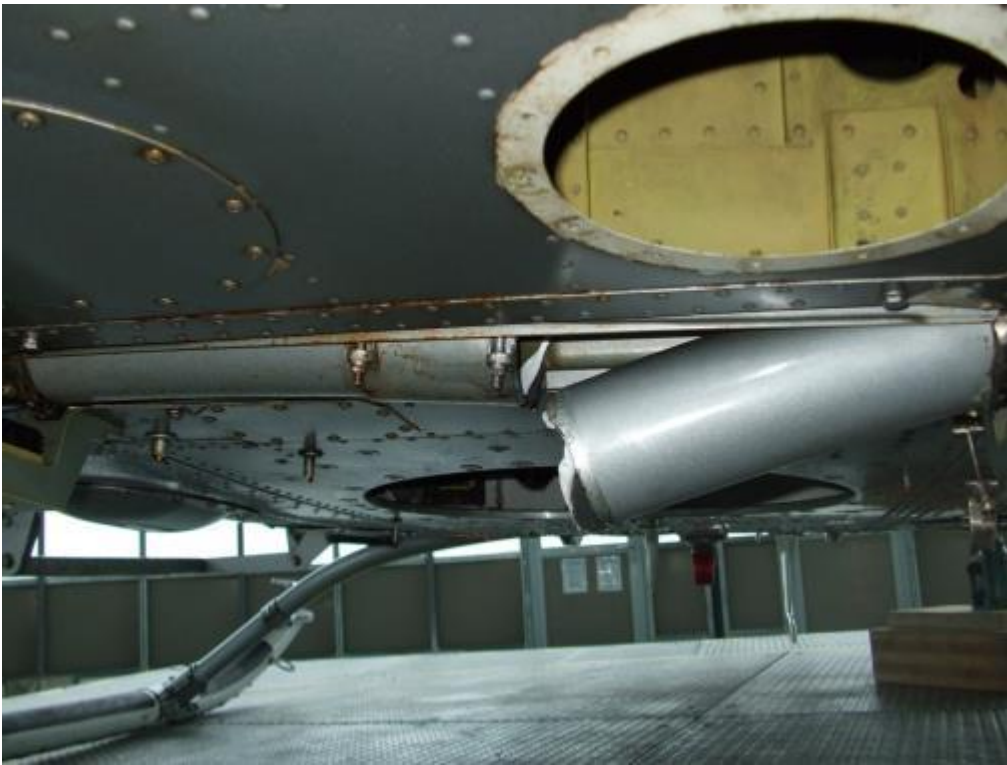
The high aft cross tube was fractured on the right edge of the half shell (Image 1). This half shell connected the aft fuselage with the cross tube. The fractured cross tube damaged the right fuselage bottom side. The damaged tail boom rested on the filling station and the wall of the landing platform behind the helicopter.

Image 1: View below the fuselage in flight direction

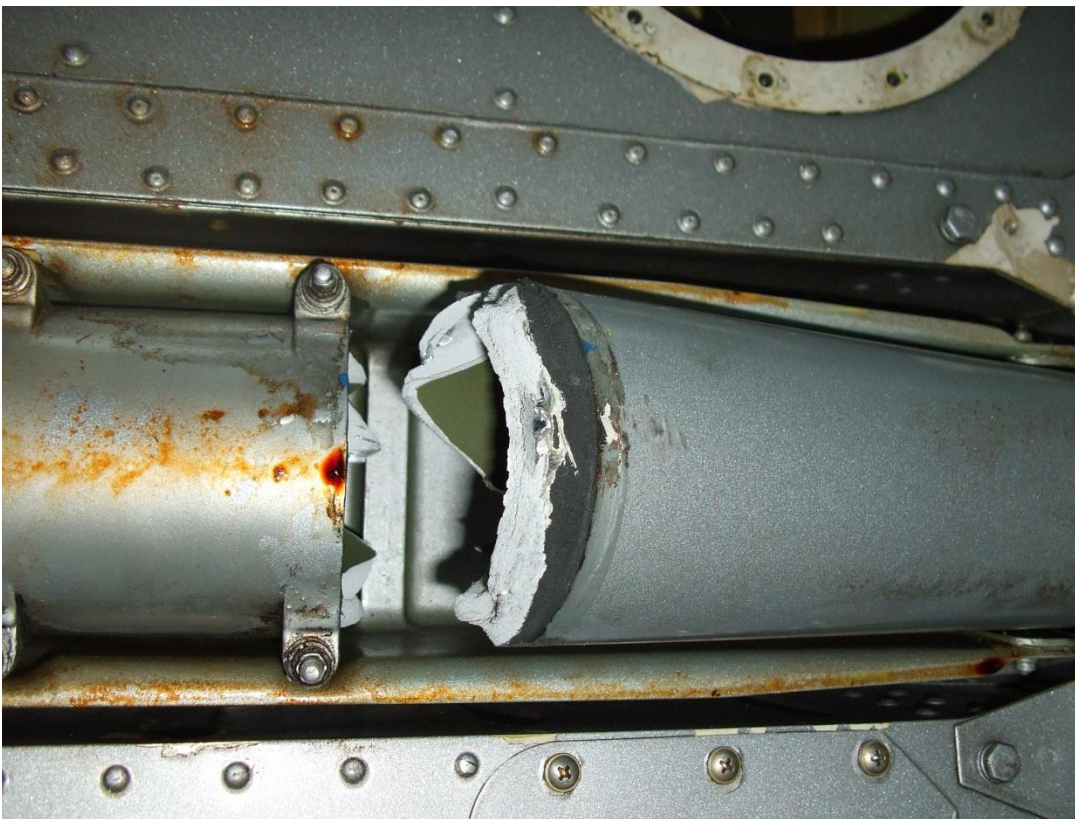
The cross tube fractured directly next to the U-bolt without much deformation (Image 2). On the outer tube underside, i.e. in the area of the largest tensile stress, a distinct thumbnail initial crack had formed. Further cracks had developed on both sides and slightly higher. The cracks were fatigue fractures. The various individual cracks and the big thumbnail crack, which consist of many small cracks, rule out a local defect on the pipe surface.

Image 2: View from below onto the fracture

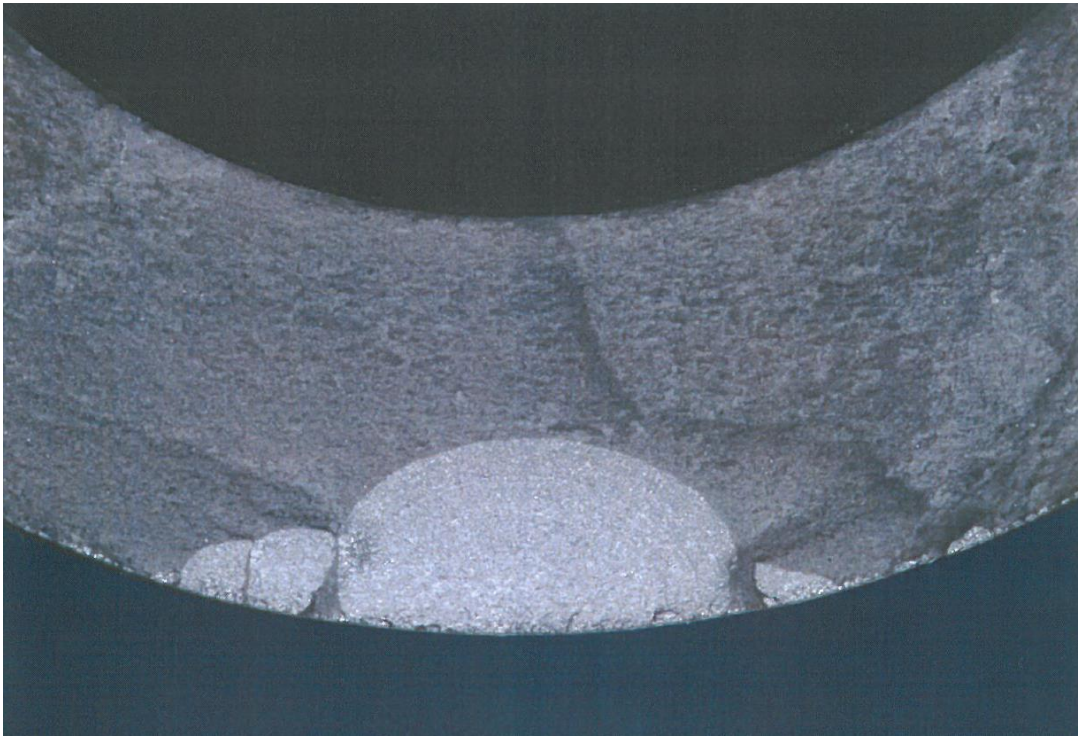
The area containing the fatigue fracture was cut out of the pipe and examined under the scanning electron microscope (Image 3). The characteristic striation microtopography confirmed the fatigue crack (Image 4). It was clearly different from the combs of the rest of the fracture with the micro-ductile structure of a forced rupture (Image 5). Especially well preserved were the striations in the two medium-sized fractures left of the central crack (Scanning Electron Microscope, Image 6). Further left in approximately the 7 o'clock position a 100 to 200  $\mu\text{m}$  wide border of various individual cracks was visible in Image 3 (Scanning Electron Microscope Images 7 to 8). The same was true for the right side where adjacent individual cracks had formed up to approximately the 5 o'clock position (Images 9 to 10).

Image 3: Detail view of the fatigue fractures (fracture surface of the half shell)

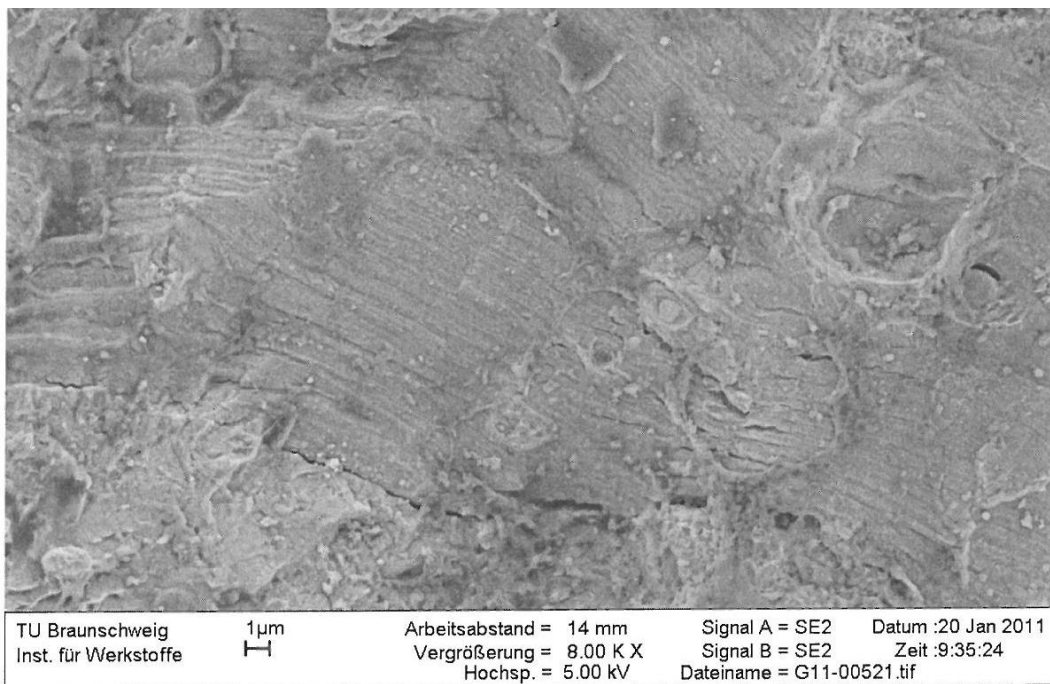
Image 4: Striations at the end of the big thumbnail

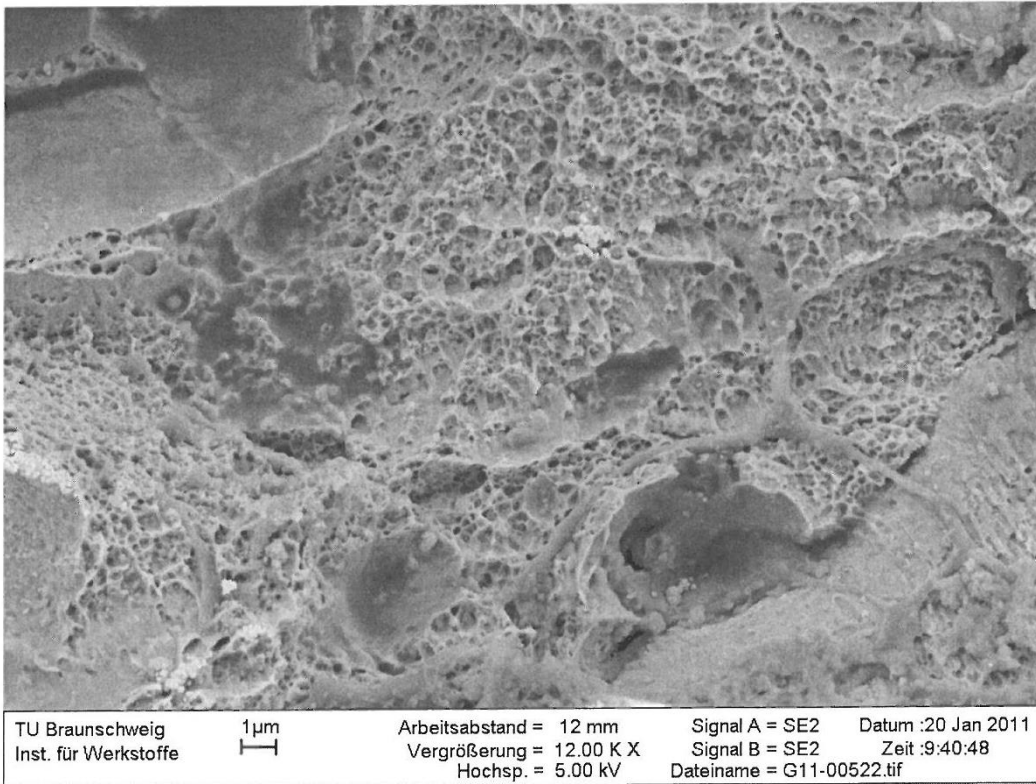
Image 5: Honey-comb structure of the microscopic ductile remaining forced rupture

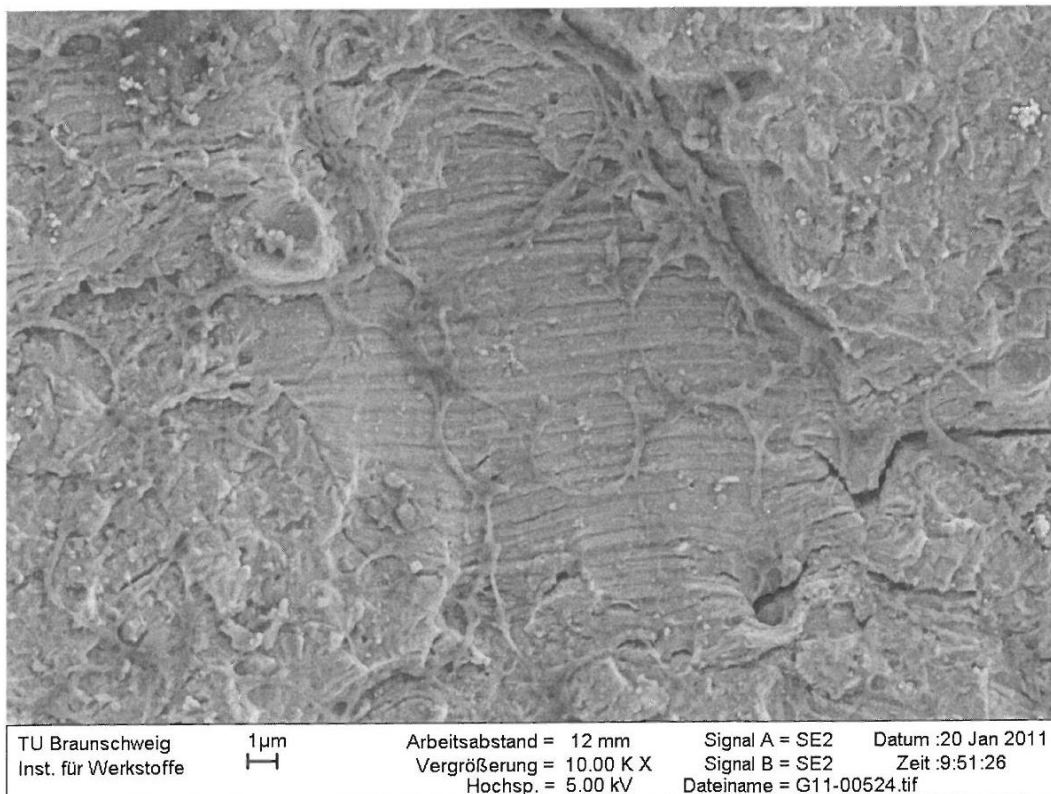
Image 6: Striations in the second crack to left of the central thumbnail

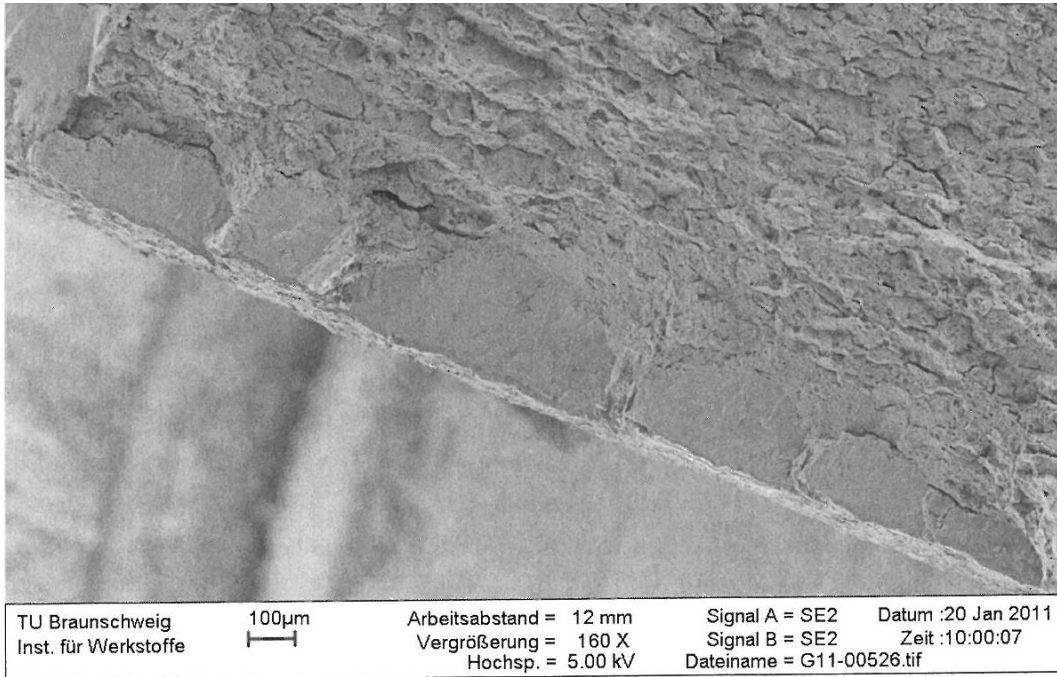
Image 7: Further fatigue fracture cracking in the 7 o'clock position

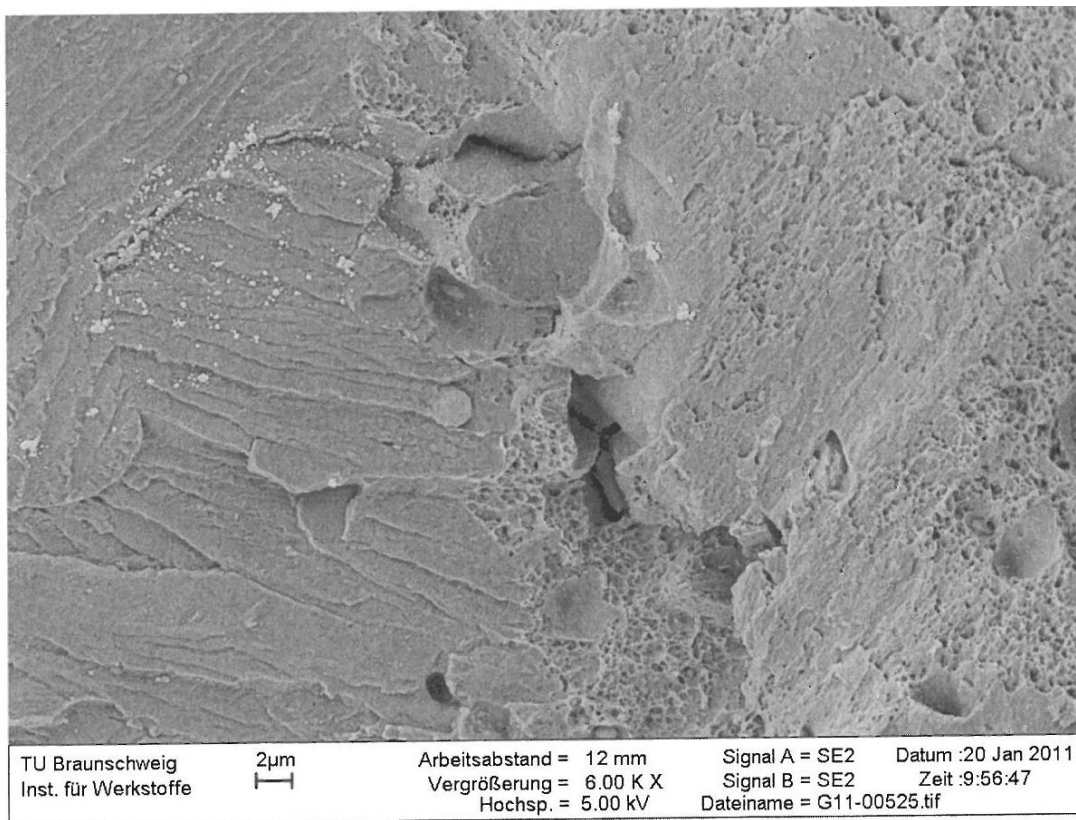
Image 8: Transition area of fatigue fracture to remaining forced rupture

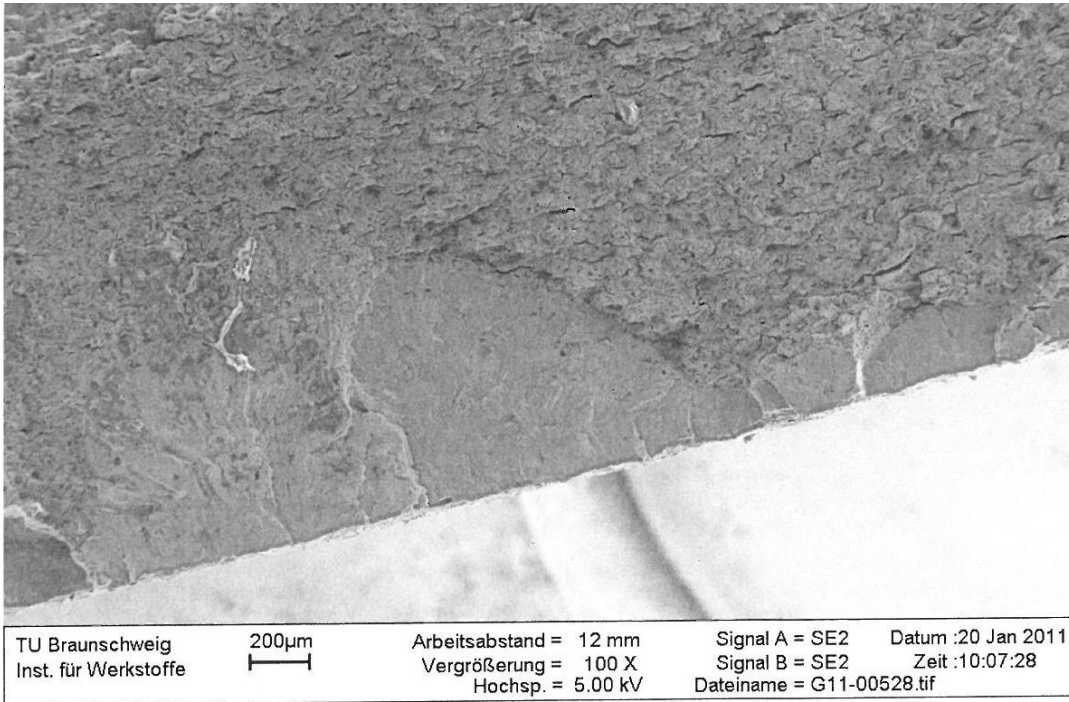
Image 9: Further fatigue fracture cracking in the 5 o'clock position

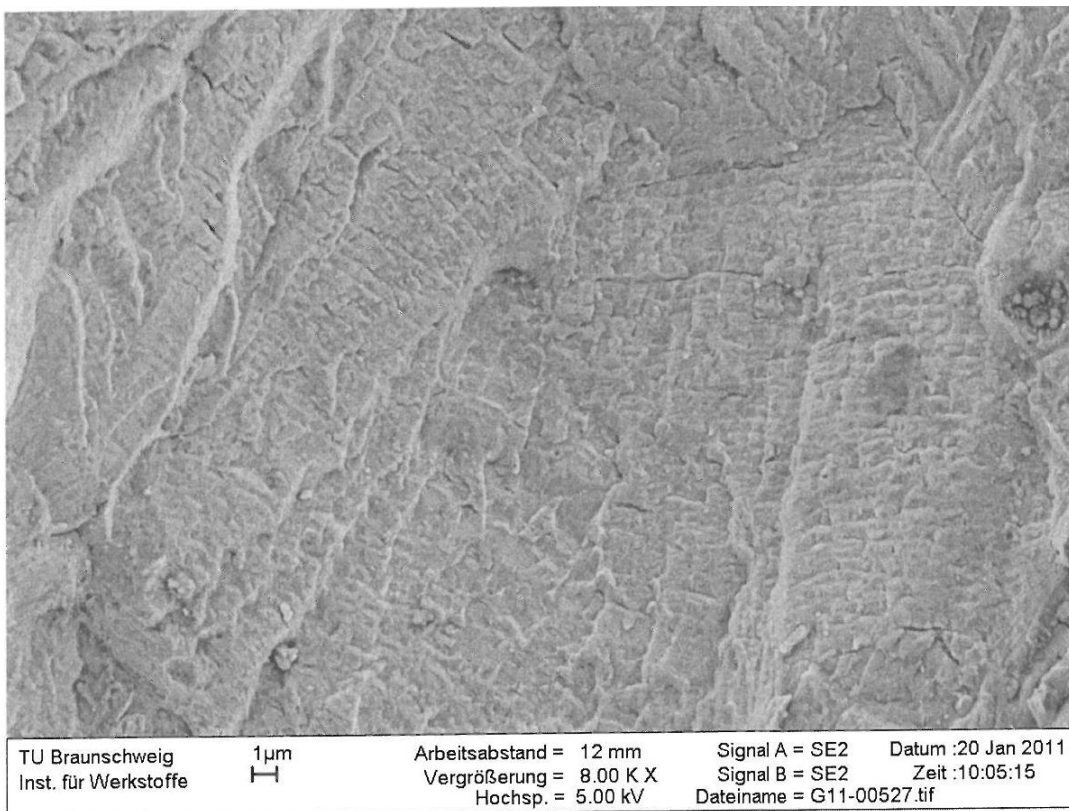
Image 10: Striations in the middle crack of Image 9
