Investigation Report

Type of Occurrence:	Serious incident
Date:	19 December 2010
Location:	Köln/Bonn
Aircraft:	Airplane
Manufacturer / Model:	Airbus / A319-132
Injuries to Persons:	Two persons with minor injuries
Damage:	None
Other Damage:	None
Information Source:	Investigation by BFU
State File Number:	BFU 5X018-10

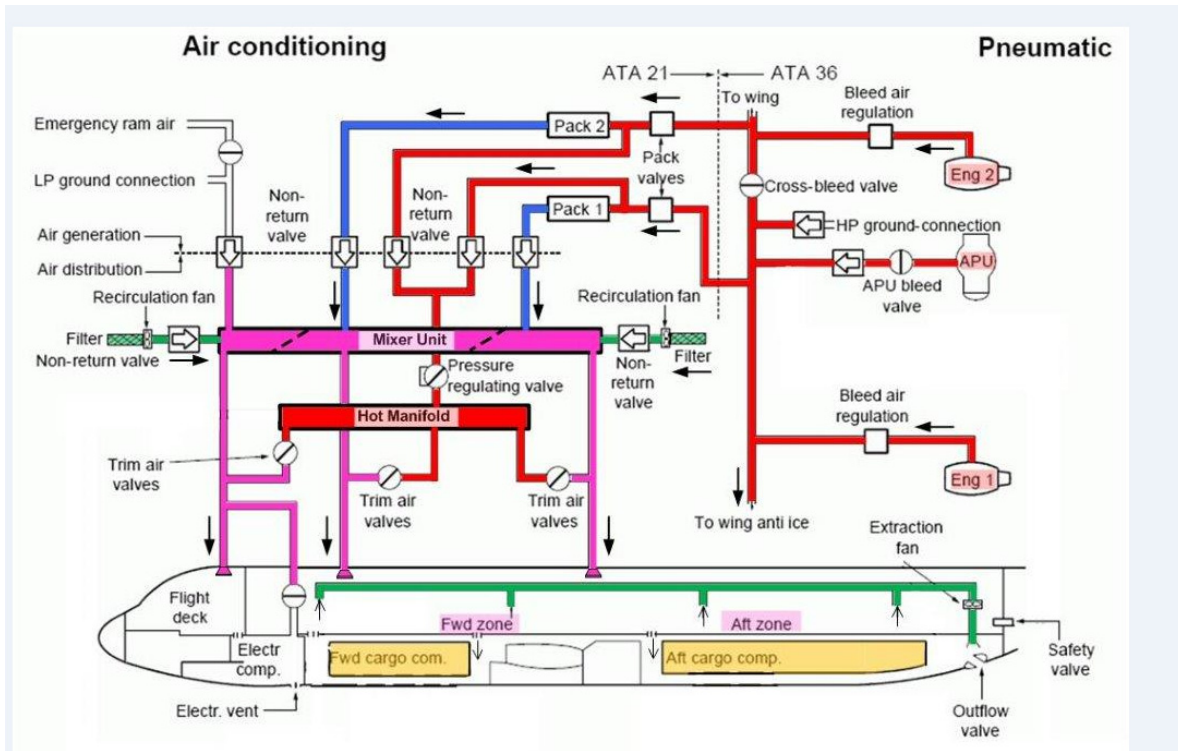
Image 4: Simplified diagram of the ECS

Had the air been contaminated it had reached the cockpit and the two cabin zones alike. The mixer design showed that contaminations of the air from pack 2 would have reached the cockpit only delayed and with reduced concentration. But since the smell had been observed in the cockpit first, contamination of the air from pack 2 could be ruled out.

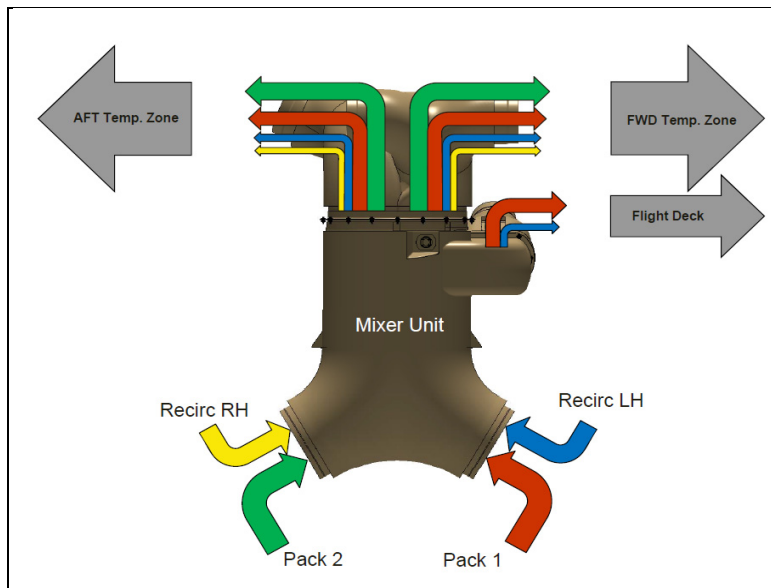
Image 5: Simplified diagram of the mixer unit

At the outlet of the mixer unit the amount of air from pack 1 which is fed into the cockpit is approximately 2.3 times higher than the air fed to the front part of the cabin. Prior to feeding the air to the respective zone, trim air from the hot manifold is added depending on the selected temperature. All zones receive the same trim air which originates either from engine 1 or engine 2 depending on the pressure ratio. During regular operating conditions the cabin zones require less trim air than the cockpit due to the higher temperatures in the cabin. The percentage of trim air for the cockpit is less than 10% of the total air flow.

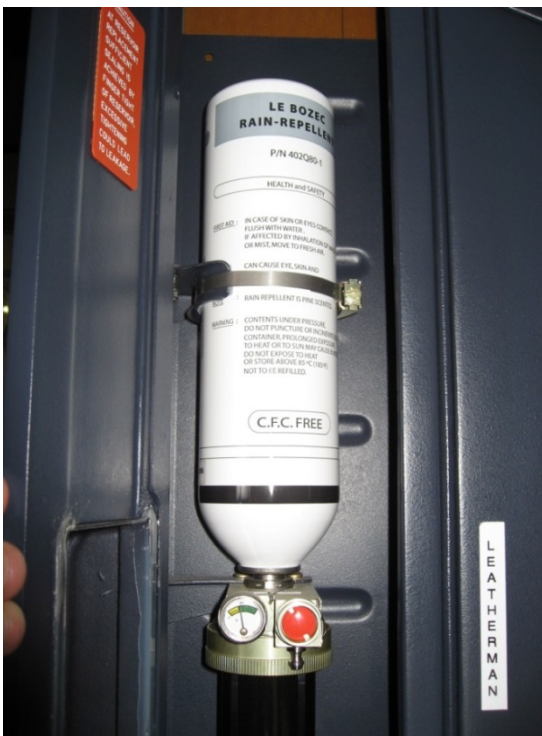
Image 6: Rain repellent cartridge Source: BFU

The BFU is of the opinion that a leakage in the rain repellent system is not very likely. Components of the system are installed in the cockpit and smell development would have been linked with leakage of the fluid. Such leakage was neither determined during maintenance nor did it occur on subsequent flights.

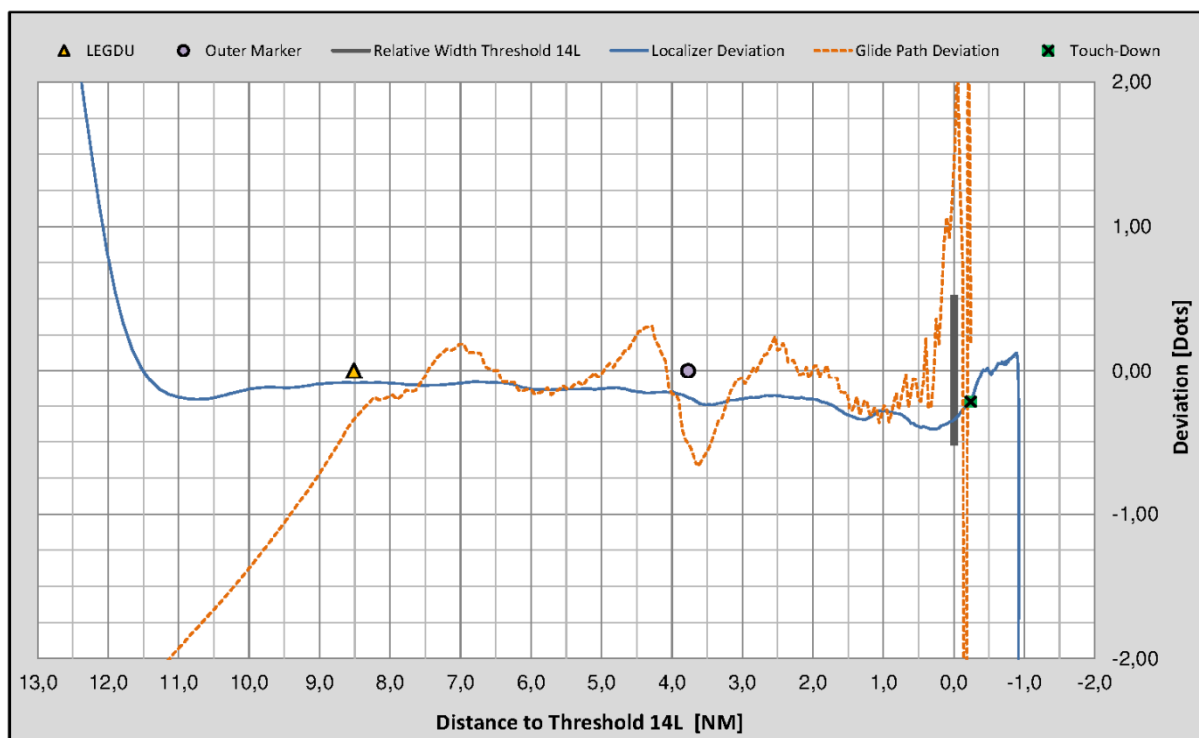
Image 10: Deviation from the runway heading and the glidepath

During the entire approach the runway heading did not show any abnormalities. The glidepath did not show any instability. The determined short-term deviations from the glidepath by about 8 - 7 NM and 5 - 3.5 NM prior to touch-down were very likely due to the change in configuration (flaps, landing gear) and speed.

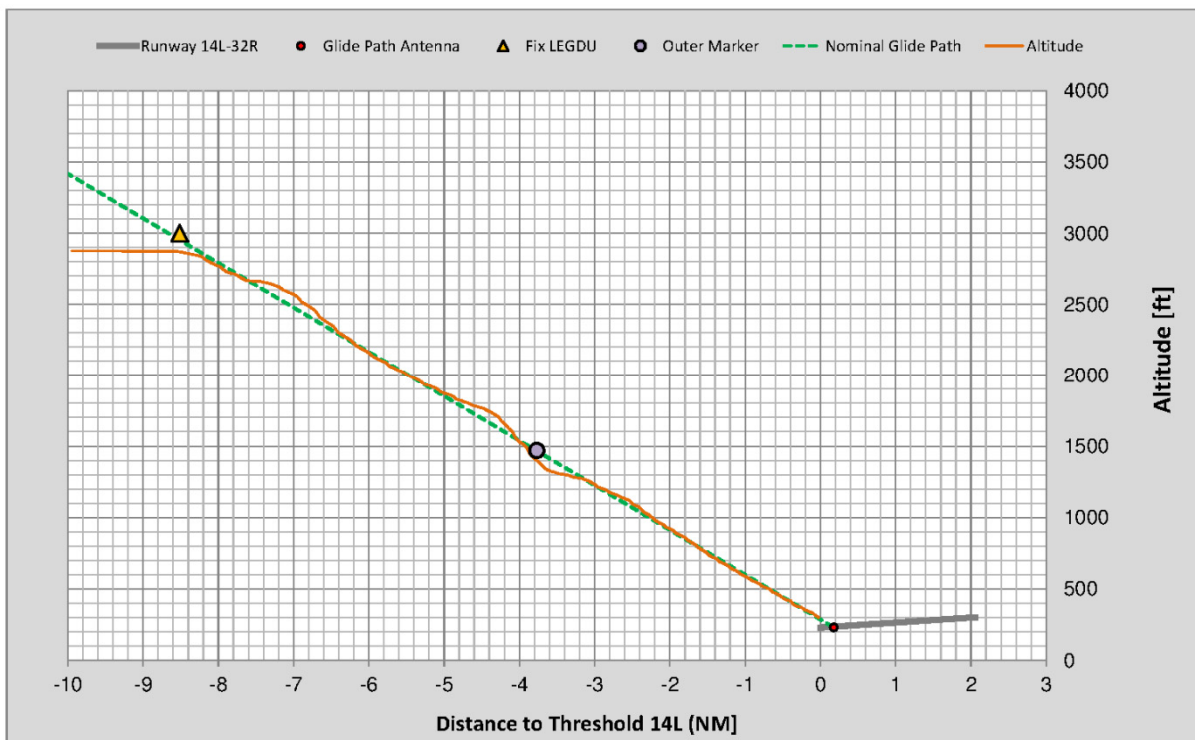
Image 11: Approach as vertical profile

The speed of the airplane was too high when it intercepted the glideslope of the ILS; the PF noticed this and corrected it several times. After the speed brakes and the landing gear were extended, the PF asked the PNF to set the flaps in position 2. He had opted for this sequence because before the speed had still been too high to set the flaps in position 2.

Because the touchdown occurred in the normal area of the runway and the fact that the airplane could leave the runway after about 1,600 m indicated that the speed during short final and touch-down was adequate.
