Investigation Report

Type of Occurrence:	Serious incident
Date:	1 March 2010
Location:	Near Stuttgart
Aircraft:	Airplane
Manufacturer / Model:	Cessna Aircraft Company Cessna 525A
Injuries to Persons:	No injuries
Damage:	Minor damage to aircraft
Other Damage:	None
Information Source:	Investigation by BFU
State File Number:	BFU 7X001-10

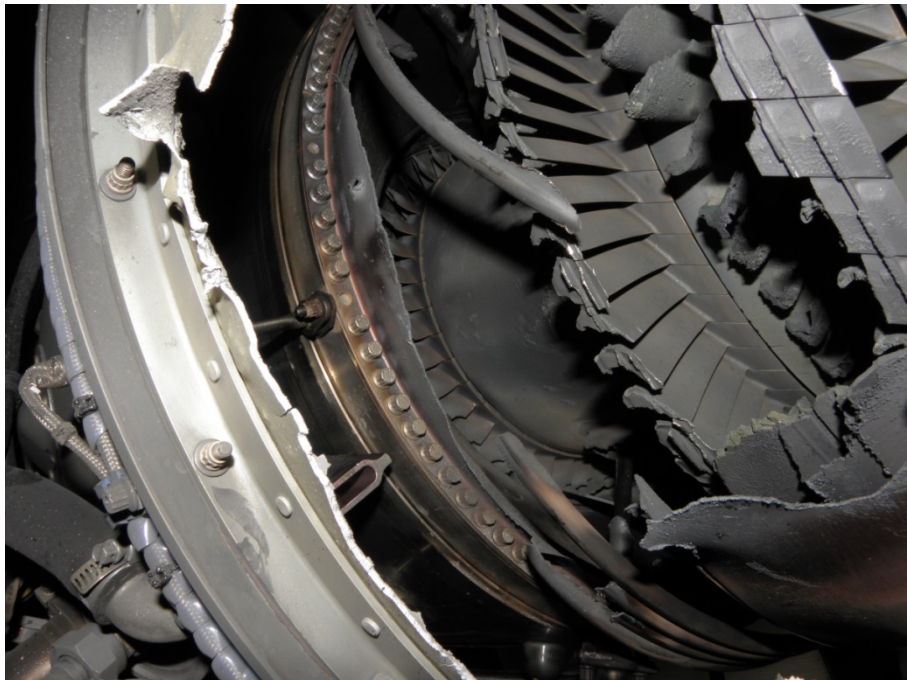
After the landing it was determined that the aft outer side of the left engine cowling had been destroyed. The engine had been damaged in this area. The engine cowling showed evenly spread puncture traces.

The engine cowling and the pylon showed signs of fire.

Damaged engine cowling and turbine

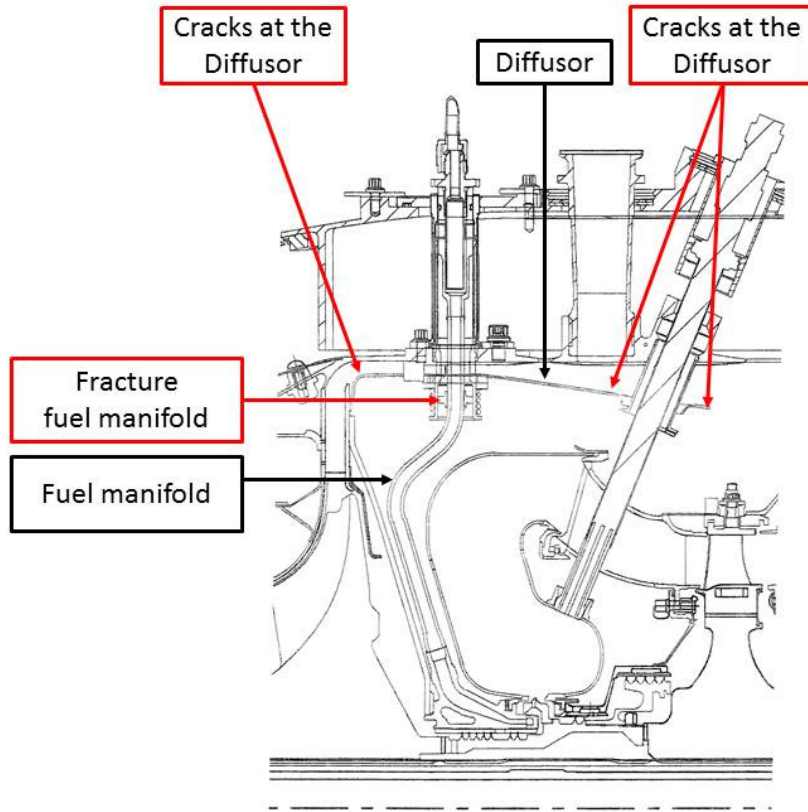
The engine examination was conducted at facilities of the engine manufacturer Williams International under supervision of the US National Transportation Safety Board (NTSB). The fan and the two compressors did not show any apparent damages. The diffuser case and skirt did not show any thermal distress. But the inner diameter of the skirt was sooted. The brazed forward end of the skirt was cracked between the 9:30 and 8:00 o'clock² position. The diffuser skirt had multiple axial cracks at the rear edge and several circumferential cracks radiating from the axial cracks.

The skirt was missing a section from the aft edge between the 2:00 and 3:00 o'clock position. The missing section had the size of 106 mm x 108 mm x 60 mm x 34 mm. It was found in the back of the combustor cover.

The hole in the diffuser skirt for the fuel manifold tube was ovalized and the clockwise side of the hole on the outer diameter had raised metal. The outer diameter of the fuel manifold tube showed abrasion signs.

The fuel manifold tube fractured at the brazed outer edge to the diffuser housing.

The engine manufacturer also conducted a microscopic examination of the fuel pipe and the cracks on the diffuser. But this examination was limited to the fracture features which had not been obliterated. The forward and aft cracks on the diffuser showed clear signs of fatigue fractures. The investigated fracture surfaces on the fuel manifold tube also showed signs of fatigue fractures. They originated in the brazed joint fillet radius in the fuel manifold assembly and continued into the area of the tube.

The diffuser cracks were caused by naturally occurring airflow buffeting and vibratory modes of the inner flow path within the engine run range. The cracks at the forward end of the diffuser inner flow path allowed the inner flow path to separate and move aft until contacting the fuel manifold tube which subsequently failed due to vibration. The fracture of the fuel manifold tube allowed an uncontrolled amount of fuel to enter the combustion zone which resulted in the burn-out of the combustion cover. All other damages were secondary damages.

The serious incident was caused by fatigue fracture on the diffuser.

Location of the fracture and cracks in the engine

At the time of the engine examination the engine manufacturer stated that so far no fractures on the diffuser of the FJ44-3A-24 model had occurred. There were however 17 cases in the entire FJ44-3A program. The diffuser was reinforced in combination with the development of the FJ44-4 model. Gradually, the FJ44-3A and FJ44-3A-24 models should be re-fitted with this diffuser. Williams International issued the Service Bulletin (SB) FJ44-72-093 for that purpose.

The engine manufacturer stated that by January 2015 almost all FJ44-3A-24 engines had been refitted with the modified diffuser. So far the engine manufacturer has not received any information about fractures on the modified diffuser.
