# Investigation Report

| Kind of Occurrence: | Serious Incident |
| Manufacturer / Model: | Cessna / Citation 525A |
| State File Number: | BFU 7X002-10 |

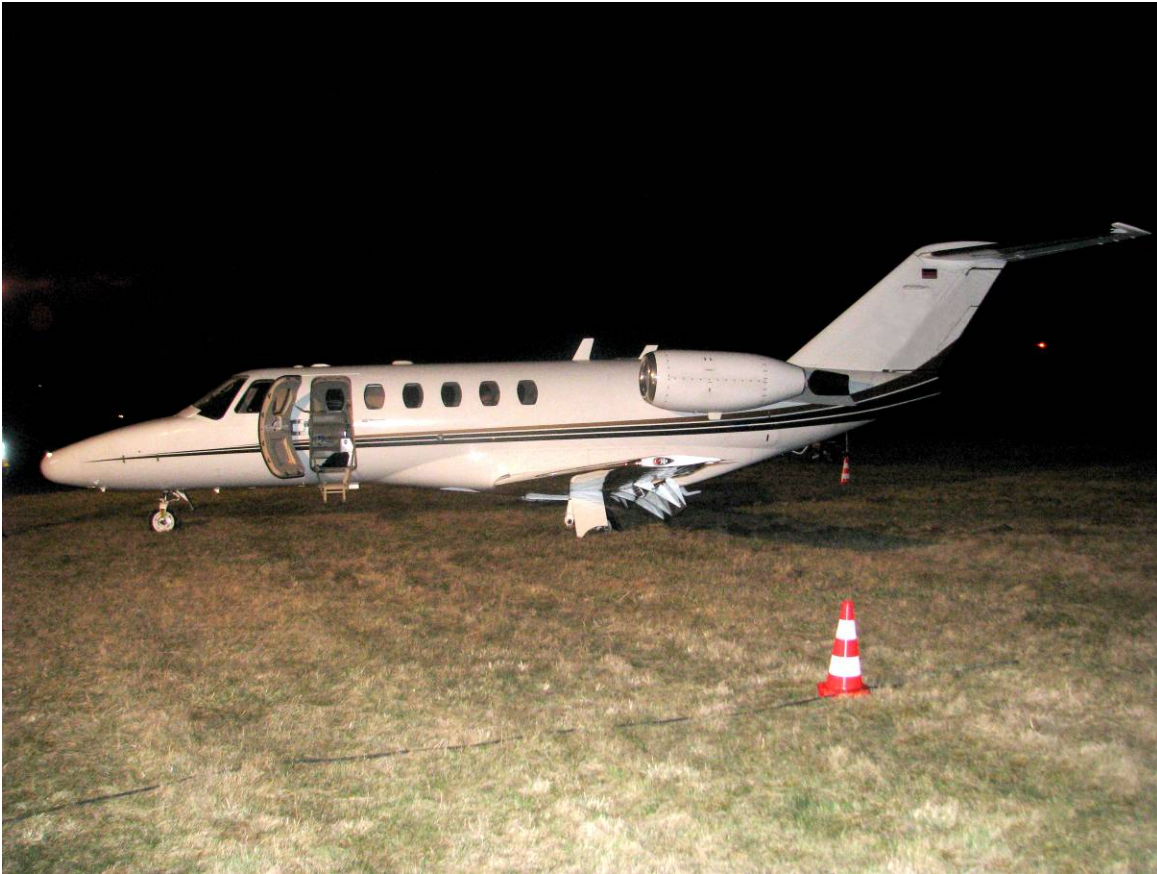
The aircraft overran the left end of the runway lip and came to a stop about 53 m further on.

The aircraft overran the left side of the runway threshold shoulder on a heading (HDG) of approx. 201° and came to a halt on grass about 53 m after leaving the runway. The aircraft came to rest with the fuselage heading about 150°. The wheels sank about 10 cm into the ground. No other part of the aircraft made contact with the ground.

Position of the aircraft on coming to rest

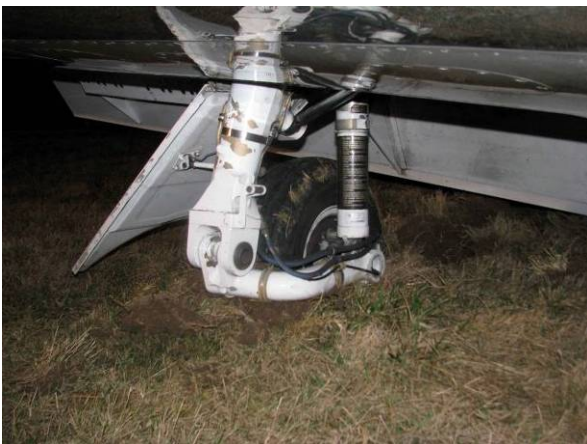
Right main landing gear

The C525 landing gear left touch-down marks on Runway 22 about 572 m after the threshold, from which point continual wheel/brake marks were left by both main landing gears.

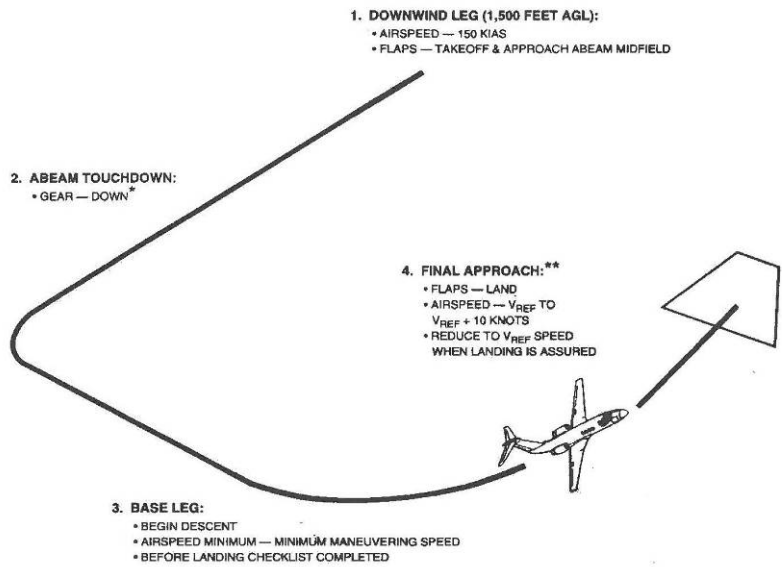
2.7.12.5 VFR APPROACH SEQUENCE

However the entire approach procedure was flown at an excessive speed and not in conformity with the instructions contained in OM-B. Below FL100 the aircraft ground speed was about 300 kt, later reducing to about 290 kt. Based on the available meteorological data and the reported wind (5 kt at 1 500 ft), this resulted in a maximum IAS of about 295 kt, ground speed 285 kt. When making the turn onto base leg – airfield wind 130° / 10 kt – the ground speed was recorded as about 210 kt (about 200 kt IAS), while on final approach the ground speed was about 190 kt (about 190 kt

The aircraft commenced its turn onto base leg and final approach about 2.6 NM from the threshold to Runway 22, which was insufficient separation at the higher IAS and ground speed.

The Air Operator should specify the visual approach sequence in greater detail, including duration of the downwind leg, and separation from the airfield on initiation of the turn to base leg and final approach. At the latest, the aircraft should be in its final landing configuration and the check lists should have been read out and completed before descending through 500 ft AGL in a properly stabilised condition.

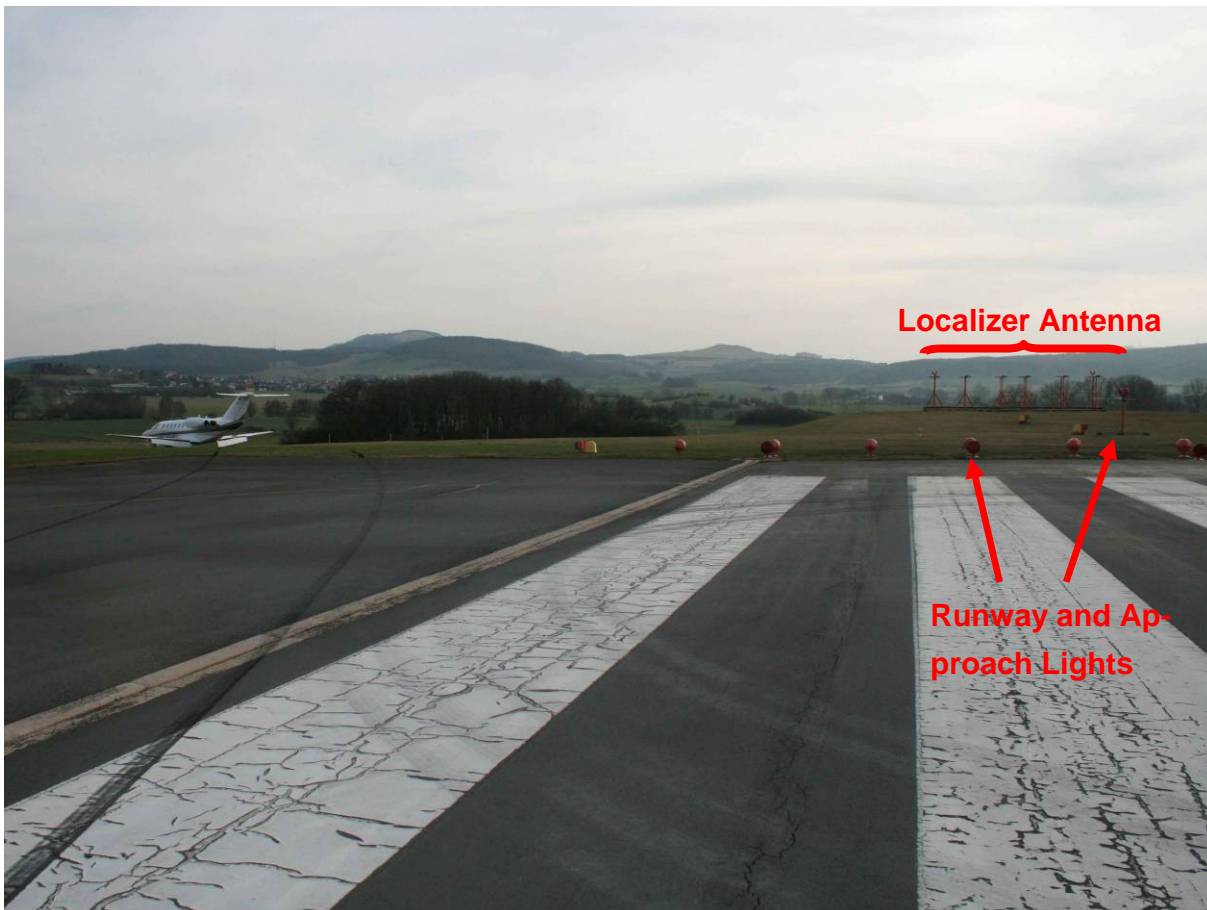
View End of Runway 22

The decision to steer the aircraft towards the left on approaching the end of the runway, prevented a collision with the Runway 04 approach lights and possibly also the Localizer antenna, which are all mounted on concrete plinths. The decision to guide the aircraft towards open space avoided serious damage to the aircraft.

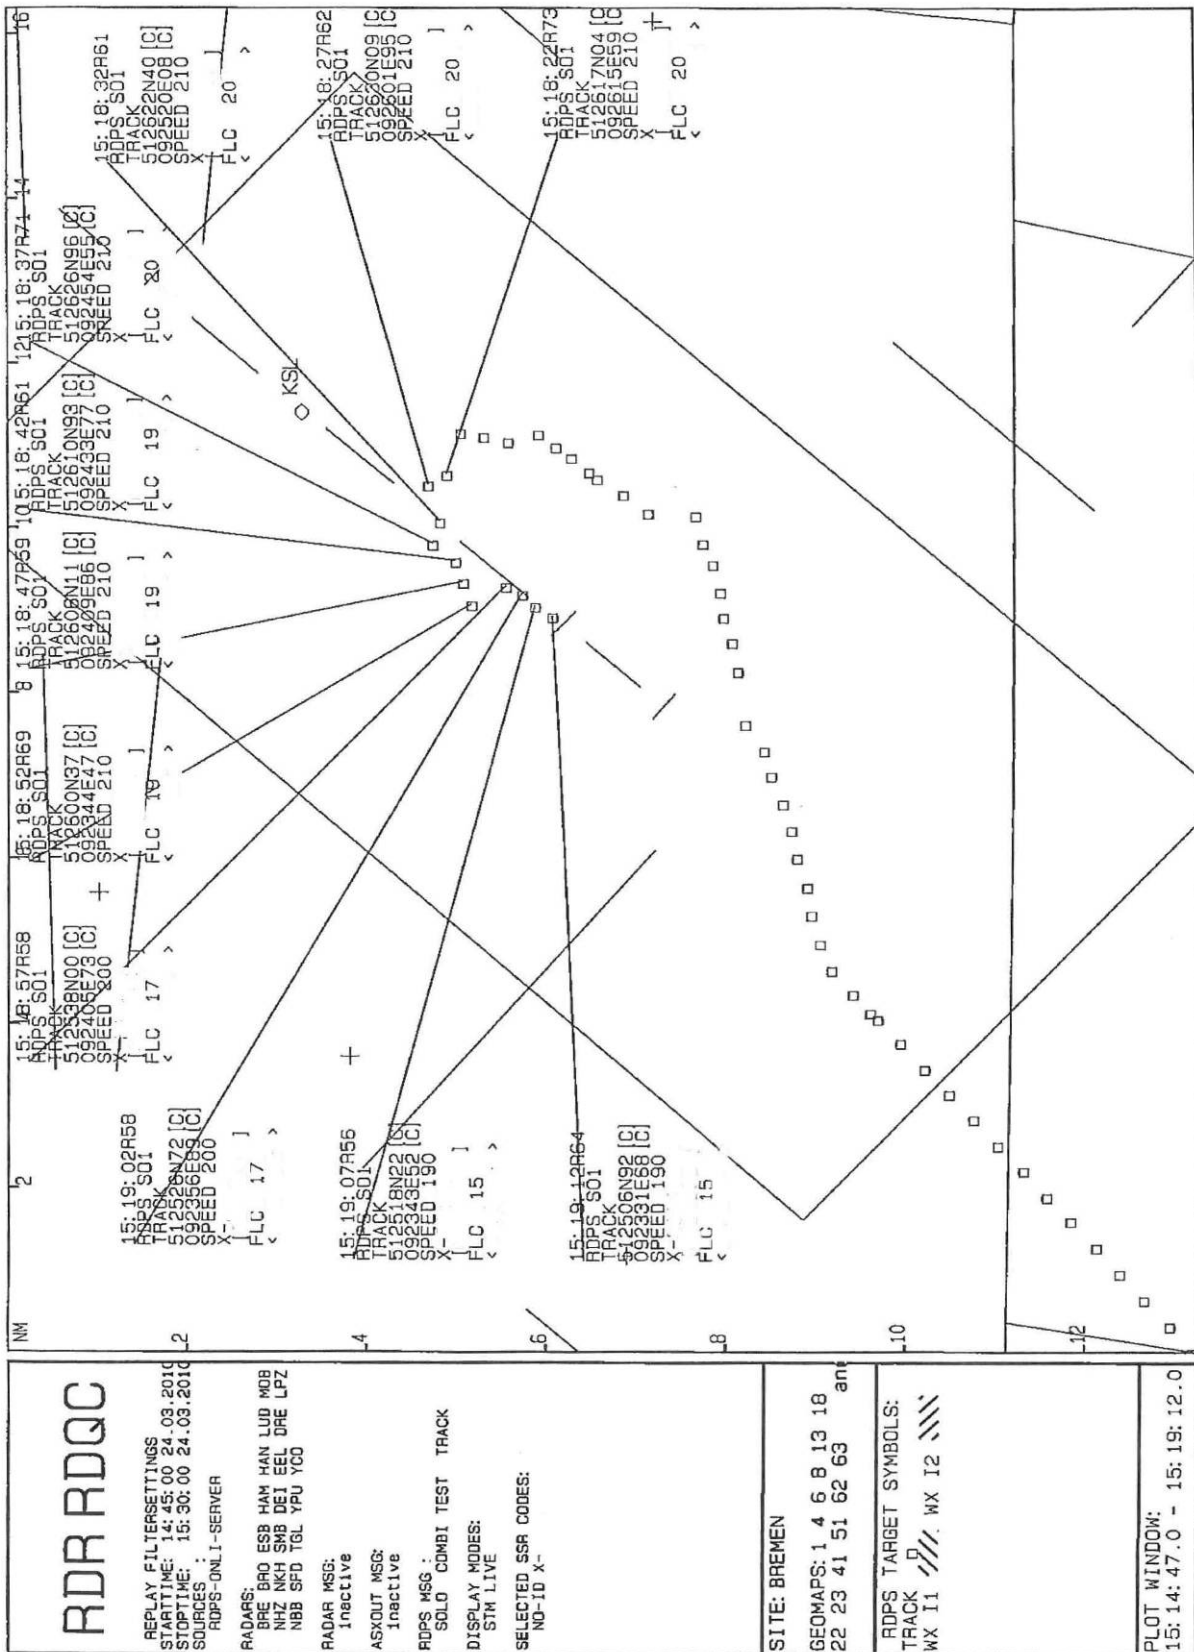
DFS Radar Trace

The Air Traffic Control radar trace of the Cessna's progress was available for this investigation. The trace showed the Cessna's approach to Kassel Airport, also changes in height and ground speed. While on base leg to Runway 22, the radar trace indicated a ground speed of about 210 kt at a height of 2 000 ft, subsequently reducing to about 190 kt at a height of about 1 500 ft in the short final approach to Runway 22.

Four radar stations monitored the local airspace. The DFS air traffic control service provider gives the accuracy of the ground speed in this approach sector as approx. +/- 10 kt.
