Investigation Report

Type of Occurrence:	Accident
Date:	6 October 2010
Location:	Gotzenalm close to Schönau am Königssee
Aircraft:	Helicopter
Manufacturer / Model:	Eurocopter France / AS 350 B3
Injuries to Persons:	Pilot slightly injured
Damage:	Aircraft severely damaged
Other Damage:	Minor crop damage
Information Source:	Investigation by BFU
State File Number:	BFU CX012-10

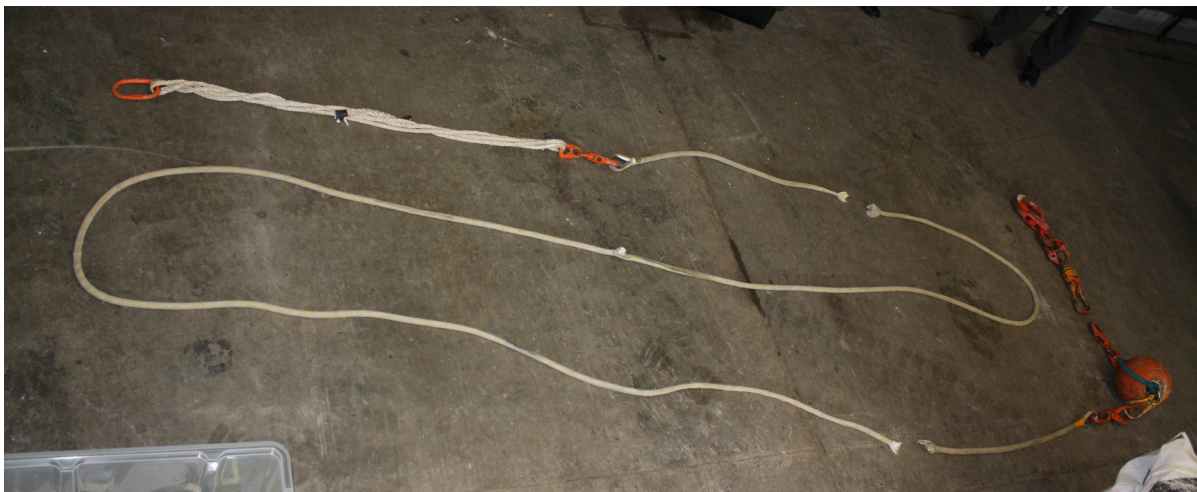
Appendix 1: External Load Suspension

One of the operator's ground assistants prepared the tree trunk for the transport. The trunk was fastened with a lifting strap in the form of a loop which was hooked into the external load rope which in turn hung on a shock absorber which itself was hooked into the helicopter's cargo hook (Appendix 1).

The load handling device was torn into several parts. The lifting strap to fasten the tree trunk including coupling, low-torque swivel, line load element and the lower part of the lifting rope with a length of about 0.9 m including the cargo hook were still attached to the tree trunk. The shock absorber including about 0.9 m of textile rope were found approximately 67 m north of the tree trunk. About 5 m north of the wreck, an 8.20 m long piece of the rope was found (Appendix 1, 2 and 3).

Based on the identified marks and other data presented, it can be assumed that the fracture of the suspension rope was caused by overload due to impact stress during the transportation of the tree trunk. No indications for a manufacturing defect or a pre-damage (e.g. cutting, abrasion or crushing) of the rope were found. Both fractures were found in the transition area of splice and free rope. For this rope construction, this area is to be viewed as typical point of rupture by overload. The fracture occurred at this point of rupture in the quasi-static tension test also. [...]

Due to an overload breakage in the area of the splice at the lower part of the rope, the rope shot upward. Thereby it had contact with the tail boom fin and the main rotor. [...]

The analysed marks allow the conclusion that the first rupture of the rope was caused by a sudden stress due to the impact of the external load with the ground. This is also confirmed by melting marks on the absorber which were found in the area of the fittings. Such massive melt down traces do not occur in normal operation. By longer use one can find abrasions on the rope cover at most.

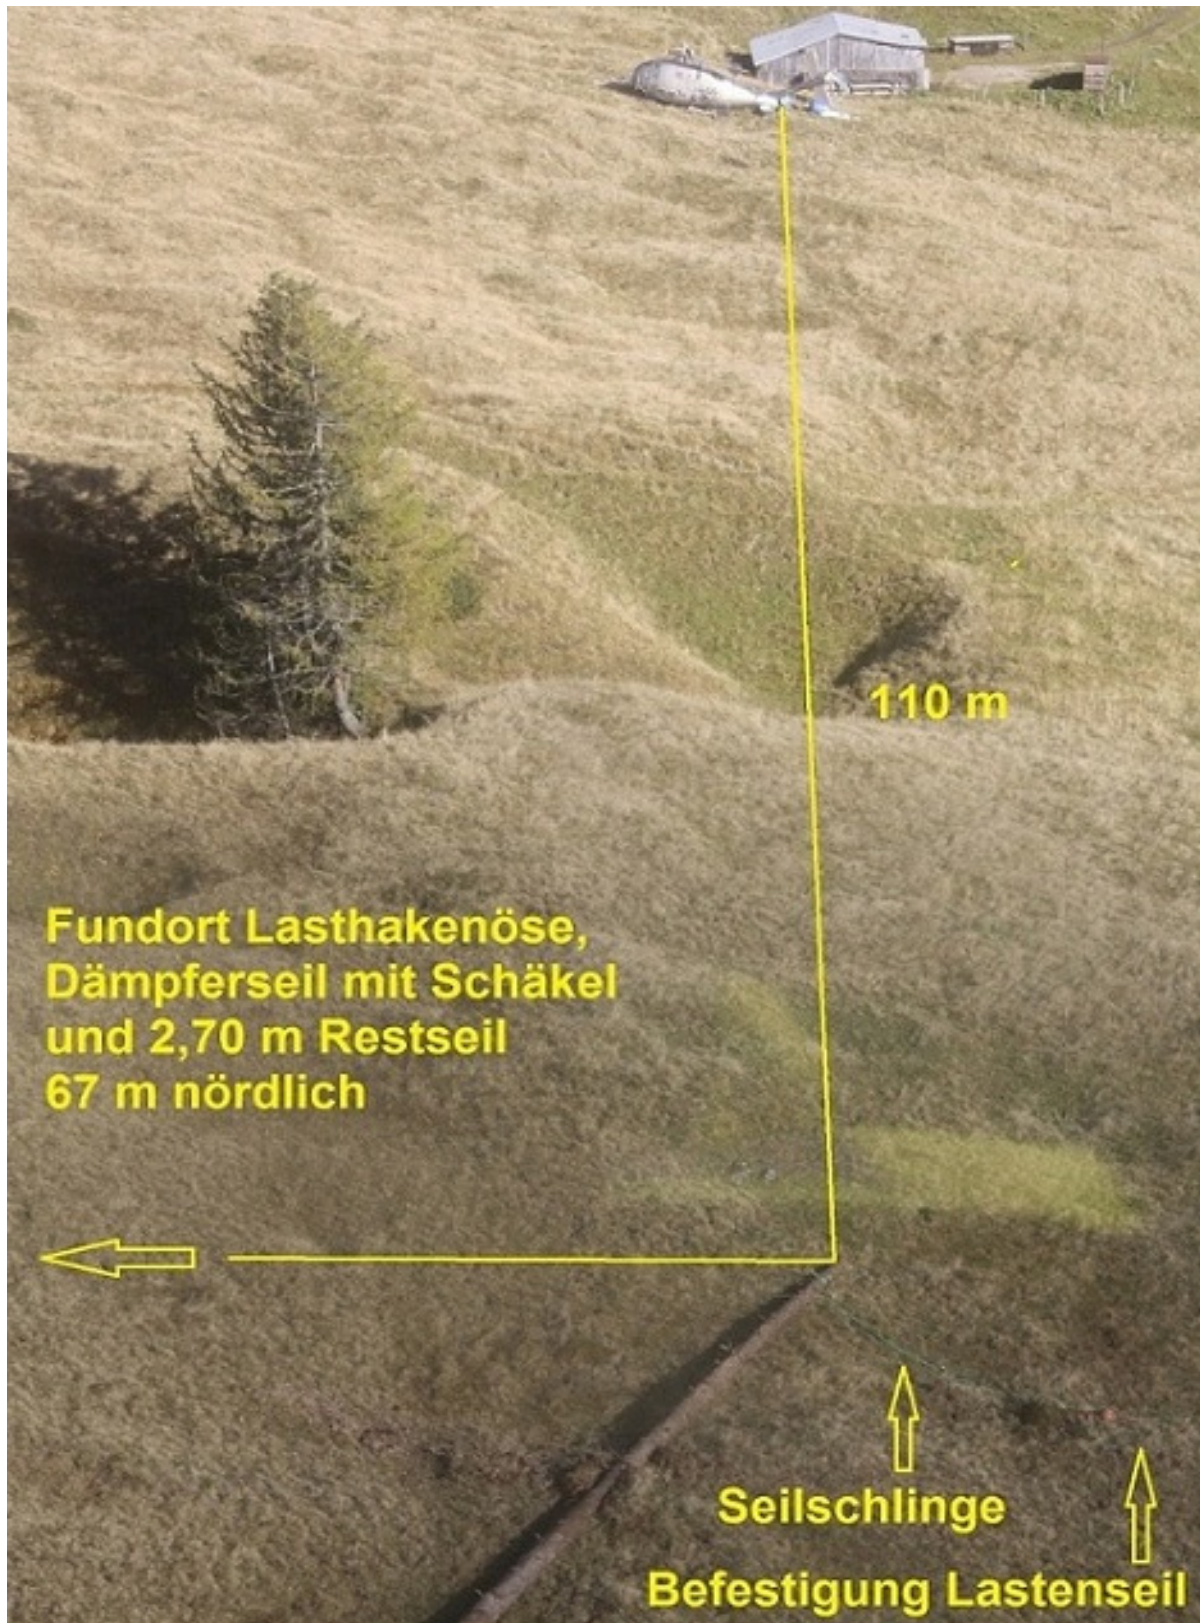
Appendix 2: Position Tree Trunk – Helicopter

The accident site was on the Gotzenalm in approximately 5,540 ft AMSL, on a very bumpy meadow with deep dips. One impact point of the tree trunk with the ground was on the edge of one of these bumps (Appendix 2 and 4). When viewed from the flight approach direction, the terrain declined.

The external load was found about 110 m from the wreck.

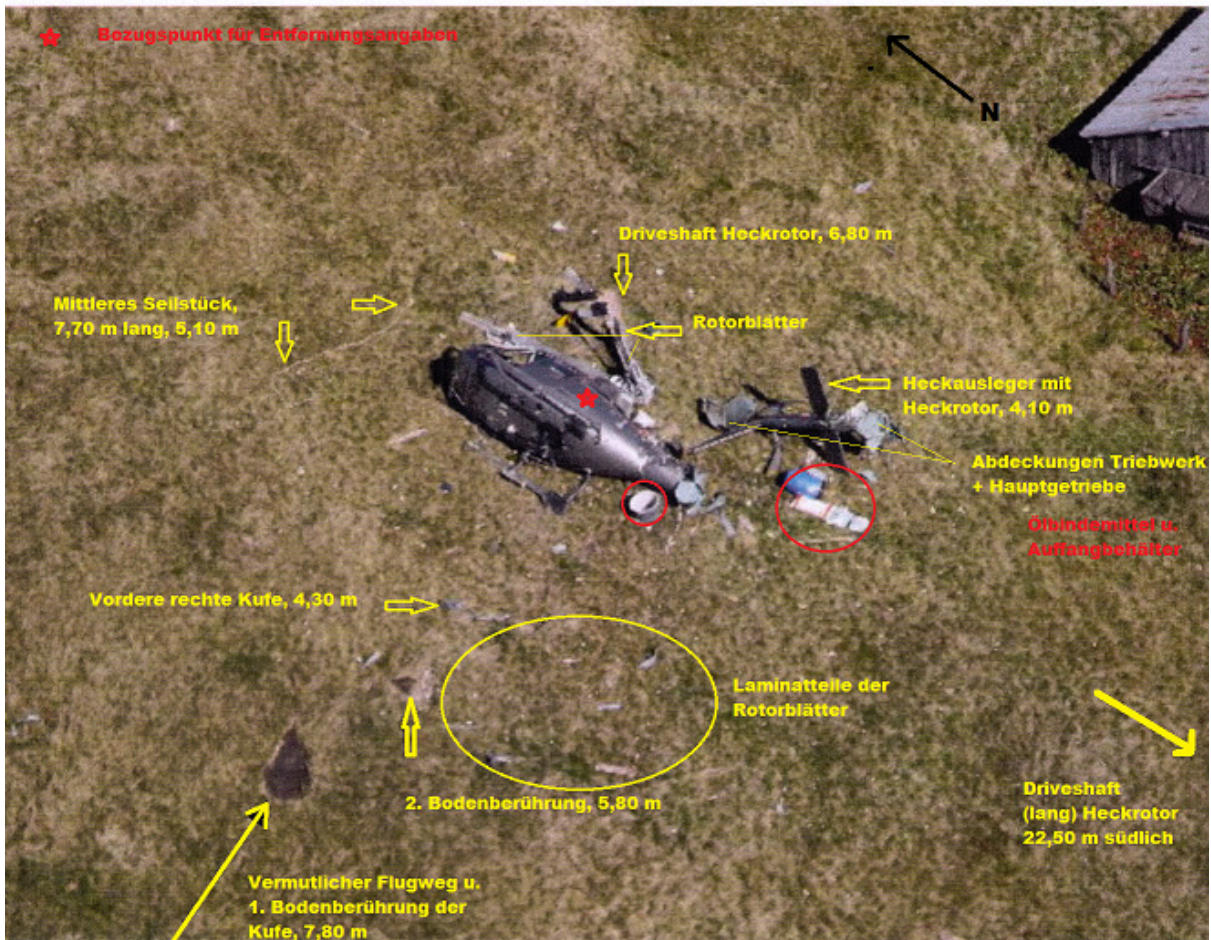
Appendix 3: Wreck Distribution

The helicopter lay on the right fuselage side. The tail boom had been severed. The three main rotor blades were destroyed, the main gear box was torn out of its mounting, the engine cowling was torn off and the engine severely damaged. The tail rotor drive shaft was torn in several places. The tail rotor gear box could be rotated by hand. Except for a small piece on the trailing edge, the tail rotor did not show any damage. There was no fuel leakage at the accident site. About 150 l fuel was removed from the tank.
