Investigation Report

Type of Occurrence:	Serious incident
Date:	17 October 2010
Location:	Near Lübeck-Blankensee Airport
Type of aircraft:	<ol style="list-style-type: none">1. Transport aircraft2. Motor glider3. Glider
Manufacturer / Model:	<ol style="list-style-type: none">1. Airbus / A320-2332. Burkhart Grob Luft- und Raumfahrt GmbH & Co. KG / Grob G 109 B3. Alexander Schleicher GmbH & Co. Segelflugzeugbau / ASW 27-18E
Injuries to Persons:	None
Damage:	Minor damage to the glider
Other Damage:	None
Information Source:	Investigation by BFU
State File Number:	BFU EX012-10

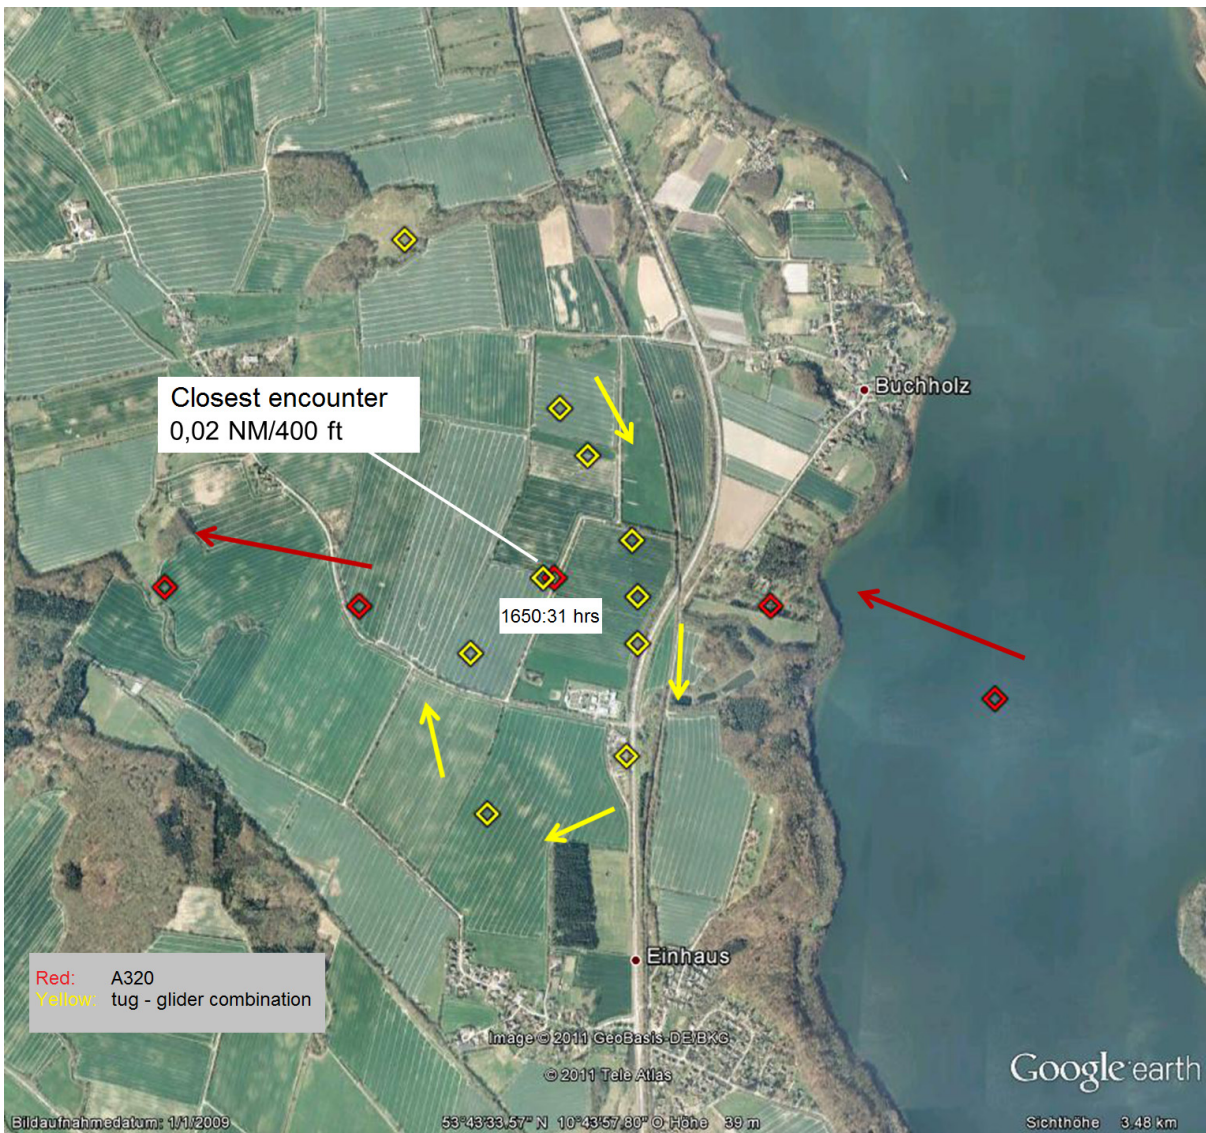
Flight paths

At 1650:31 hrs¹ about 1.5 Nautical Miles (NM) south of Lübeck-Blankensee Airport in airspace E an airprox occurred between an Airbus A320-233 (A320) and a tug – glider combination consisting of a Grob G 109 B (G109) as towplane and an ASW 27-18 E (ASW). The Airbus A320 flew in accordance with Instrument Flight Rules (IFR) and the tug – glider combination in accordance with Visual Flight Rules (VFR). The radar data showed a minimum horizontal separation of about 0.02 NM and a vertical separation of 400 ft.
