# Investigation Report

Type of Occurrence:	Accident
Date:	10 September 2011
Location:	Hanover
Aircraft:	Helicopter
Manufacturer / Model:	Eurocopter France / AS350 B2
Injuries to Persons:	None
Damage:	Aircraft severely damaged
Other Damage:	Damage to a building
Information Source:	Investigation by BFU external experts for field investigation
State File Number:	BFU 3X148-11

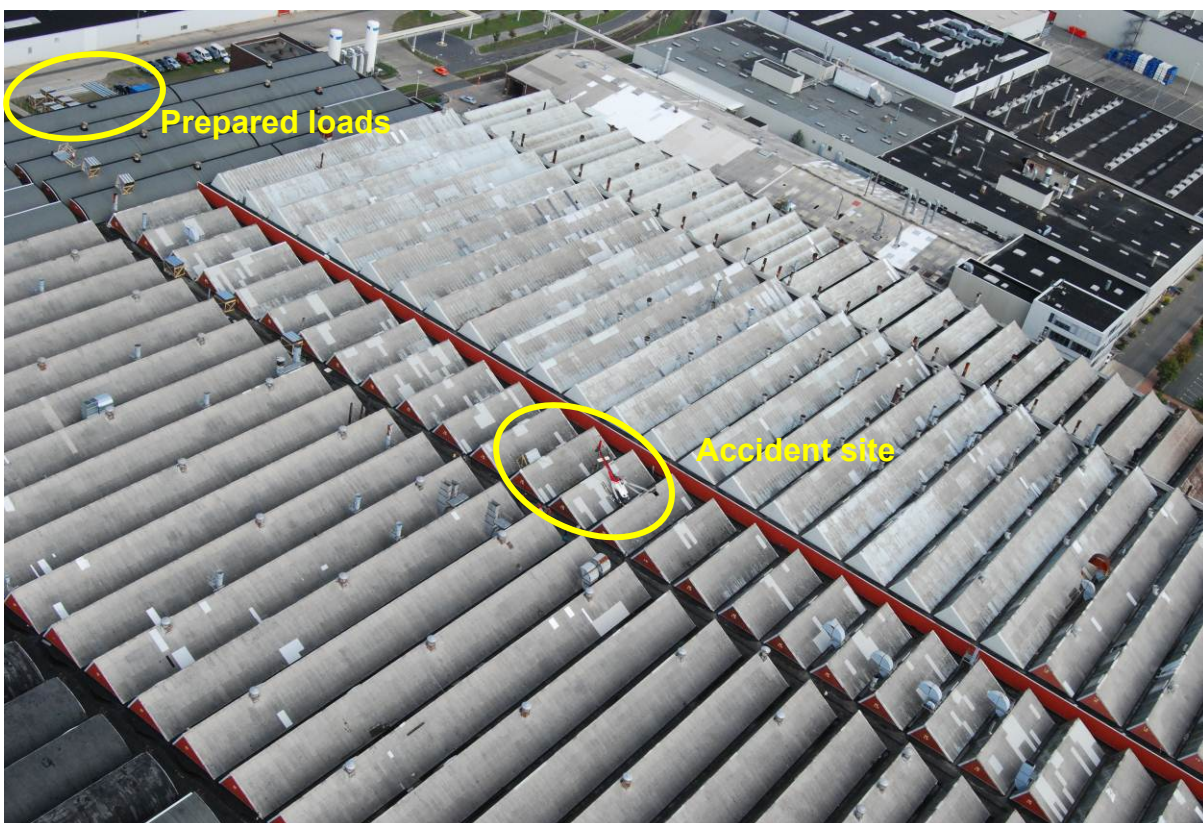
Overview pick-up location, drop area and accident site on the shed roof

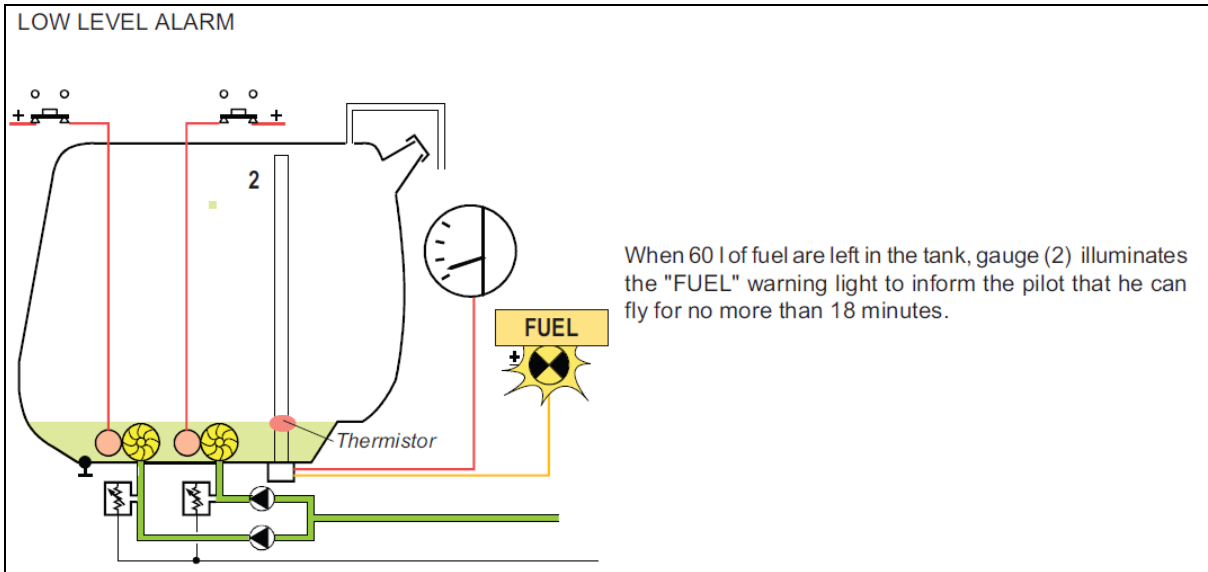
The helicopter's tank has a fuel capacity of about 540 litres. Mean fuel consumption per flight hour is about 180 litres. The fuel quantity in the tank is shown in the cockpit in per cent. In the warning panel a FUEL indication illuminates once a fuel quantity of about 60 litres is reached. According to the flight manual about 18 minutes of flight time remain once the warning indication is on; large changes in the flight attitude are to be avoided. The remaining usable fuel in cruising attitude is about 1.25 litres.

Schematic diagram of the fuel warning indication

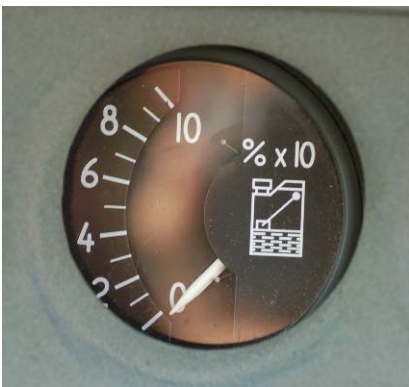
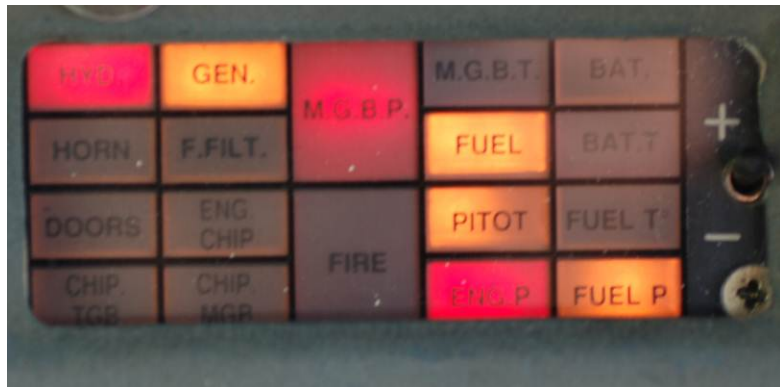
The pilot stated that during the approach the fuel pressure indicator (FUEL P) illuminated suddenly. According to his memory at that time the fuel quantity indicator

showed a remaining fuel quantity of about 7%. The fuel quantity indicator (FUEL) had already been illuminated for 15 minutes. Because he had anticipated an engine failure and did not want to put anyone from the ground crew in danger, he decided to steer the helicopter to the left and put the external load down between the pitched roof areas. At that very moment the engine failed and he made a hover-autorotation onto the roof.

Fuel indicator and warning display in the cockpit

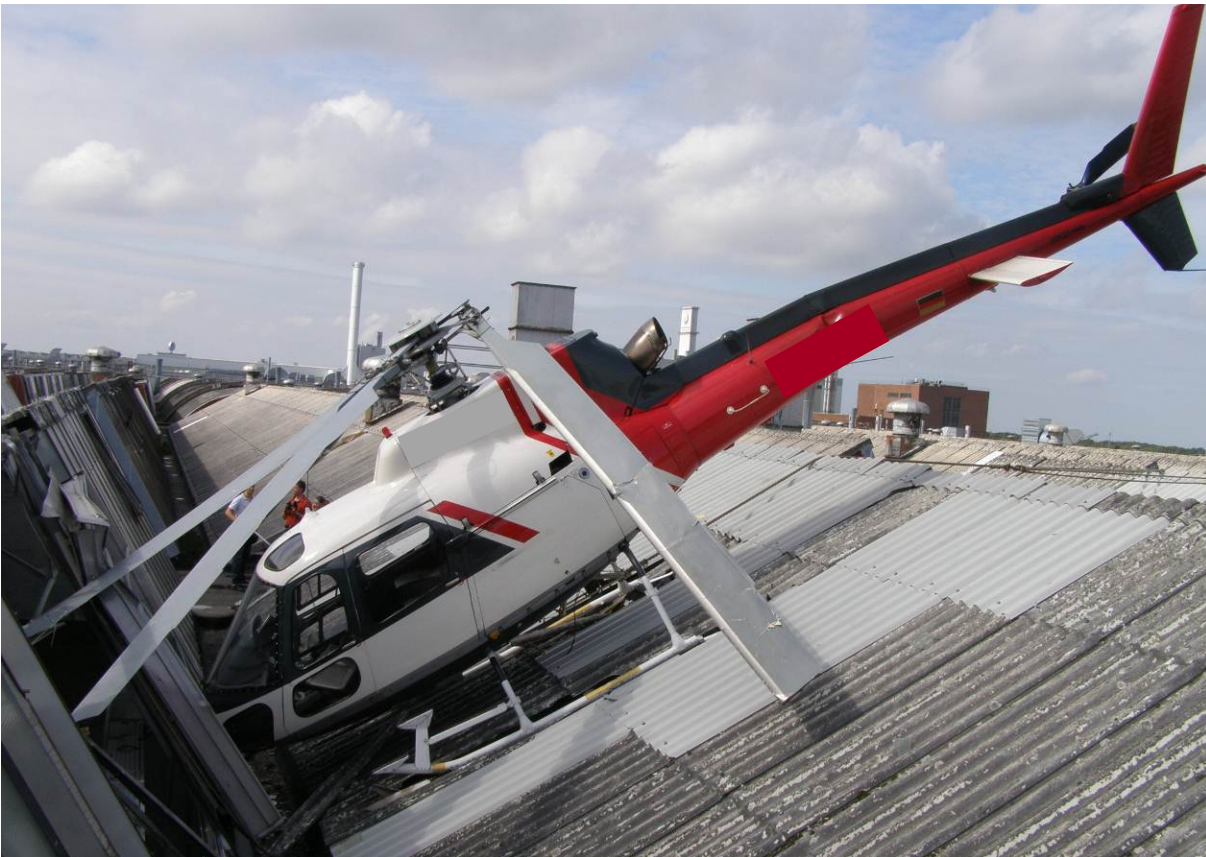
The accident site was located on factory premises in Hanover. The helicopter stood nose down on one of the pitched roof areas of the shed roof of the factory workshop. The external load stood behind the helicopter and was still attached to it. The load rope was stretched tightly.

All three rotor blades were severely damaged and the blade roots were partially fractured. The nose was damaged. The tail boom was bent level with the registration markings. No fuel was leaking onto the accident site. Roof panels beneath the landing skids and on the shed roof in front of the helicopter and windows were damaged.

After the salvage operation of the helicopter, a remaining fuel quantity of about 2 litres was drained from the tank.

Accident site overview
