Investigation Report

Type of Occurrence:	Serious incident
Date:	9 August 2011
Location:	Near radio beacon WLD
Type of aircraft:	1. Airplane 2. Airplane
Manufacturer / Model:	1. Cessna Aircraft Company / Cessna 172RG 2. Mooney Aircraft Corporation / M 20R
Injuries to Persons:	None
Damage:	None
Other Damage:	None
Information Source:	Investigation by BFU
State File Number:	BFU 7X011-11

At 1204 hrs¹ an airprox between a Cessna 172RG and a Mooney M 20R occurred in airspace E about 3 Nautical Miles (NM) north-west of the radio beacon WLD (WALDA) in an altitude of 4,100 ft AMSL. The Cessna flew in accordance with

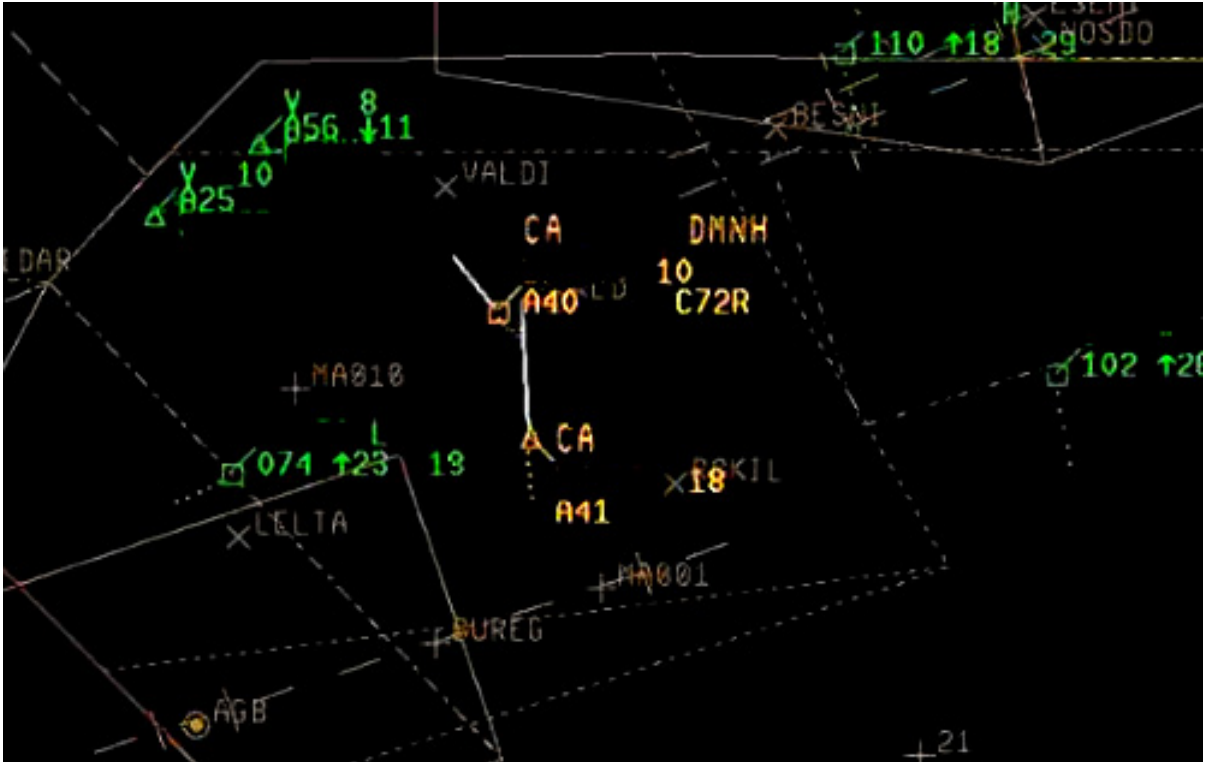
At 1202:20 hrs at a distance of about 3 NM the STCA changed from predicted to current. The radar targets changed from yellow to red. Another acoustic signal did not occur and was not intended.

Image 2: 1202:20 hrs – Current alert

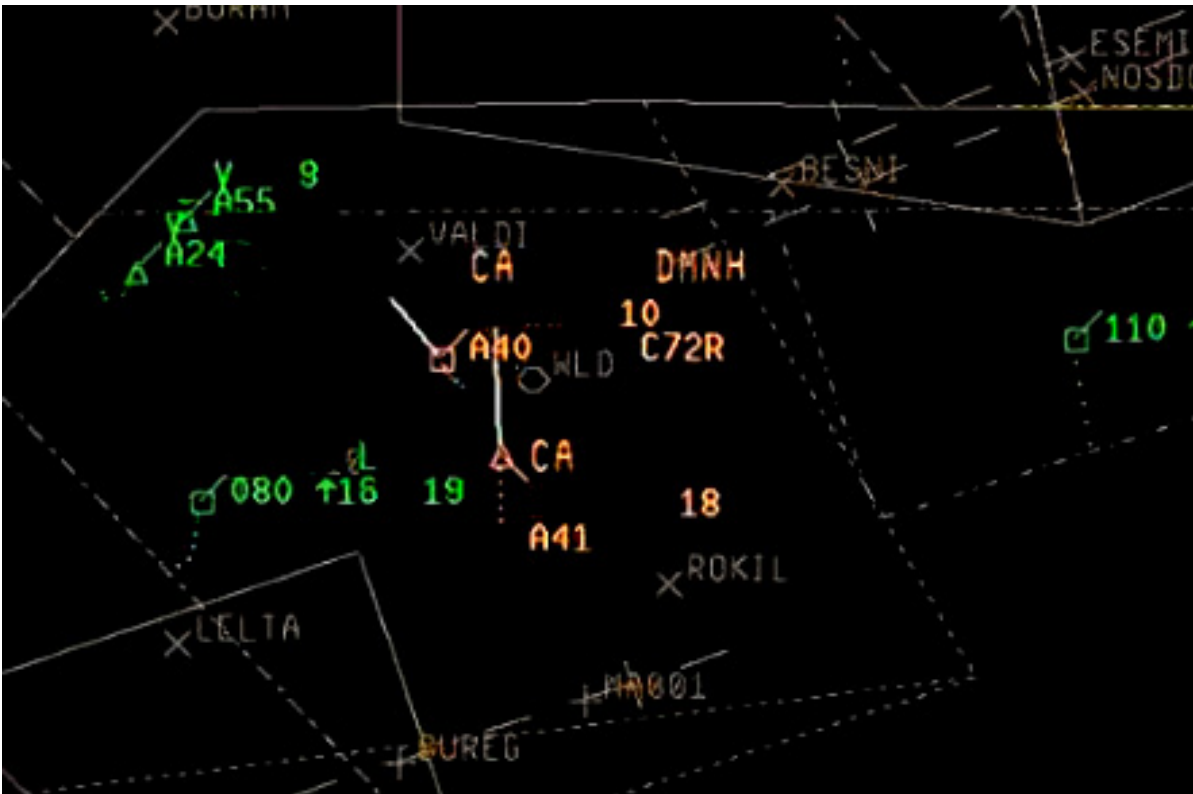
At 1203:05 hrs the Cessna crew reported "(...) ready for approach after completing this holding" and at 1203:09 hrs received a clearance for a standard instrument approach to runway 25: "... after completion of the holding you are cleared for the standard ILS runway 25". At the time, the Cessna had a heading of about 310°. Shortly afterwards the crew initiated a right-hand turn. At the time the distance between the two aircraft was about 2 NM.

Image 3: 1203:05 hrs

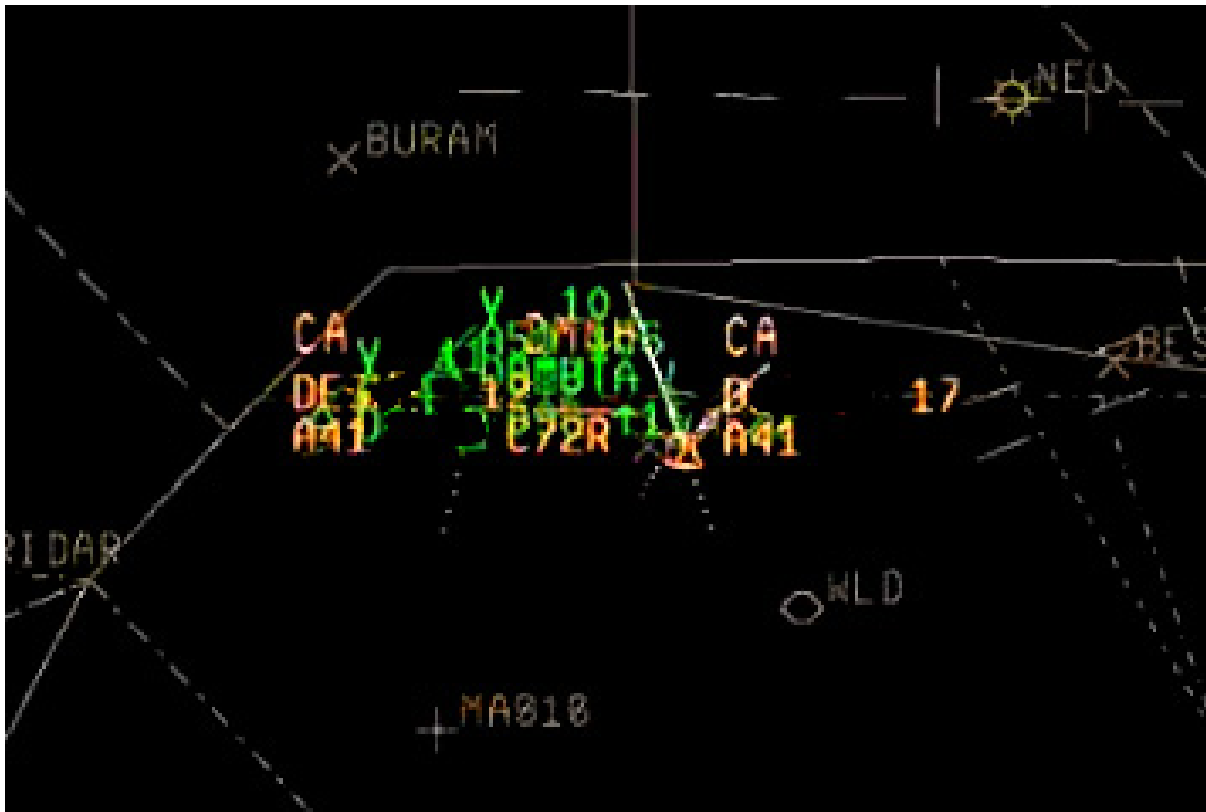
At 1204:14 hrs while the Cessna was just about passing 060° the airprox with the Mooney occurred. At 1204:17 hrs the flight instructor subsequently informed the controller who had just taken over the position about the occurrence. He answered: "... roger, you are inside airspace E".

Image 4: 1204:14 hrs - Time of the closest proximity

Due to the temporary overlapping of the labels and the radar targets the indication on the radar screen was at times unclear (see image 4). The clarity on the radar screen would be considerably increased if the overlapping of information were avoided and therefore the workload would be decreased.

- The visual and acoustical warnings (STCA) were not sufficient to draw the controller's attention to the impending conflict.
- The controller had a high workload due to the complexity of the air traffic.
- Because the labels overlapped it was not possible at times to accurately track the radar targets and to extract data from the labels.
