Investigation Report

Type of Occurrence:	Accident
Date:	14 December 2011
Location:	Berlin-Tegel Airport
Aircraft:	Airplane
Manufacturer / Model:	Bombardier / DHC8-300
Injuries to Persons:	One person severely injured
Damage:	None
Other Damage:	None
Information Source:	Investigation by BFU
State File Number:	BFU AX001-11

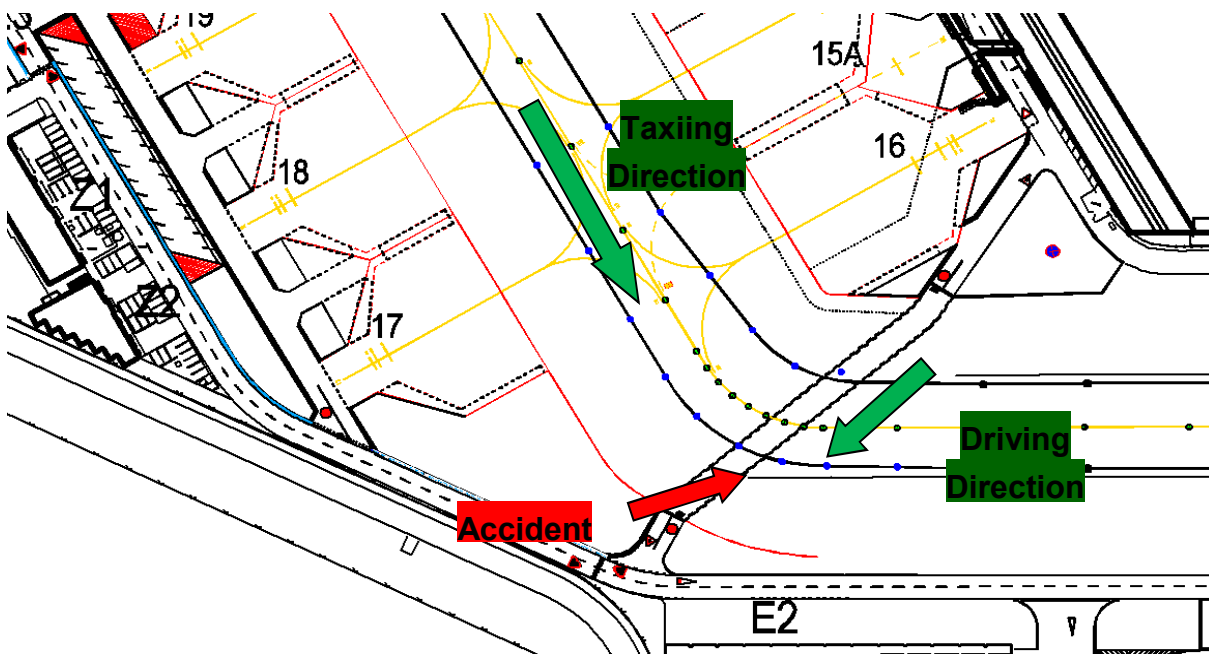
Apron in the area of stand 16

According to the statements of the crew, at 2017:25 hrs they had to brake heavily abreast of stand 16 because a vehicle coming from the left did not stop at the holding position of the road intersecting the taxiway and cut across in front of the airplane.

The accident occurred on taxiway PW abreast of stand 16. The airplane was taxiing south and came to a stop before reaching the road. The car drove south-west on the road intersecting the taxiway. Shortly behind stand 16 the road intersects the taxiway. Airplane and car remained undamaged.

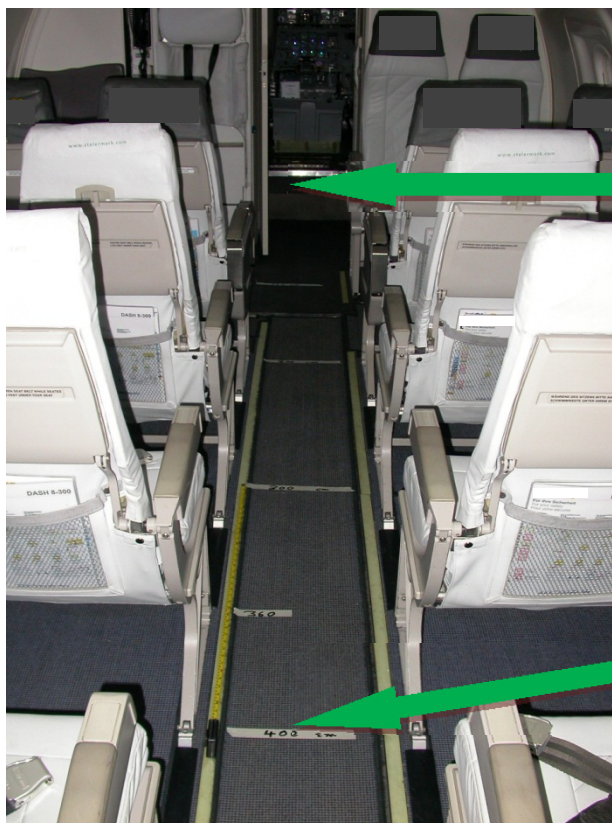
That is when the flight attendant fell. She stated that at that time she had been talking to the passenger in seat 4c and had given her nosedrops from the first aid kit. According to her statement, prior to talking with the passenger she had been checking the seat rows and seat belts.

When all of a sudden the airplane braked she could not find any support and was suddenly thrown toward the cockpit. The right side of her body hit the coat rack or the cockpit door and she fell to the floor. The emergency physician was called from the cockpit.

The distance between row four and the cockpit door is about four meters.

Position of the flight attendant after the emergency braking

Position of the flight attendant before the emergency braking

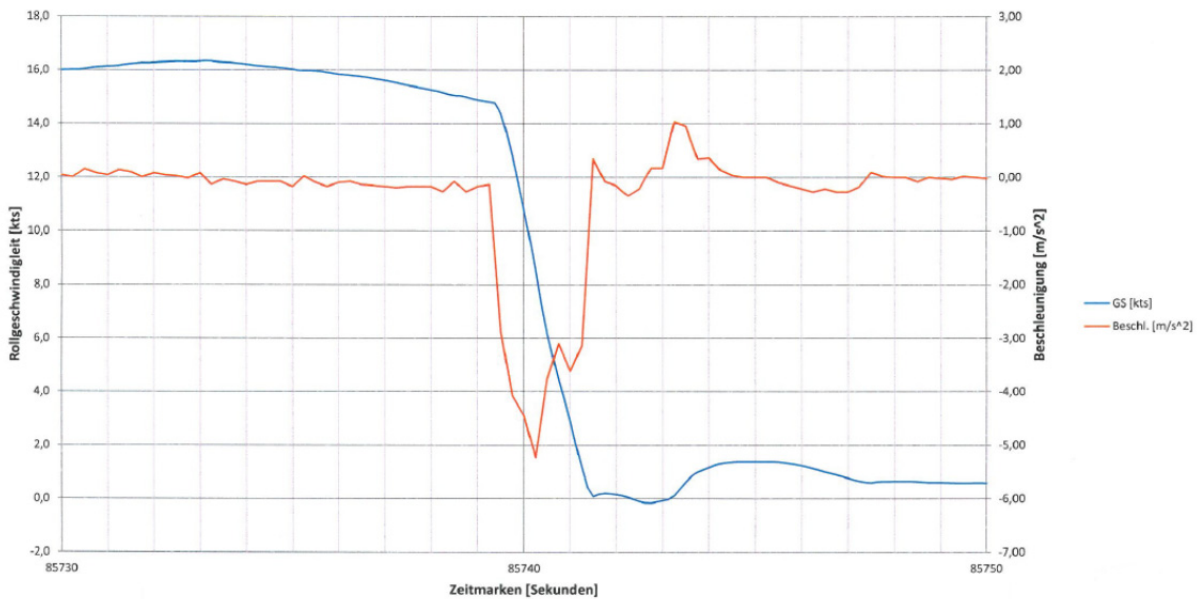
Flight data recorder analysis

The analysis of the flight data recordings showed a taxiing speed of about 16 kt.

According to the flight data recorder the airplane decelerated with about -5 m/s^2 until standstill.
