Investigation Report

Type of Occurrence:	Accident
Date:	25 March 2012
Location:	Near the county Gelsdorf
Aircraft:	Helicopter
Manufacturer / Model:	Aerospatiale / AS 350B2
Injuries to Persons:	Pilot severely injured, three passengers and one ground crew member with minor injuries
Damage:	Aircraft severely damaged
Other Damage:	Crop damage
Information Source:	Investigation by external expert for field investigation and BFU staff members
State File Number:	BFU 3X014-12

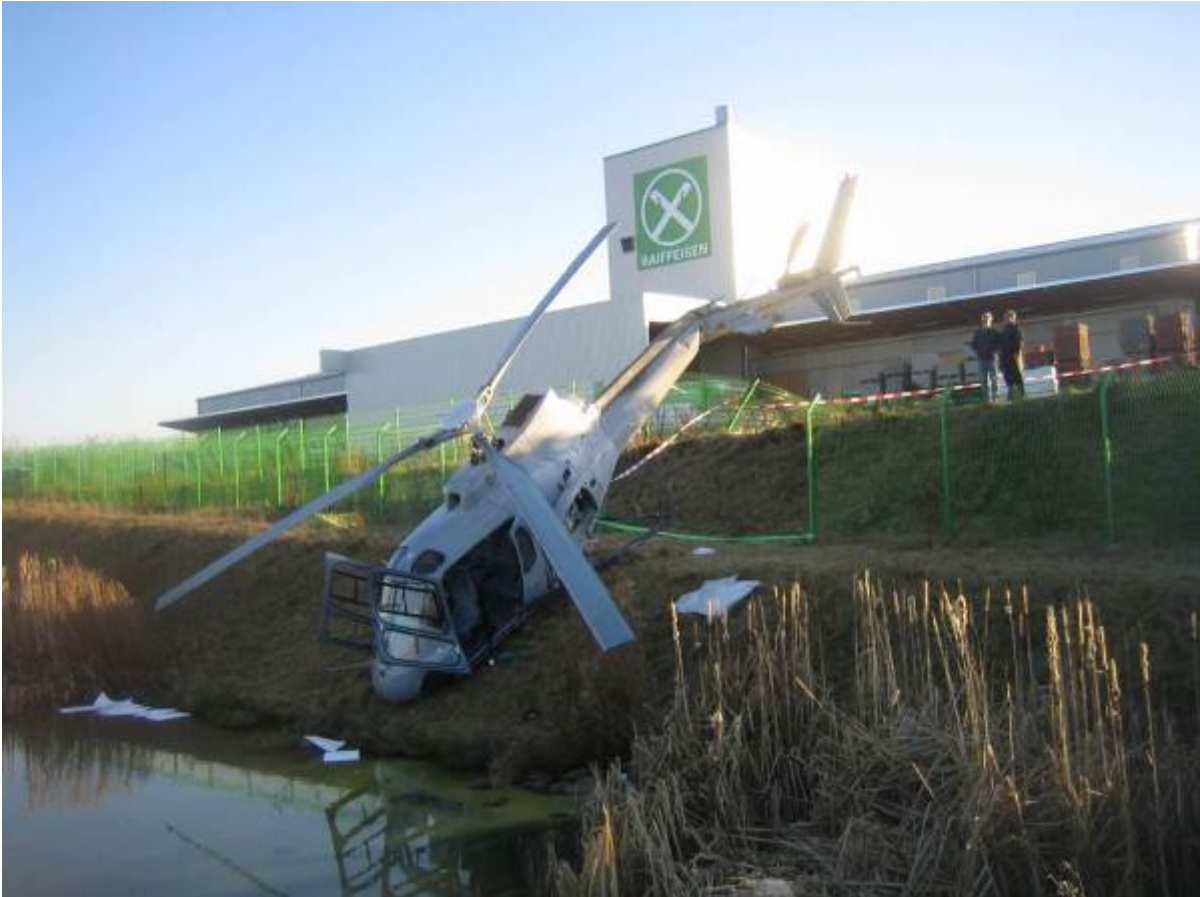
Overview take-off site, accident site, fire protection pond

The pilot stated during an interview by the police that after the engine failure he had tried to cross the fence in front of him and to settle the helicopter in the fire protection pond also in front of him.

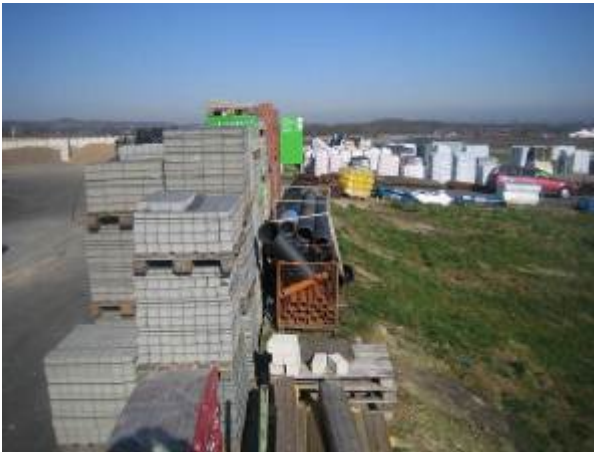
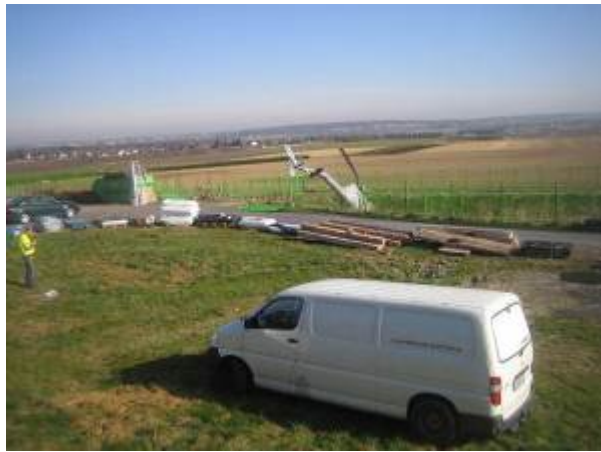
The take-off site for the planned sightseeing flight was located in the rear property area of an agriculture business. The entire estate was fenced in by a wire fence which was about 2 meters high. Stacked merchandise, building material, empty wooden pallets and other objects surrounded the take-off site on all sides. A red and white plastic chain cordoned off the take-off site.

Overview take-off site and surrounding objects

The chosen take-off and landing site was suitable only to a limited extent. The area behind the agriculture business was surrounded by goods which were partially bulk goods. During take-off and landing there was always the danger of objects being pulled up by the downwash and thrown at bystanders or sucked into the rotor. Take-off and landing paths were not free of obstacles. This resulted in a steep take-off and landing profile. Due to this, the helicopter was for a short period of time in altitude and speed areas which were, according to the flight manual, unfavourable for successful autorotations in case of engine failure. The chosen site did not correspond with the site stipulated in the permission.

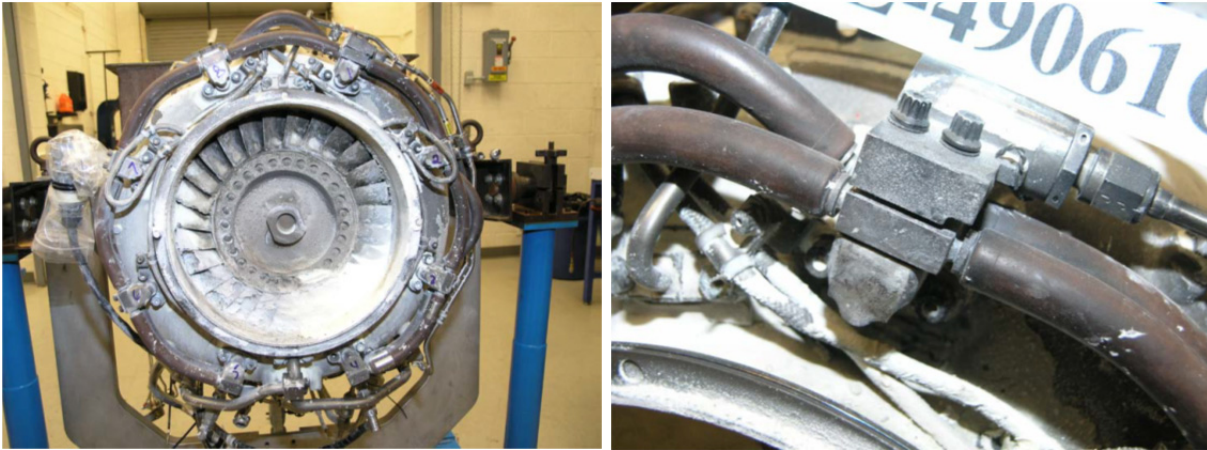
Two screws of the fuel divider on the fuel injector ring around the combustion chamber were found loose. The divider could be raised by about 3 mm. The divider has two seals one of which was missing. Fire traces were found in the area of the divider and the engine cowling.

extinguishing agent. Oil and fuel filter and the chip detector in the oil system were free of dirt and chips. The oil pressure sensor mounting was loose. Of the eight fuel nozzles only the one on the fuel divider was loose. A compressed air check was conducted which showed leakages on the T1 compensator, the fuel control housing, the Pg accumulator and the Pr accumulator.

Contamination with extinguishing agent and loose connections on the divider Photos (2): Honeywell

It was determined that the fuel flow divider bolts of the fuel nozzle No 1 most probably loosened due to the rotor imbalance when the gas producer turbine blade separated. The respective documentation for the engine overhaul showed the check mark for the correct tightness with the correct torque moment of 25 in-lbf according Service Bulletin (SB) LTS101-73-10-0240. During function test of the fuel injection system all measured values were within the prescribed target limits.

The loose screw connection on the fuel divider due to engine vibrations after the turbine blade separated was classified as a safety issue. An engineering change order is in process to implement safety wire on the flow divider bolts.

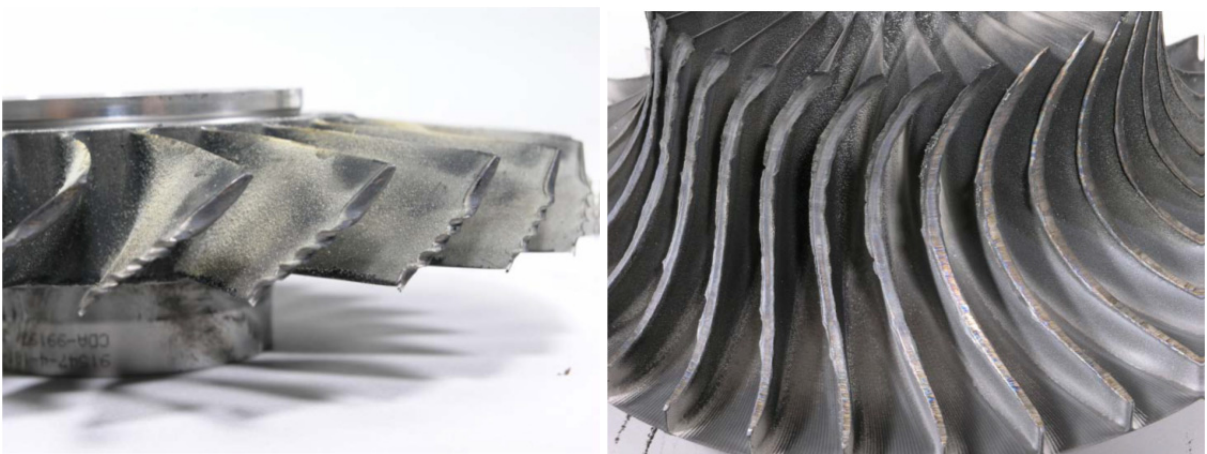
The compressor showed contact traces of the blades with the outer wall in the axial and the radial area. There were corresponding rub marks on the outer wall of the compressor. All rotor and guide blades were present.

Axial and radial compressor blades with contact traces

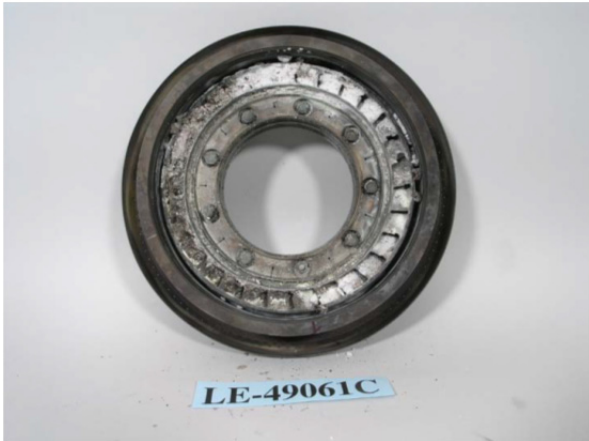
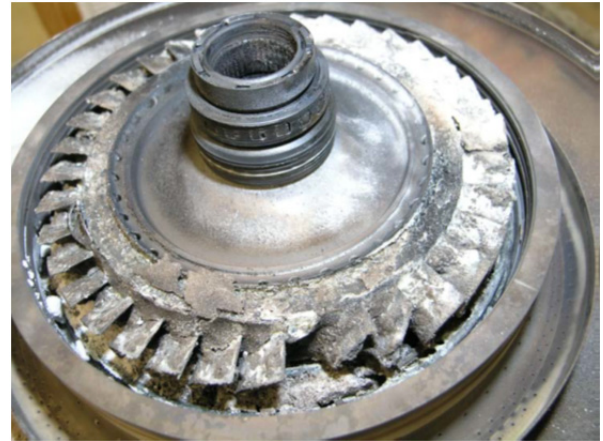
The gas producer module (N1) was disassembled and damages to the turbine nozzles were found. One blade of the gas producer turbine rotor was separated at the fir tree connection.

Damage to the nozzle vanes and separated turbine blades

Teardown and inspection of engine LE-49061C disclosed that the loss of engine power was due to a high cycle fatigue separation of a single gas producer turbine rotor blade. The HCF separation is believed to be due to abnormalities in the blade coating.

Honeywell aerospace, which applied the coating to the gas producer turbine blades, completed a design of experiments study to investigate the coating process. By packing coating media into the internal blade passages, Honeywell was able to duplicate the characteristics of the separated blade including internal coating thickness and aluminium content. The most likely scenario is that the blade was accidentally dropped into the coating media. Coating media may have remained inside the blade in the cooling passages during the coating process. In 2008 the coating procedure was changed and since then a similar incorrect coating could be eliminated. All other turbine blades from the same production lot were identified and 2013 removed from flight operations.

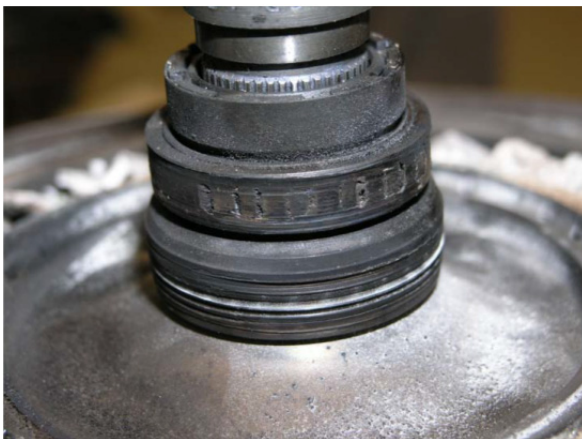
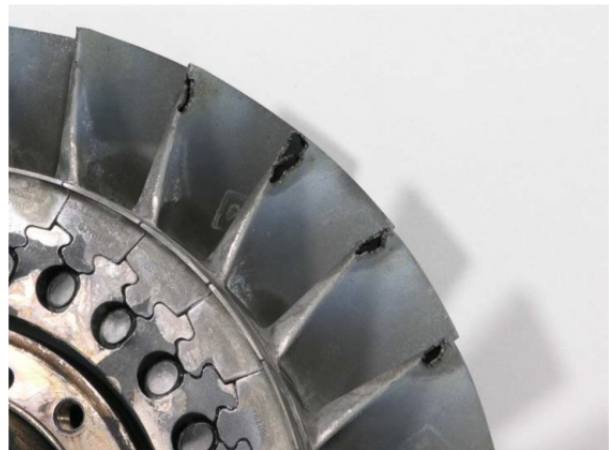
The rear bearing support housing of the turbine was loose and twisted by about 180°. The No. 2 bearing and bearing races were intact but the roller elements were flattened. The power turbine module was comparatively intact but individual blades had damage to the leading edge.

Damages on the rear main bearing and the power turbine

The rear main bearing is normally located in a bearing housing which is connected with the outer turbine wall by 18 welding points. The bearing housing was torn off and twisted by 180°; the oil supply pipes were torn off. Three of four welds illustrated features consistent with fatigue. In the view of the laboratory the examination was difficult because the fracture surfaces were "smudged" and damaged, respectively.

When the gas producer turbine blade separated, the resulting rotor imbalance and vibration caused the bolts fastening the flow divider to the #1 fuel nozzle to loosen and fuel to leak from the joint, resulting in a fire in the engine nacelle. The rotor imbalance and vibration also caused the rear bearing support housing stitch welds to fracture and flatten the No. 2 bearing roller elements.

Low weld penetration and starting fatigue fractures in the rear bearing support housing was classified as a quality issue. Root cause and corrective actions are underway with the vendor of the part.

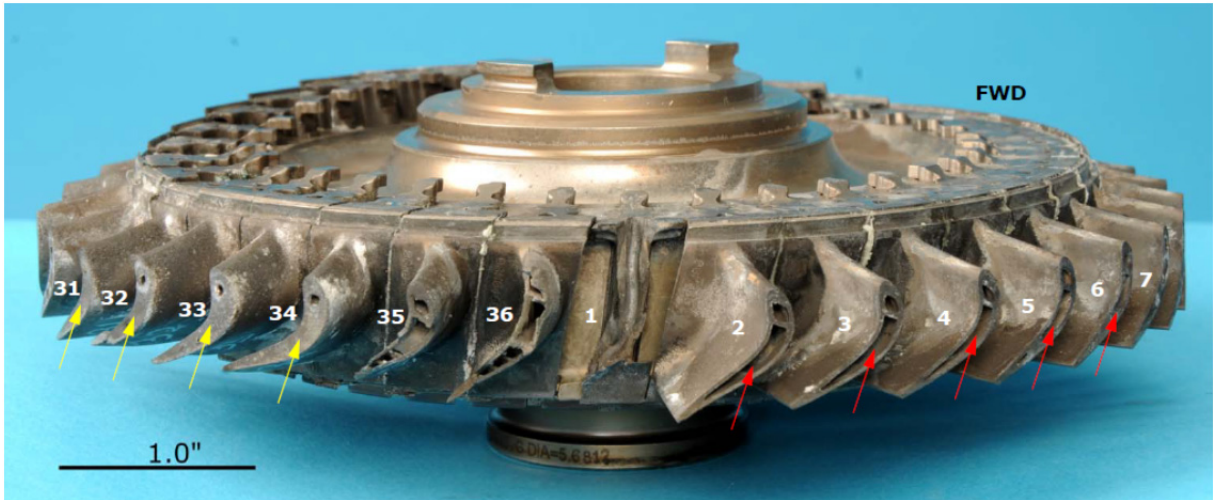
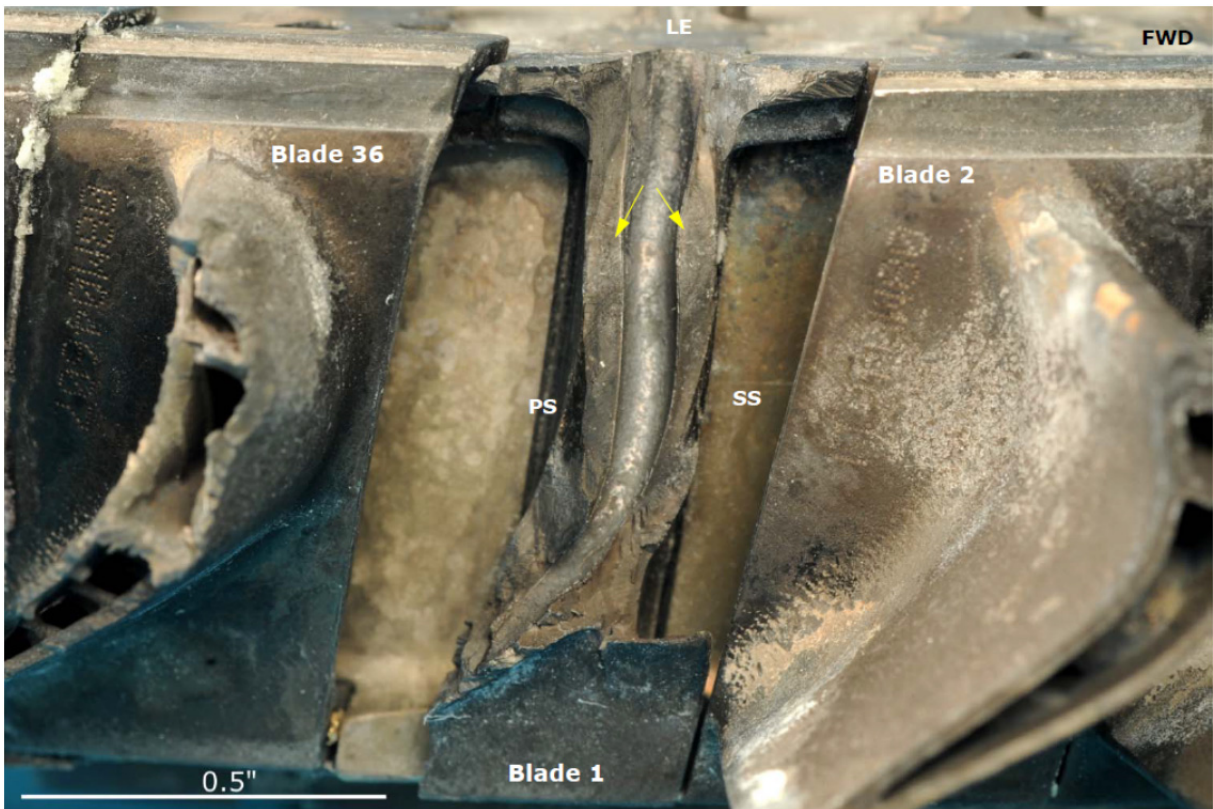
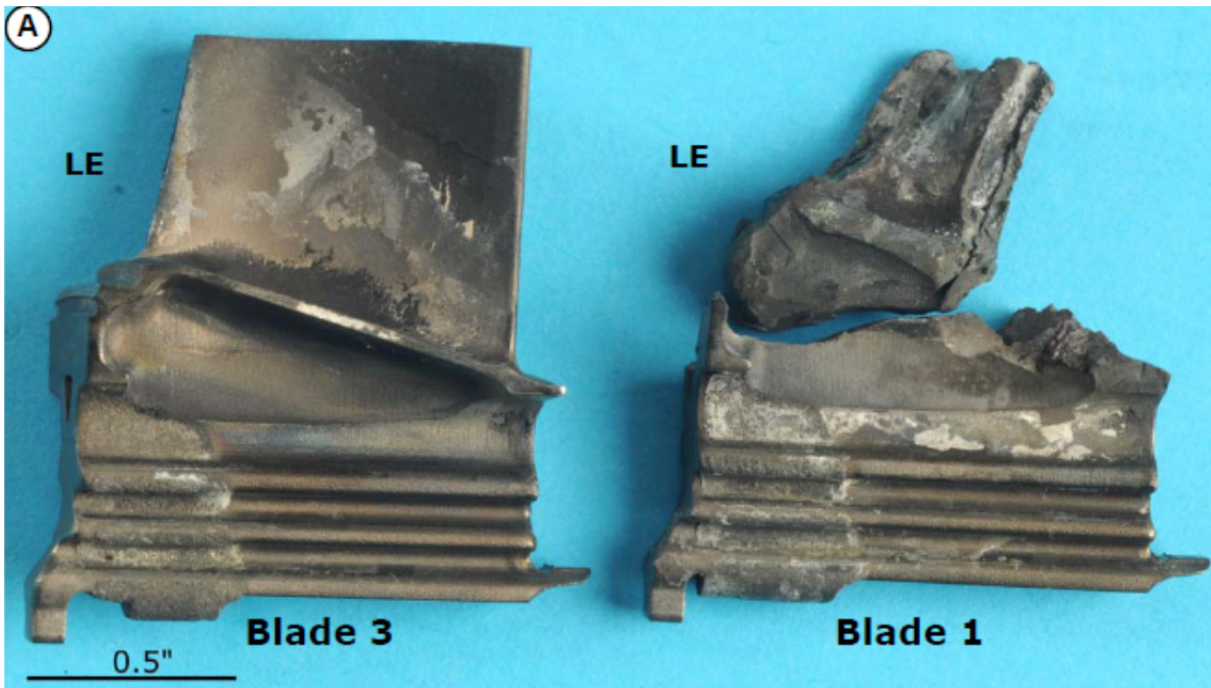
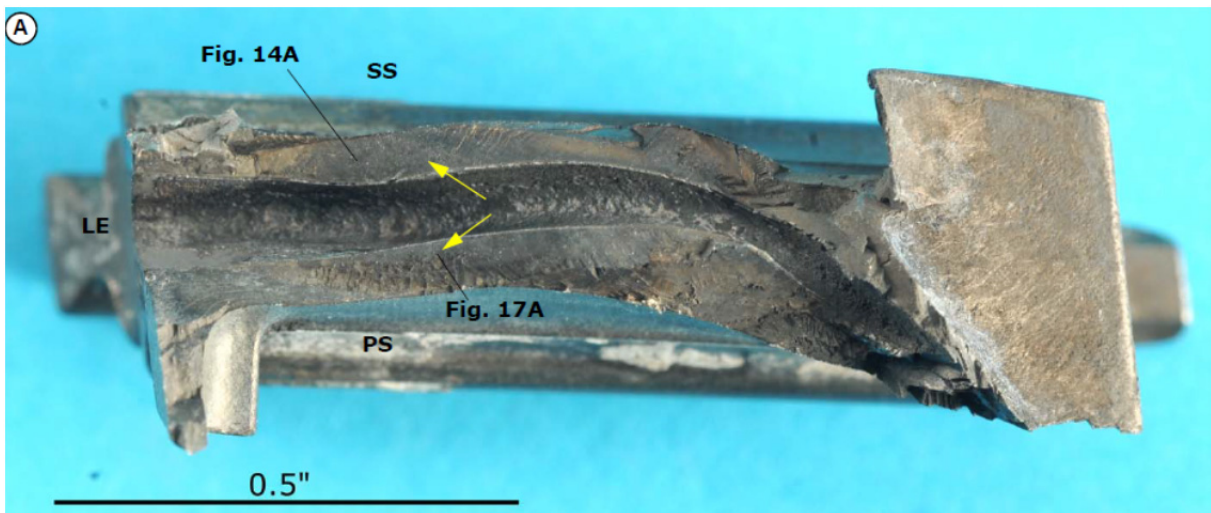
Appendix 4: Photos of the examination of the torn-off turbine blade (N1)

The investigation of the remainder of the torn-off gas producer turbine blade determined a high cycle fatigue fracture as cause. The fatigue fracture began in the area of the inner cooling air flow where the coating was either brittle or missing (Appendix 4). Based on these findings, additional gas producer turbine rotor blades of the same production lot were examined which did not determine any irregularities or deficiencies in coating.

would have made operation of the engine impossible due to pressure and fuel loss and a progressing bearing failure would have produced chips and metal abrasion. The oil supply was free of chips, however. Further examination of the remaining blade base revealed unambiguous signs of fatigue fracture, so-called high cycle fatigue, probably caused by a faulty coating of the cooling duct within the blade.
