Investigation Report

Type of Occurrence:	Accident
Date:	9 September 2012
Location:	Roßfeld Glider Airfield
Aircraft:	Helicopter
Manufacturer / Model:	Eurocopter / EC 120B
Injuries to Persons:	Pilot and passenger suffered minor injuries, one spectator was fatally, two spectators were severely injured and one spectator suffered minor injuries
Damage:	Aircraft severely damaged
Other Damage:	Persons and vehicles
Information Source:	Investigation by BFU external experts for field investigation
State File Number:	BFU 3X133-12

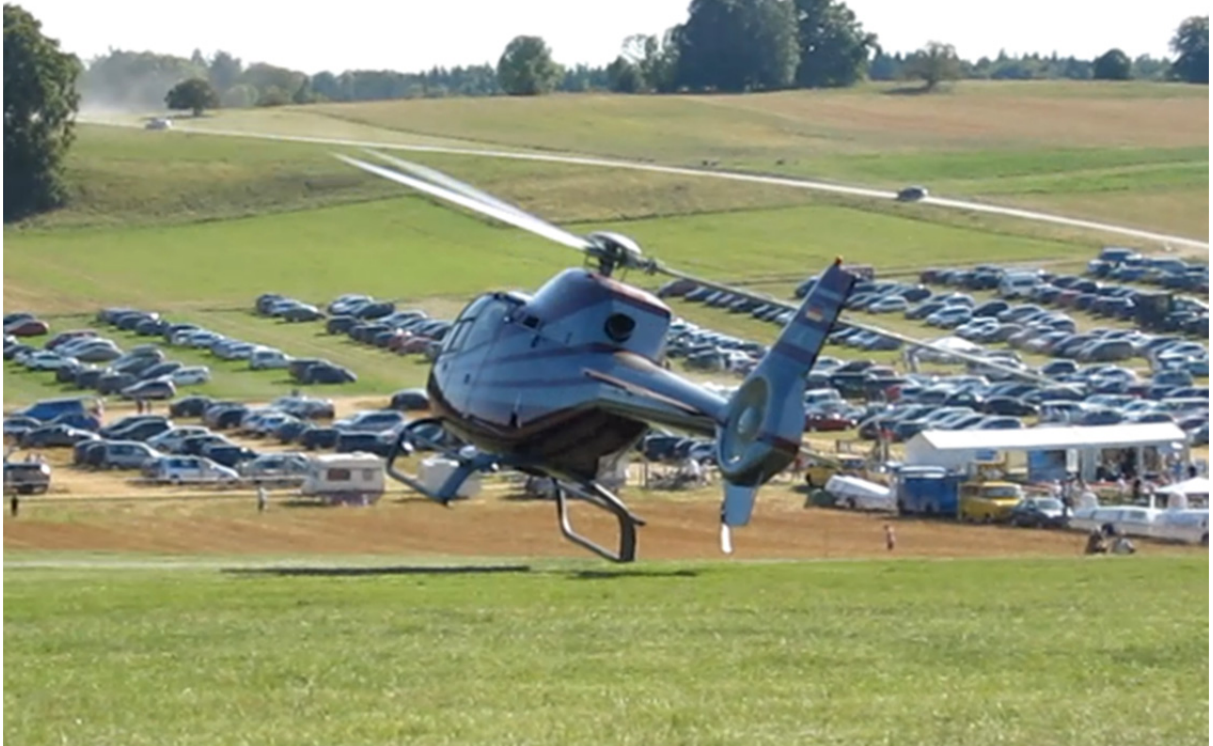
Single image of the accident, the right landing skid "hooks" into the meadow

The video recordings of the accident show a typical so-called dynamic rollover which resulted in the accident. After the sideways hover the left skid had ground contact which resulted in deceleration and caused the right skid to have ground contact, together with the tail skid it served as pivot point for the tilting helicopter.

Due to the selected hover height being too low an inadvertent ground contact of the skids during sideways hover occurred as result of which the helicopter rolled over.

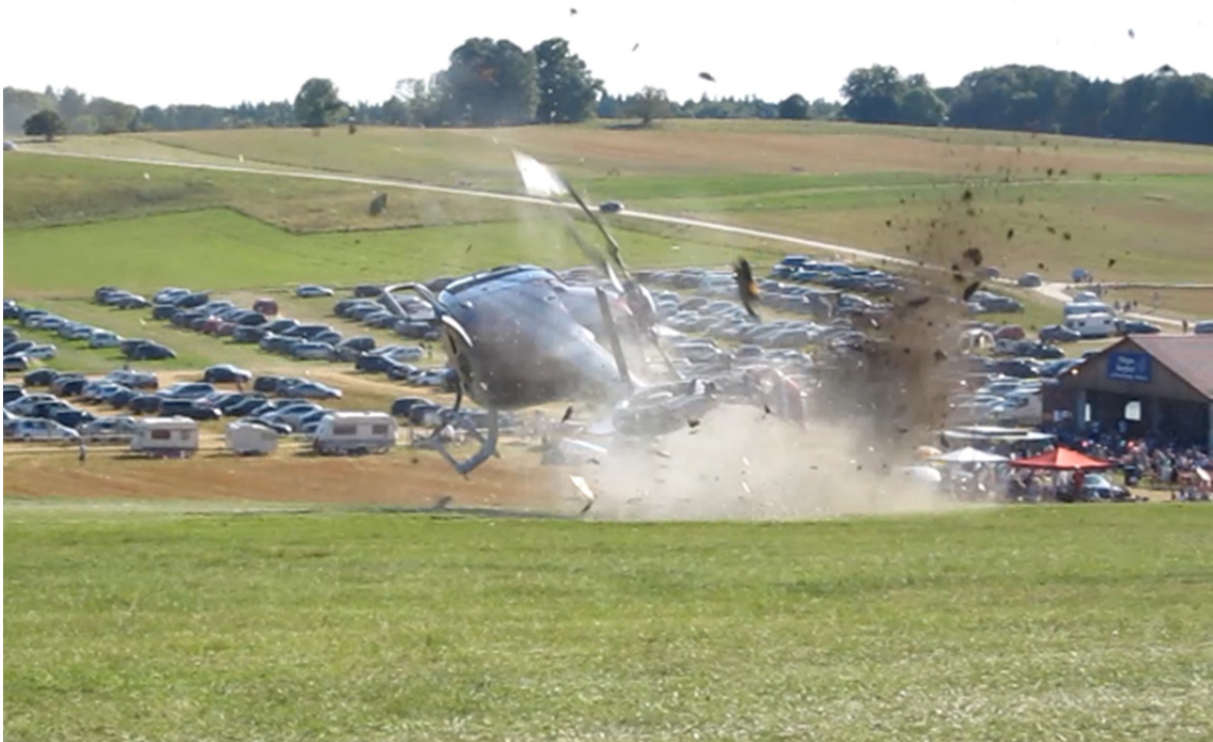
Four spectators were injured and one vehicle was damaged by parts of the main rotor or cube-like weights from the main rotor blades flying through the air. One of the injured spectators died as a result of his injuries at the site.

Parts of the rotor blades and earth flying through the air

The spectator who was killed had been about 45 m away from the accident site when he was hit by several weights from the main rotor blades. The weights had a dimension of 12 x 9 x 9 mm and weighed about 40 g. Two of the weights were found directly in front of the body and several during the post-mortem examination inside the body.

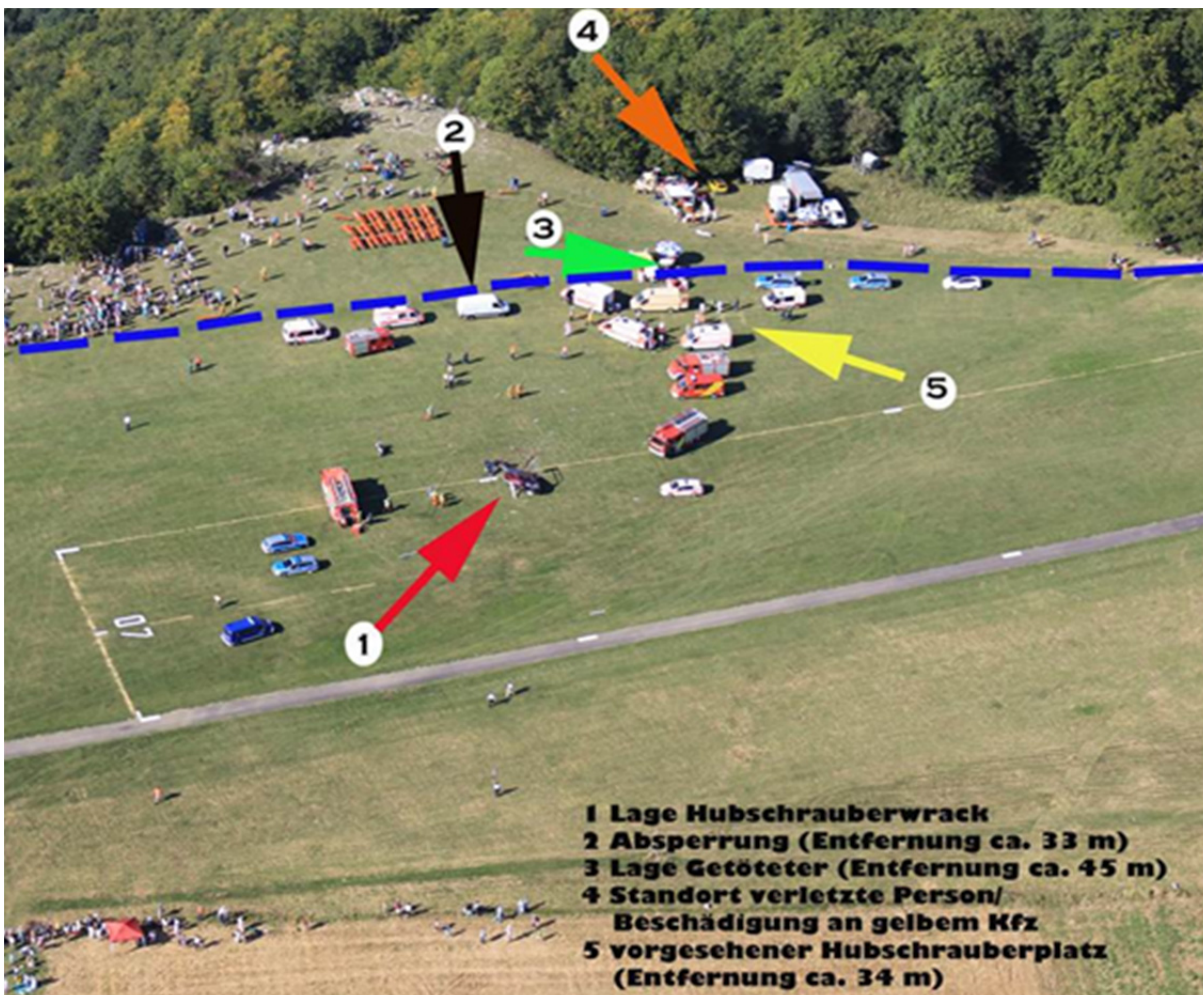
The helicopter in question had received its own parking position marked by an "H" written with saw dust north of runway 07 in front of the spectator barrier (blue line in the photograph). The helicopter also used this landing area the day before (Saturday). According to police investigation, on Saturday, the responsible official of the Aviation Supervision Office at the Regierungspräsidium Tübingen being at the site, ordered that the next day the landing area for the helicopter was to be moved to the western end of the asphalt track due to the limited space and the short distance to the spectators and that generally a minimum distance of 30 m between spectators and helicopter has to be observed.

Overview airfield, accident site and area for the spectators

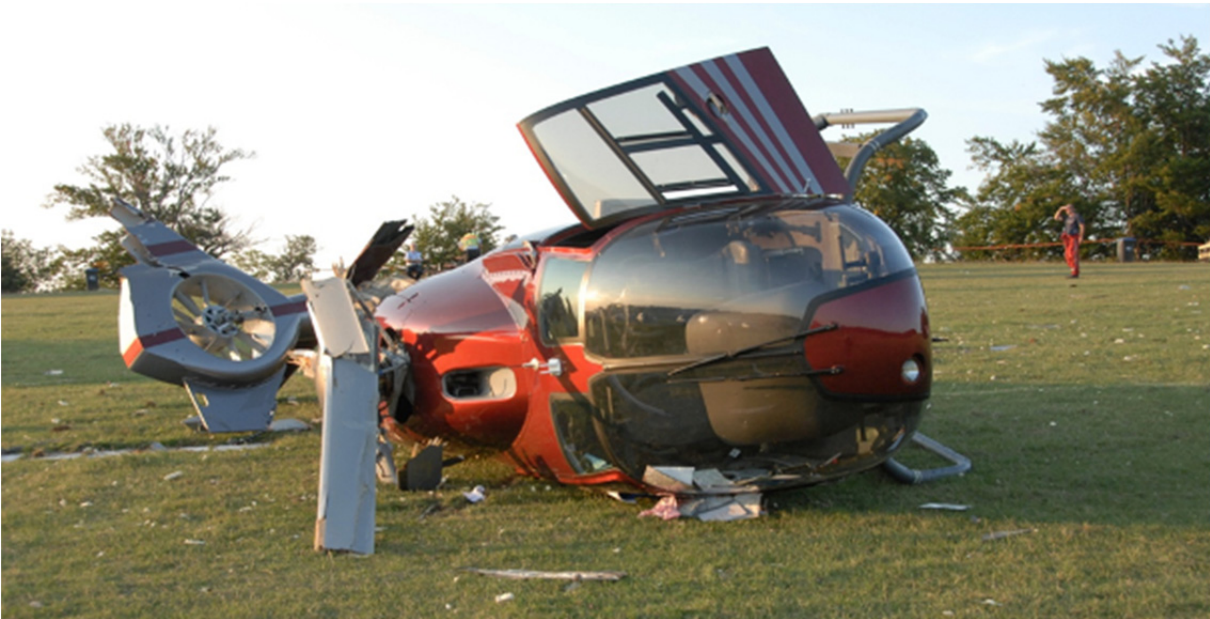
The helicopter rested on the right side. The torn off tail boom was found next to the fuselage and was only attached to the fuselage via the push-pull-cables of the Fenestron. The mounting point of the aft crosstube of the skids was torn out of the fuselage. Two of the three main rotor blades were torn off the main rotor hub, the remaining blade was bent. The torn-off blades had fractured into many individual pieces. The main drive shaft between the engine and the main gear box had fractured. Witnesses stated that the engine was still running until it was shut off after the helicopter had come to rest on its side. Evidence that the controls had been impaired was not found. The control rods to the swash-plate and to the engine controller had a frictional connection.

Helicopter wreckage

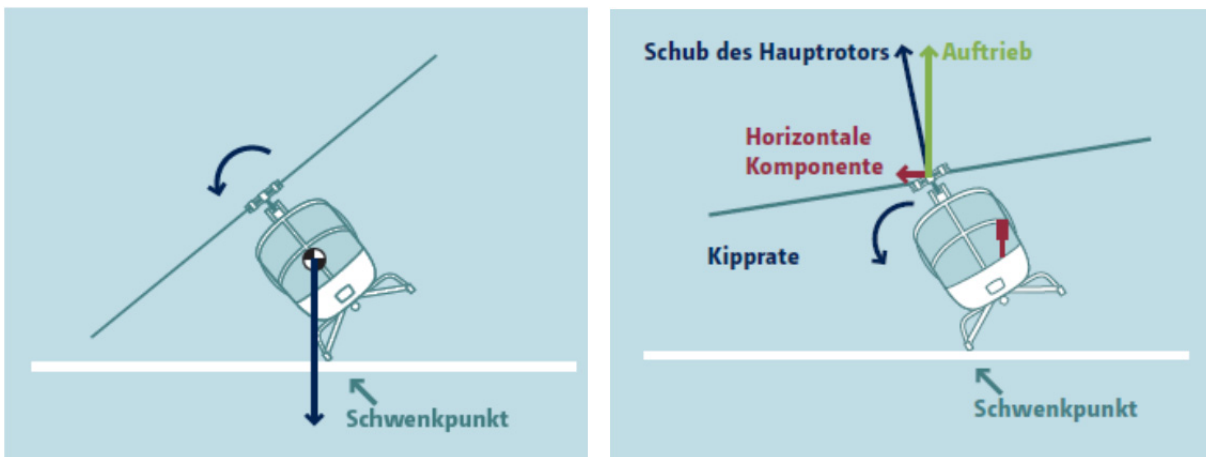
Helicopter can roll over under certain conditions. One skid has to have ground contact and serve as pivot point and a rolling movement has to be present. This is a so-called static or dynamic rollover. As soon as the critical roll angle is exceeded, the pilot has, generally, no chance to prevent the helicopter from rolling over. The attempt to pull the helicopter into the air by using the pitch usually quickens the roll over; therefore, it is recommended to push the pitch down immediately.

Static and dynamic rollover
