Investigation Report

Type of Occurrence:	Accident
Date:	5 December 2012
Location:	Neustädter Bucht
Aircraft:	Helicopter
Manufacturer / Model:	Eurocopter / AS 350BA
Injuries to Persons:	Pilot and system operator fatally injured
Damage:	Aircraft severely damaged
Other Damage:	None
Information Source:	Investigation by BFU
State File Number:	BFU CX024-12

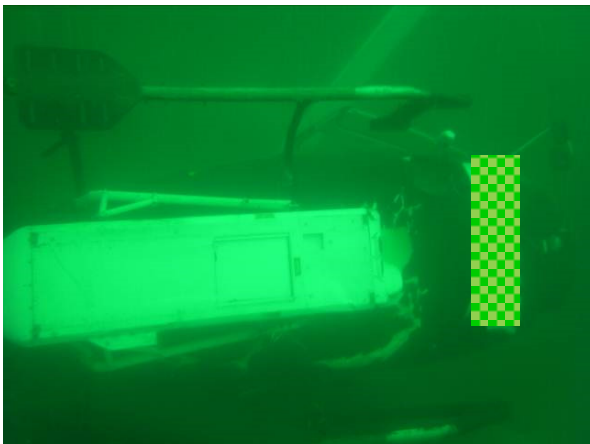
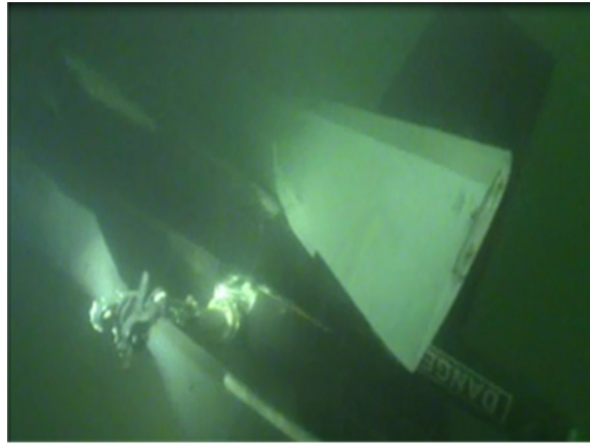
The helicopter was lying on the seabed of the Neustädter Bucht on its main rotor hub, tilted right toward the left fuselage side. The tail boom had been severed and was found next to the fuselage beneath the skid cross beam opposite to the fuselage direction with the horizontal stabiliser horizontally on the ground and the tail skid pointing upward. One of the main rotor blades jutted out and pressed down on the tail boom prior to the vertical fin with its trailing edge. In this area the trim edge of the rotor blade was damaged. The right cabin door, the safety belts on the seats front right and rear right were open. On the left front seat one of the two transport wheels attachable to the skids was fastened with the seat belt.

Fuselage lying on its side with open cabin door and tail boom

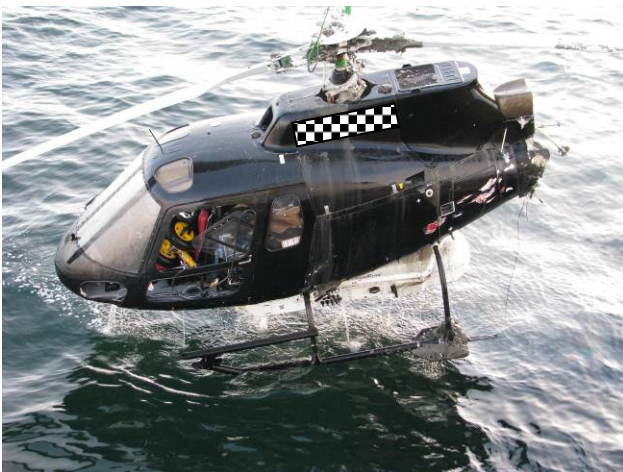
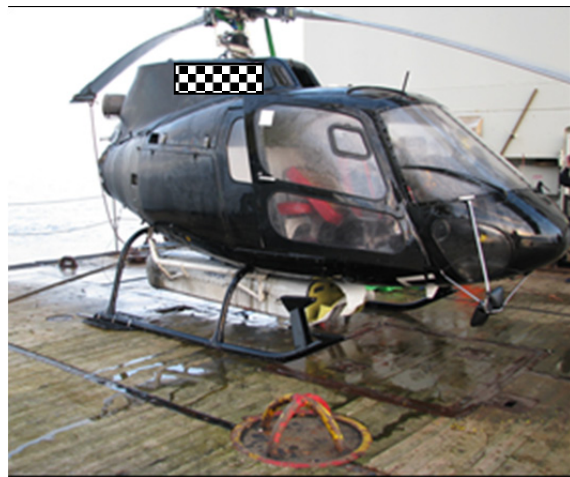
After the fuselage had been recovered it was determined that all maintenance compartment doors and fairings were closed and secured. The cabin's front windows and the window panes on the right side and the door were intact. The window panes of the left side were pushed inside the fuselage. The left bottom window pane was missing. The left lower fuselage side and the area of the front skid cross tube were pushed in. The front part of the TopEye™ cargo container was pushed in and torn open.

Fuselage after recovery

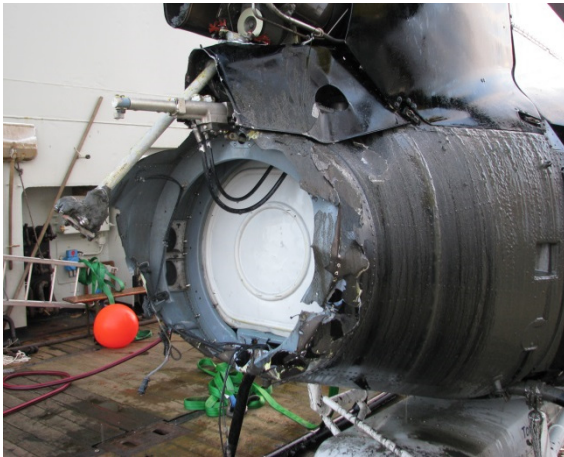
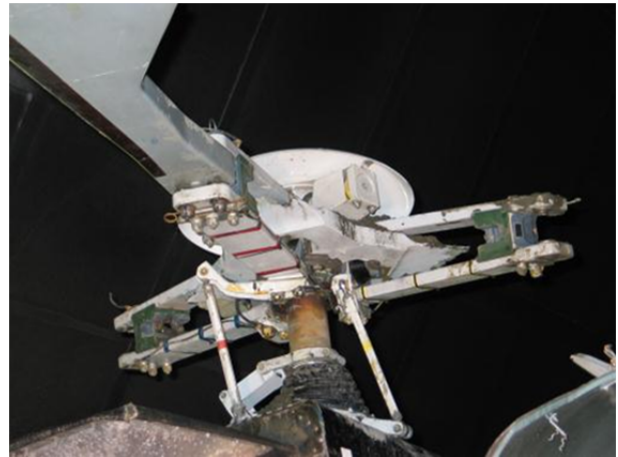
The main gear box, the engine, the control units and the hydraulic system did not show any apparent damages after the mud had been washed off. The fuel control lever was locked in position "flight". Of the three main rotor blades only the "yellow" showed slight damages in the area of the trim edge and the "red" blade had a bent tip at the end of the blade. On the rotor head the Star Flex to all three blade grips was

torn off. The power transmission from the turbine to the drive shaft, main gear box and main rotor shaft was connected. The free-wheeling unit opened and locked as designed. The sheet metal of the fracture area on the aft fuselage section where the tail boom had been torn off was dented on the underside, the right side was warped and the left stretched. The forward tail rotor drive shaft protruded from the aft fuselage section.

Damages on the aft fuselage section and the Star Flex rotor head

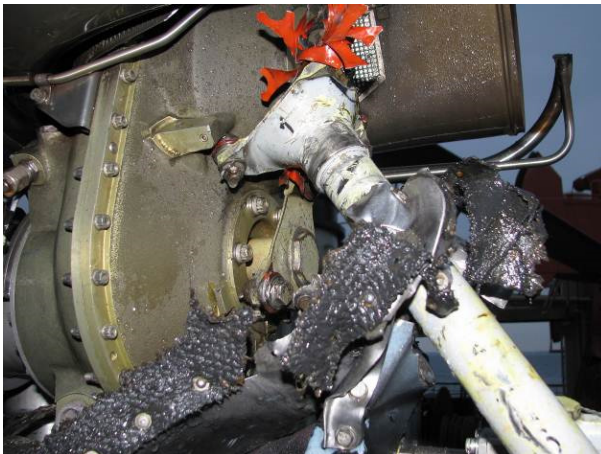
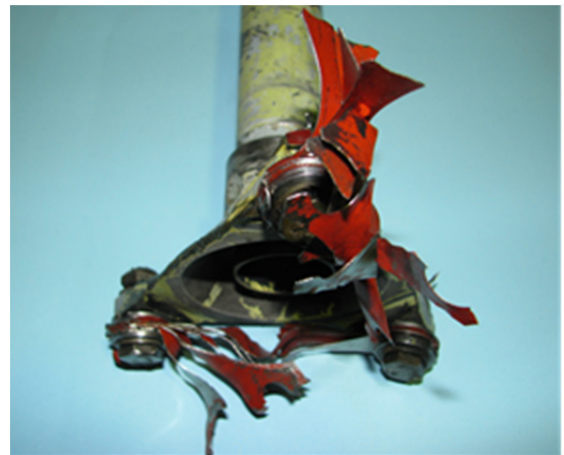
The forward flexible coupling of the tail rotor drive shaft on the engine's backside was torn. The fairing in this area and the two half shells surrounding the forward end of the drive shaft showed rotation tracks, were torn out of their mountings and damaged.

Damages on the forward coupling of the tail rotor drive shaft

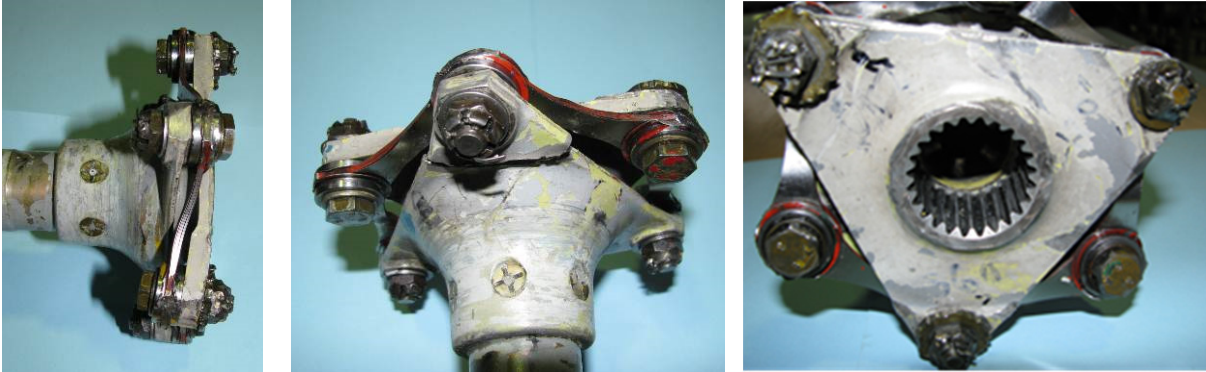
On the rear end of the tail rotor drive shaft the flexible coupling was pushed in, the flanks of the flanges were bent and one flange was torn off. On the outer side of the

splined flange rotation tracks were found. The securing nuts were deformed and the washers were partially jaggedly pushed in.

Damages on the rear coupling

The damages on the flexible coupling and the flanges of the aft part of the front tail rotor drive shaft can be traced back to the separation of the splined shaft due to elongation (the tail boom was bent downward during ditching) with the shaft still rotating until the front part of the coupling failed.

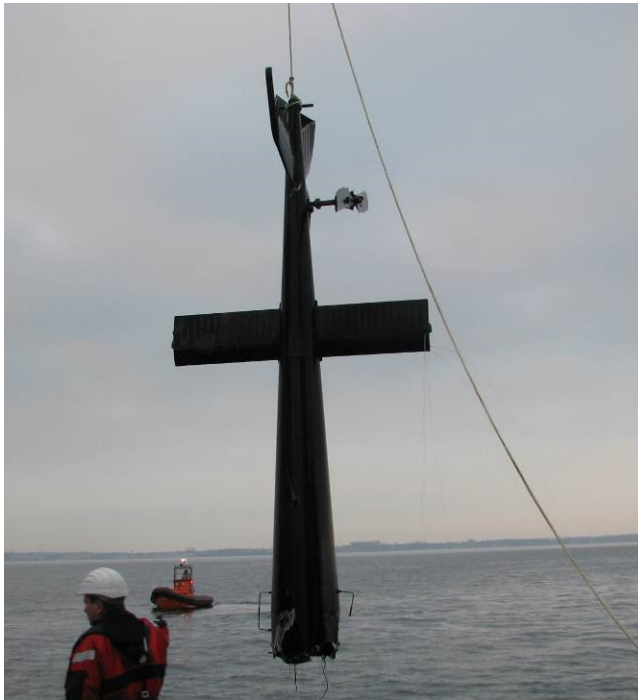
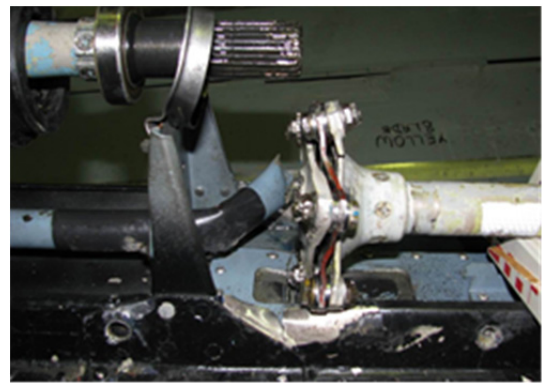
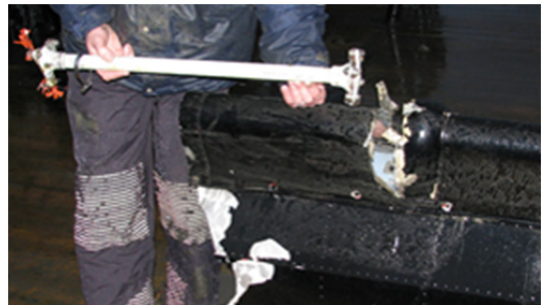
After the tail boom was recovered it was determined that the tail rotor was undamaged. Soot and combustion residue had not been washed off the tail rotor. One of the two pitch links was slightly bent. Except for the most forward tail rotor drive shaft fairing all segments of the fairing were intact. The rear tail rotor drive shaft could be turned soundlessly and without resistance. The tail rotor gear box transmitted the rotation and the tail rotor turned. The chip detector of the tail rotor gear box was free of chips. The tail rotor gear box was filled with water. The foremost segment of the tail rotor shaft fairing was milled from the inside out in the area of the flexible coupling. The foremost three quick release fasteners on the left side were torn out. The inside of the fairing showed straight scratch marks stretching from the milling groove to the forward fairing opening. The tail rotor drive shaft was sent to France to the manufacturer for further investigation under BEA supervision.

Damages on the forward tail rotor drive shaft fairing and coupling

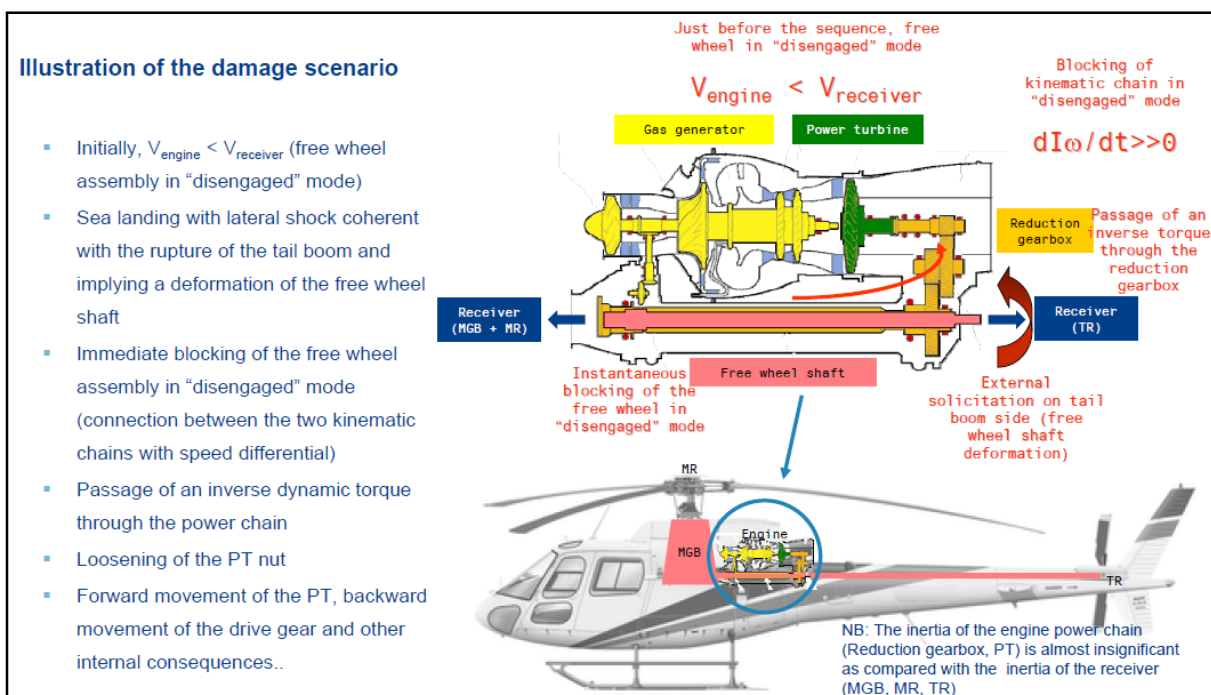
In the presence of BEA representatives the engine was fully disassembled and examined at Turbomeca facilities. The result was a 44-page investigation report detailing the damages found on the engine component. They were assessed to be consequences of the accident. The findings were: the free wheel sprags showed severe damage in the disengaged state, the aft part of the free wheel assembly was deformed, the power turbine (N2) splined nut was loose, and the power turbine showed light contact marks in the 8 - 11 o'clock position. Two teeth on the non-working flank of the reduction gearbox show contact marks. These findings allow the following conclusions:

Excerpt engine investigation report

The engine test conducted by the manufacturer indicated that at the time of ditching and bending of the tail boom the free-wheeling unit was disengaged. This would mean that the engine had failed or its rpm was less than that of the power transmission between main and tail rotor. The missing damages on the engine compressor and the N1 and N2 turbine blades support the assumption that during ditching the engine did not produce full thrust or high rpm.

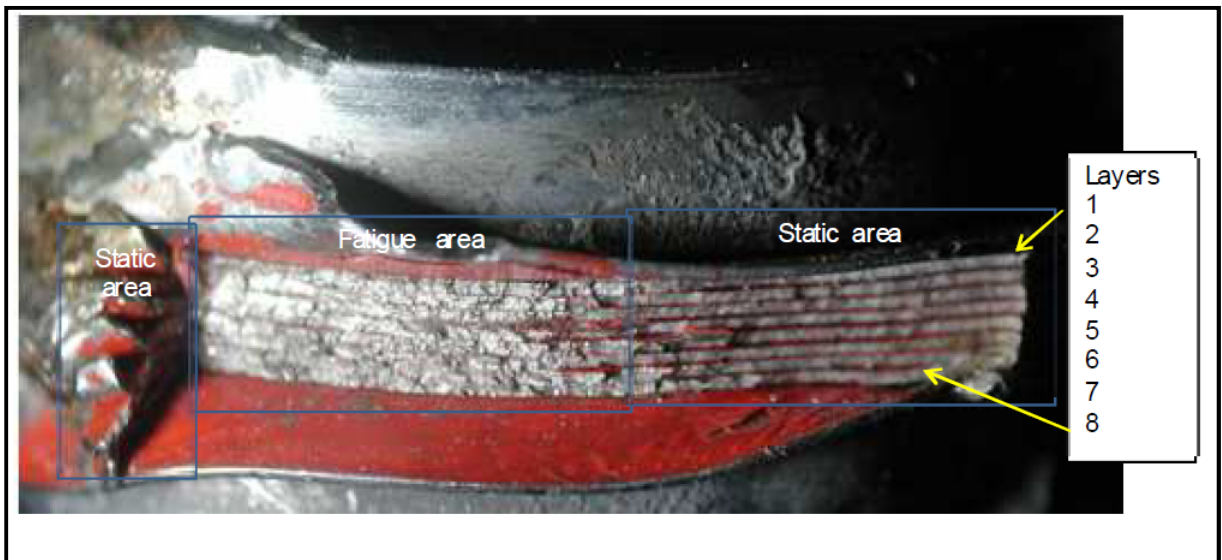
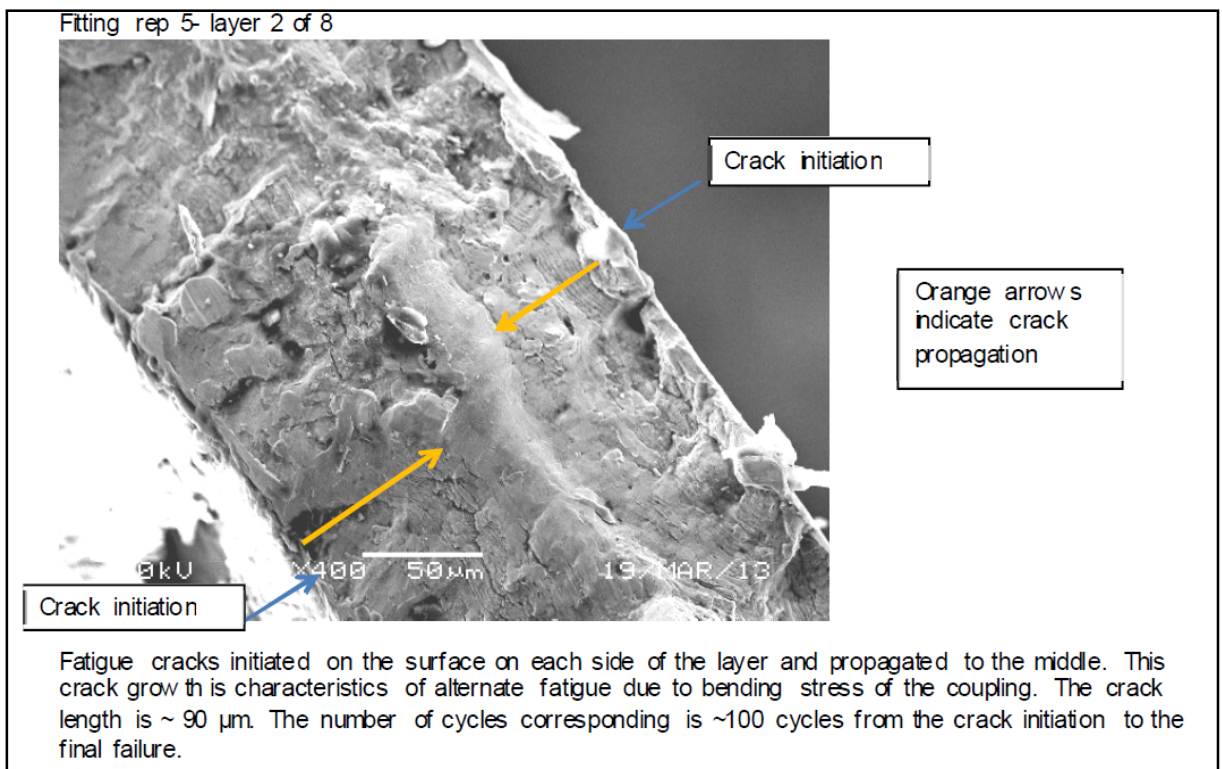
The tail rotor drive shaft with the splined shaft was examined at Eurocopter facilities under BEA supervision and a 24-page report prepared. The results were that the flexible coupling discs partially showed fatigue and forced fractures. Due to the size and dimension of the fatigue fracture striations the final fracture occurred after about 100 cycles.

Excerpts (2) from report of the examination of the tail rotor drive shaft

The examination of the tail rotor drive shaft and the flexible coupling determined that the front flexible coupling discs showed fatigue fractures after about 100 cycles due to excessive deformation before the coupling failed. This matched the probable course of the accident after ditching.
