Investigation Report

Type of Occurrence:	Accident
Date:	30 November 2013
Location:	Beesten
Aircraft:	Ultralight aircraft
Manufacturer / Model:	Evektor-Aerotechnik a.s. / EV 97 Eurostar 2000 R
Injuries to Persons:	Pilot fatally injured
Damage:	Aircraft destroyed
Other Damage:	Crop damage
State File Number:	BFU 3X137-13

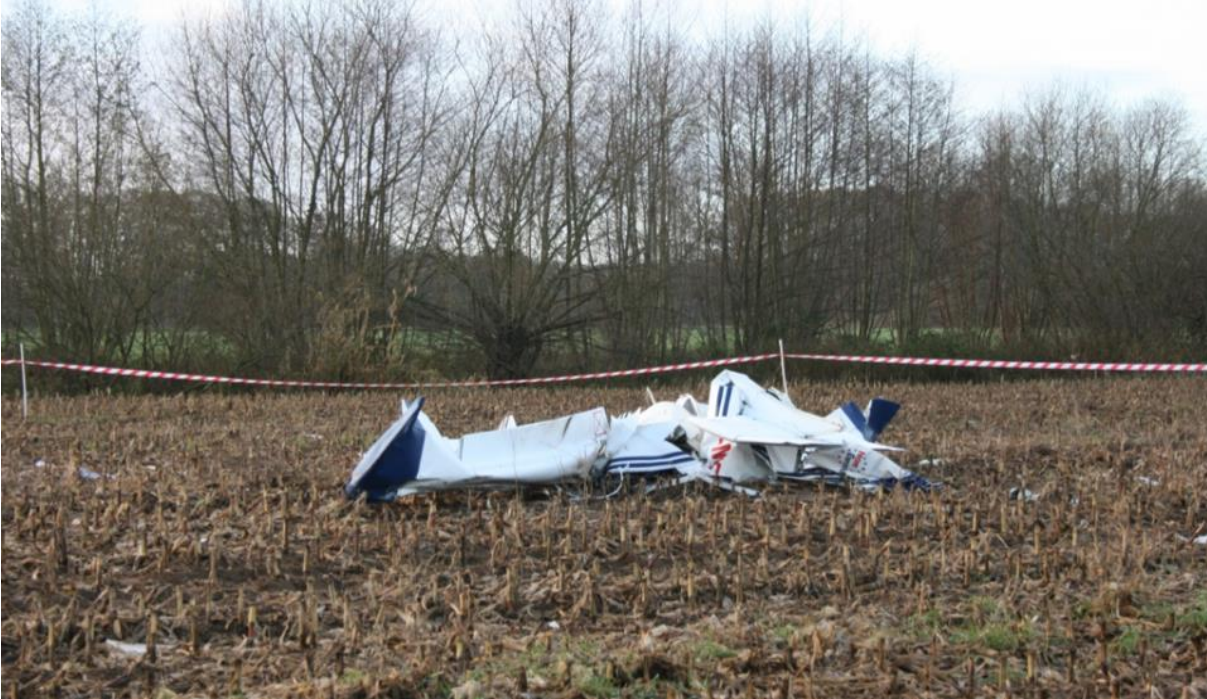
Accident site

In the engine area a severed propeller blade was found in the ground. The second propeller blade (Varia propeller) could not be found. Slivers of the glass canopy were found in a radius of 15 m around the wreckage.

Several pieces from the cockpit were strewn across a distance of approximately 500 m in north-west direction to the wreckage. Starting approximately 500 m before the accident site several aeronautical charts were found strewn across a distance of 300 m. The aircraft log book was found about 80 m south-east and a jacket of the pilot about 70 m south-east of the wreckage.

Fuel had leaked from the fractured fuel tank.

The wreckage was complete as was the control system.

The rescue system had not deployed. A member of the Bomb Squad of the Landeskriminalamt Niedersachsen (state office of criminal investigation) disarmed the rocket prior to the salvage operation.

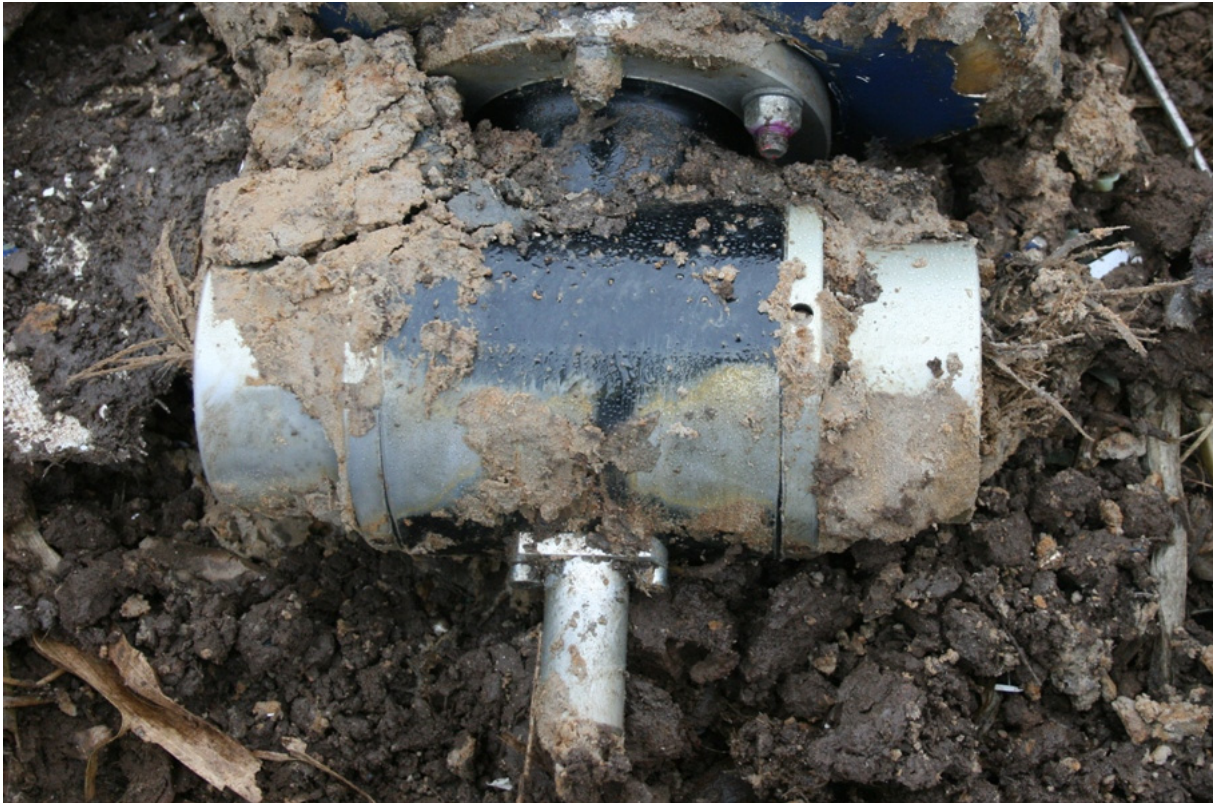
Propeller hub

The BFU examined the propeller flange and blade. The fractured blade correlated with the fracture surface on the propeller hub.

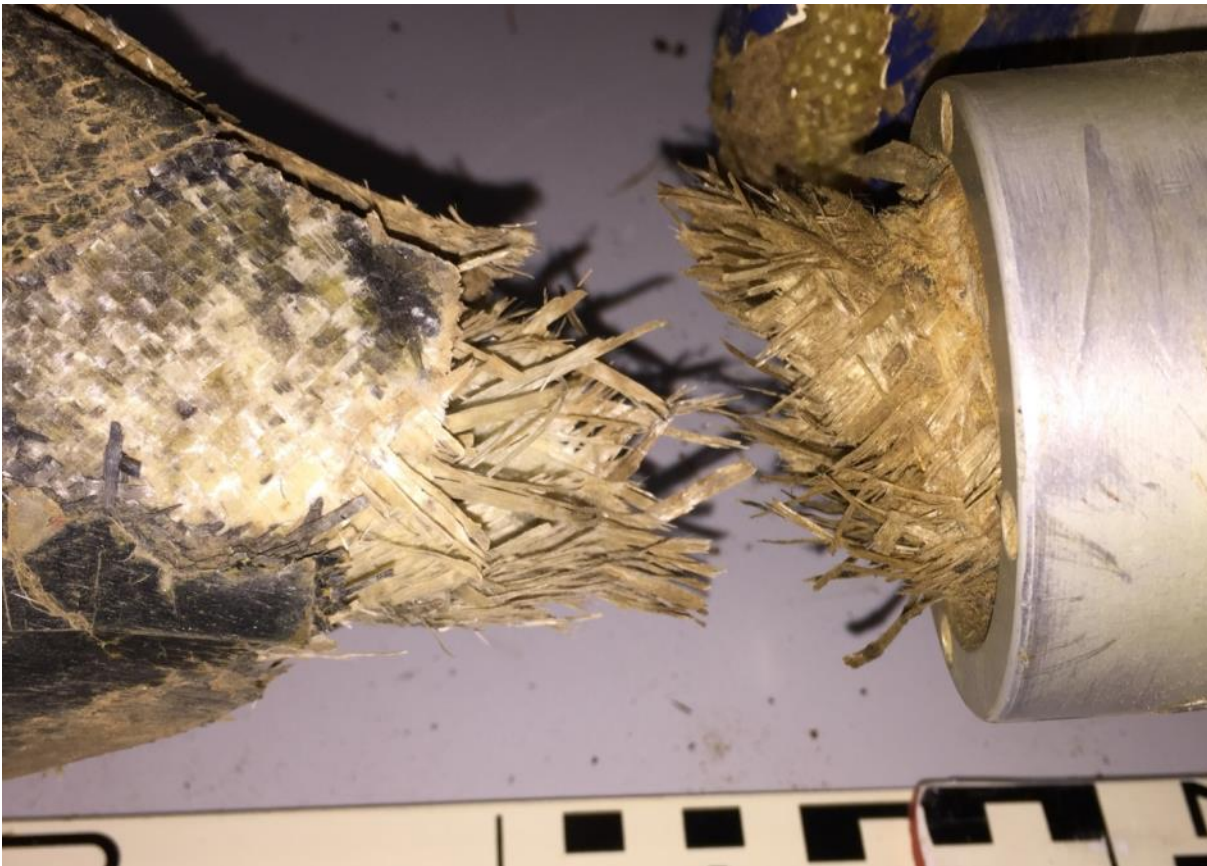
Fracture propeller blade

The fracture surface of the propeller blade found at the accident site showed that the blade had been bent backward toward the fuselage. The opposite fracture surface indicated that the blade had been pulled out of the propeller hub. It is highly likely that one propeller blade had been torn out of the hub during cruise flight and the other remained in the propeller flange until the impact and therefore caused unbalance and heavy vibrations. The vibrations resulted in the opening of the cockpit cover. Because of the open cockpit cover objects from inside the aircraft were flung out and later found on the way to the wreckage.

The BFU has received several reports of damages on the mountings of this propeller type, which cause the loss of propeller blades. The investigation revealed significant exceedance of the maintenance interval and non-adherence to the requirements of the manufacturer. The BFU is of the opinion that adherence to the recommendation of the Service Bulletin LAA CR 1.9.2010 / Sicherheitsmitteilung Deutscher Aero Club e.V., Luftsportgerätebüro DAEC 2012-003 may have indicated material changes of the mountings of the propellers.
