Investigation Report

Type of Occurrence:	Accident
Date:	27 May 2013
Location:	Wolfsbehringen
Aircraft:	Airplane
Manufacturer / Model:	Piper Aircraft Corporation / PA39
Injuries to Persons:	Pilot fatally injured
Damage:	Aircraft destroyed
Other Damage:	Crop damage
State File Number:	BFU CX006-13

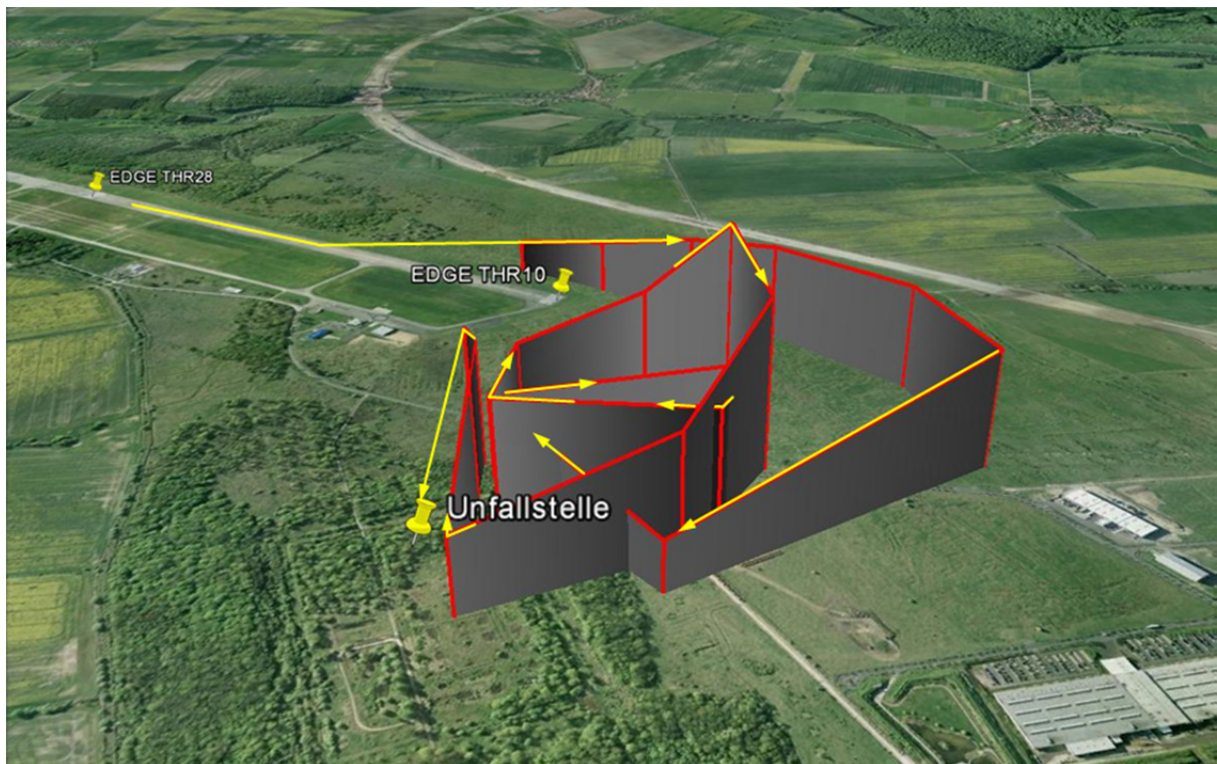
Flight path according to the radar data

According to the radar data the airplane initially climbed to 1,750 ft AMSL and turned right after take-off from runway 28. After the turn had been completed by about 90° the airplane lost about 300 ft altitude and then continued the turn with more changes in altitude. Shortly before it had completed the second full turn it climbed to 2,250 ft AMSL and then lost about 700 ft in a steep descent.

At 0927:34 hrs the airplane reached about 2,000 ft AMSL after it had continued the full right turn and shifted once again into climb. At this point the radar recording ended.

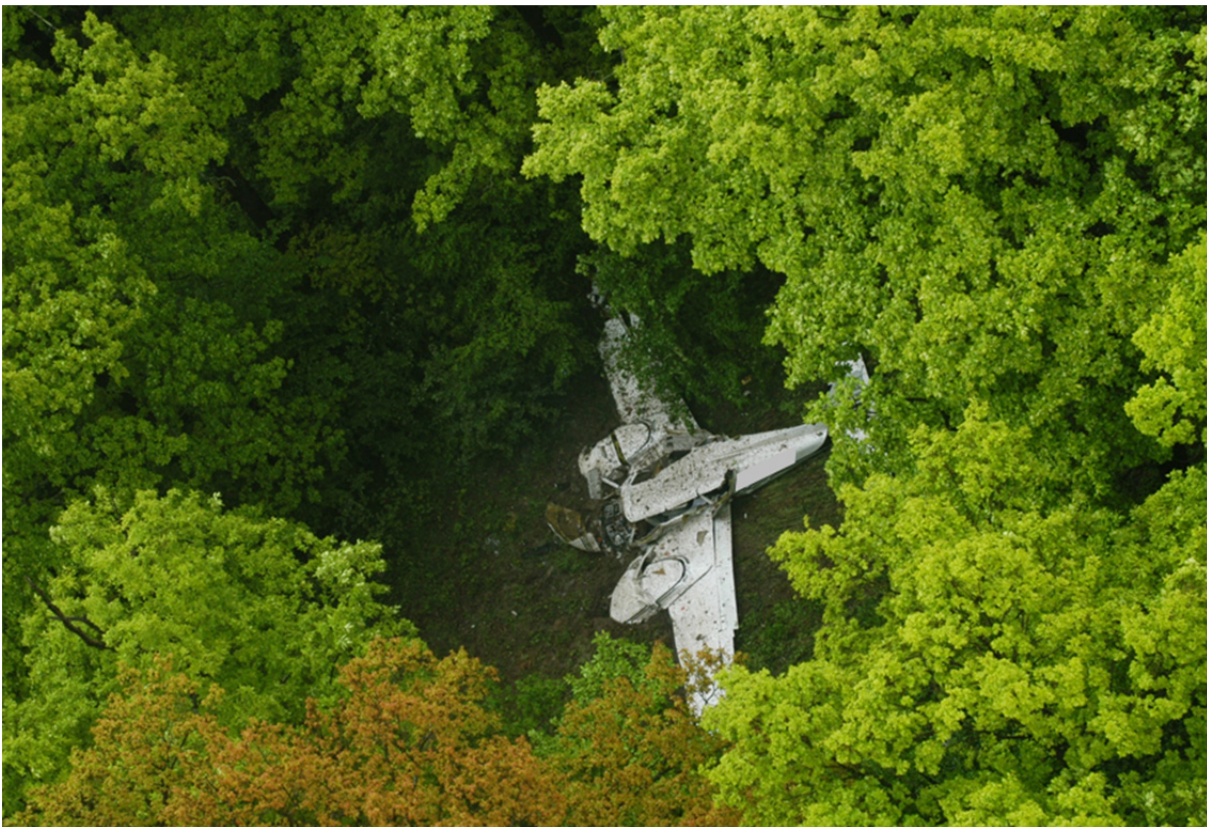
Lying on boggy ground, the wreckage was tilted forward by about 10°. The airplane's longitudinal axis was oriented to 320°. The cabin had split open in impact direction; all cockpit windows had burst. The fuselage and the tail section had been pushed into the aft part of the cabin. In this area the fuselage panelling had partially been torn. The wing leading edges of both wings had been indented. Deformation lines, running almost parallel to the main spar, were visible at the upper and lower wing surfaces. The aileron on the right outer wing section had been torn off. The engine struts in the wings had been compressed. Both engines, including propellers, stuck about 60 cm deep in the boggy ground.

Landing gear and flaps were retracted.

Wreckage and accident site

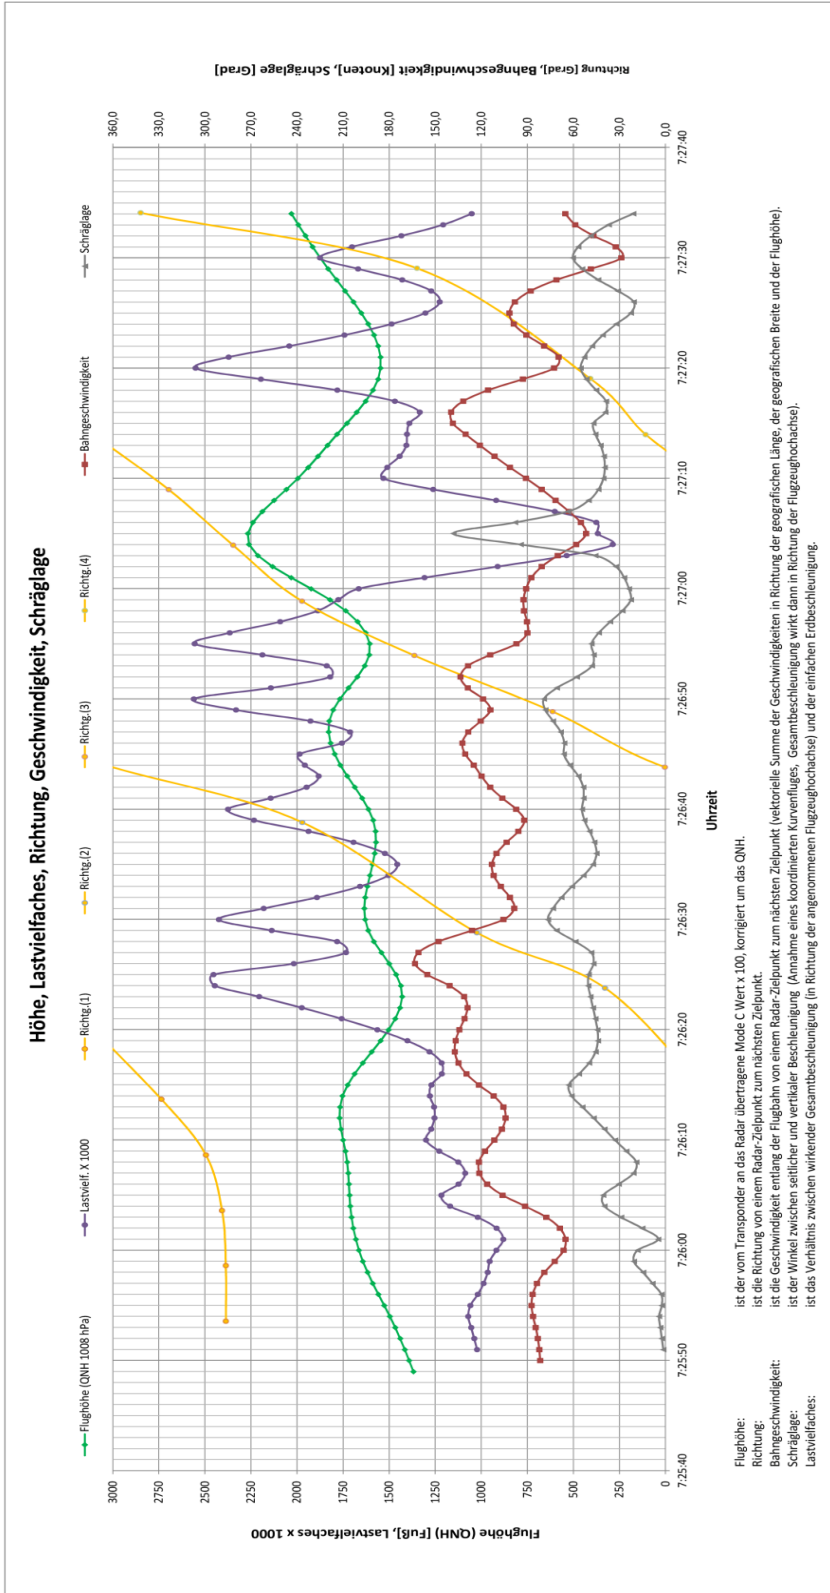
Appendix 1

The radar recording (Appendix 1) had a duration of 95 s and the analysis showed the flight path of the aircraft. During circling the difference between the lowest and the highest altitude recorded was about 1,000 ft. The load factors were calculated and several times reached 2.5 times the acceleration of gravity.

The track speed oscillated between 30 kt minimum and 160 kt maximum. The calculated bank angle oscillated between 30° and 60°.

Radar data analysis

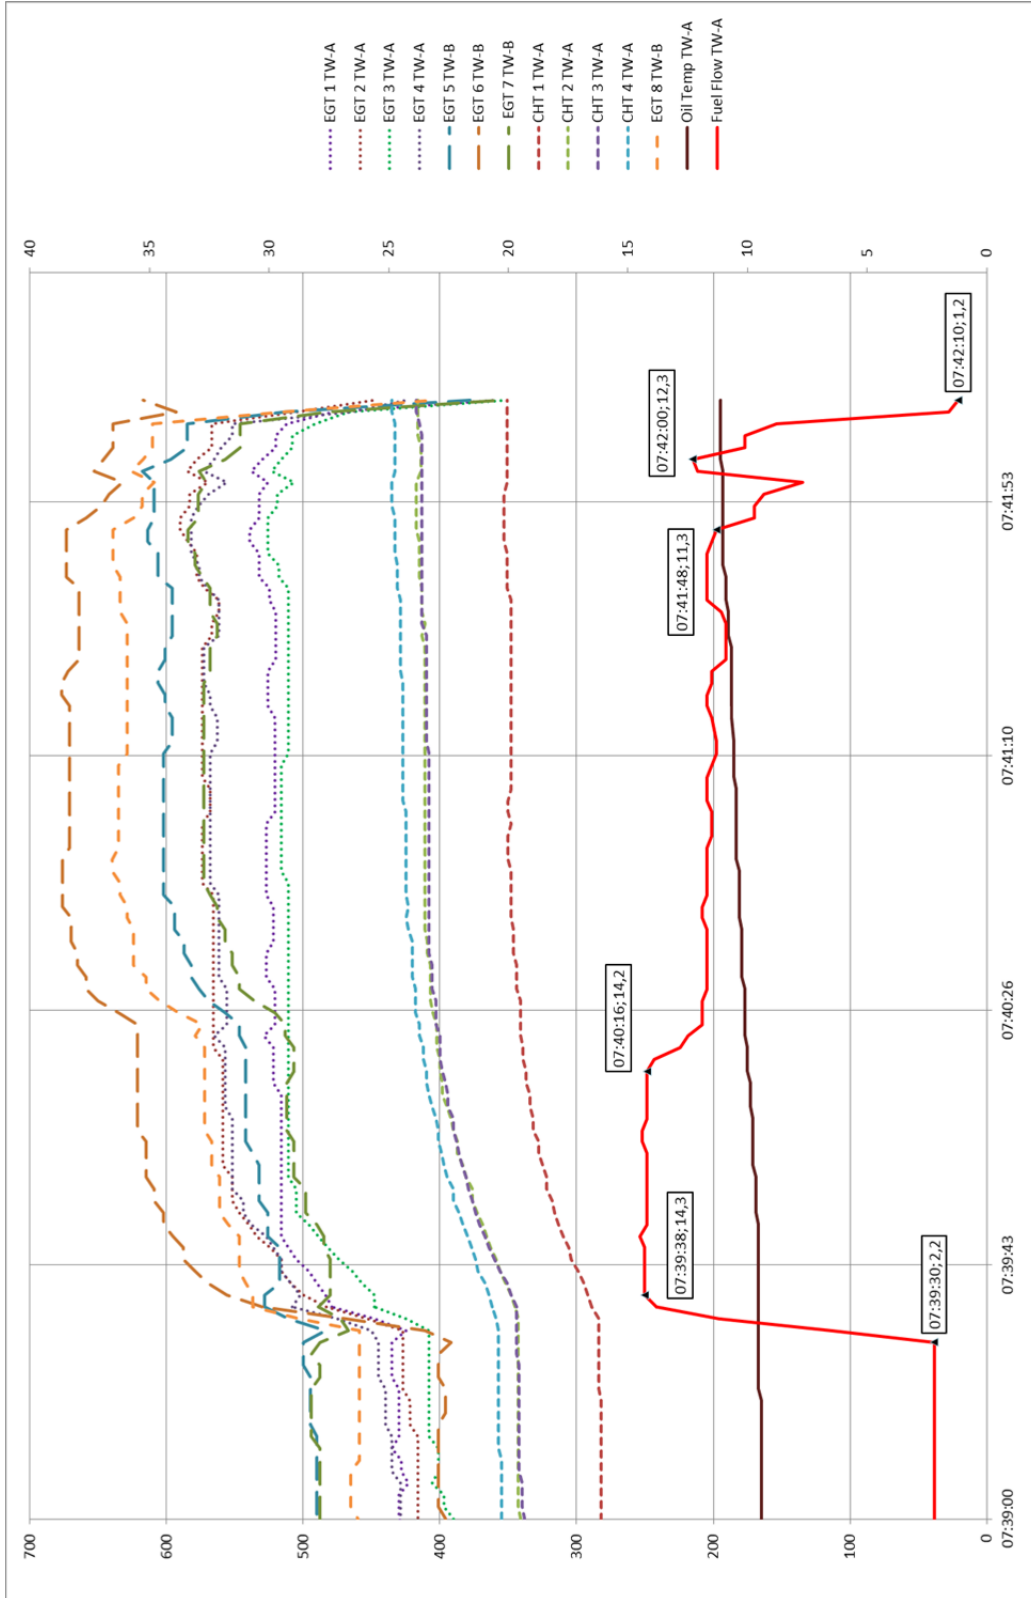
Appendix 2

The analysis of the engine data was based on the data of the EDM 700 (Appendix 2). Correlation of data and right or left engine or individual cylinders was no longer possible. The data showed that from 0739:30 UTC on the fuel flow and the operating

temperature increased continuously (The EDM has an internal clock which is subject to drift and may deviate from the radar time data.). At 0740:24 UTC the EGT value of engine B increased, which may have been caused by leaner fuel-air-mixture. In combination with the decrease in fuel flow at 0741:48 UTC operating temperature also decreased. The subsequent increase in fuel flow ran parallel to the temperature. At 0742:06 UTC rapid decrease of all parameters within 2 s was recorded. The recording ended at 0742:10 UTC.

The data recording showed that no limits were exceeded. There were no signs of engine malfunction.

Engine data analysis
